# Shinsei-maru Cruise Report KS-23-J06C

DONET maintenance

Kumano-nada  
Off Kii-channel

May. 17, 2023- May. 26, 2023

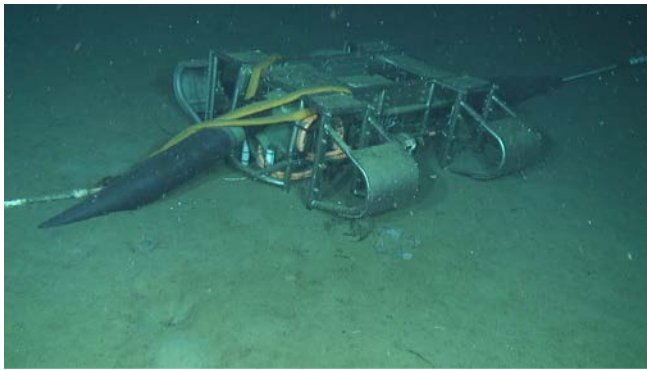
In this dive, the visual inspection of Termination Unit 1E (TU-1E) was conducted. The ROV Hyper Dolphin started dive at 13:28 and arrived at TU-1E at 14:47. The overall main body of TU-1E was covered in patina, and by using a small camera through the maintenance hole, it was conformed that the high-voltage type bulkhead connector was also covered in patina. The visual inspection was ended at 15:28. Miniature transponders ID 31 and ID 70 were collected, and The ROV lefted seafloor at 15:34.

Photo 3.1-1 Termination Unit 1E

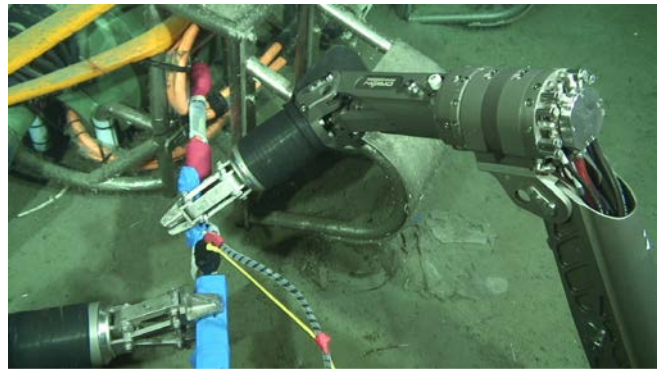
Photo 3.1-2 Checking the bulkhead connector.

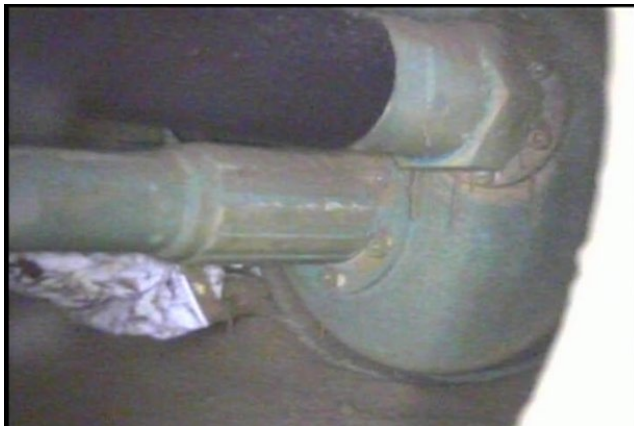
Photo 3.1-3 High-voltage bulkhead connector

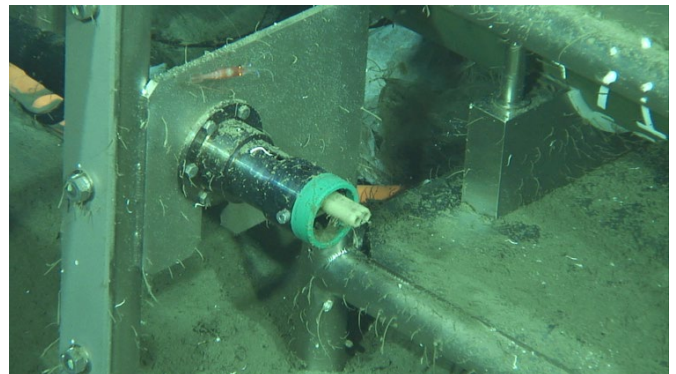
Photo 3.1-4 Damaged Underwater mateable connector

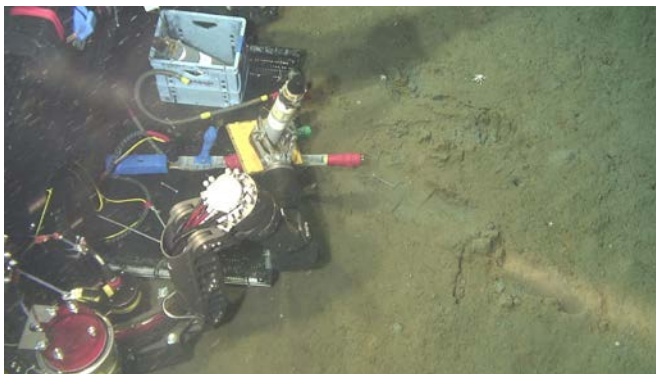
Photo 3.1-4 Recovered miniature transponder.

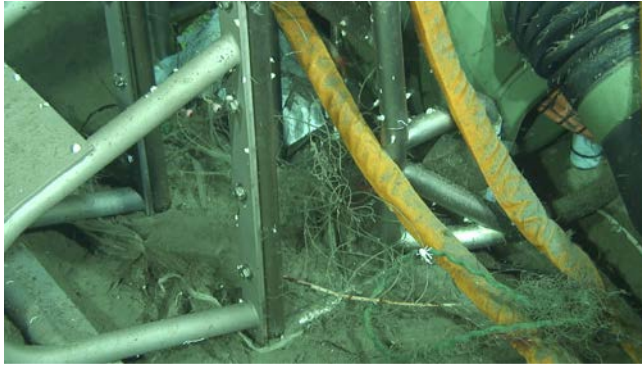
The visual inspection of TU-1E was carried out from different angle than the one in Dive#2208. The ROV started dive at 8:33, and landed on seafloor at 9:41. At First, we attempted to check the high-voltage bulkhead connector through the other maintenance hole, but we gave up on the inspection because debris, including rope, had accumulated near the maintenance hole. Next, the ROV landed around the TU and conducted the inspection of the main body. At last, we checked both side of the submarine cable, the ROV leaved the seafloor at 12:20.

Photo 3.2-1 Debris near the maintenance hole

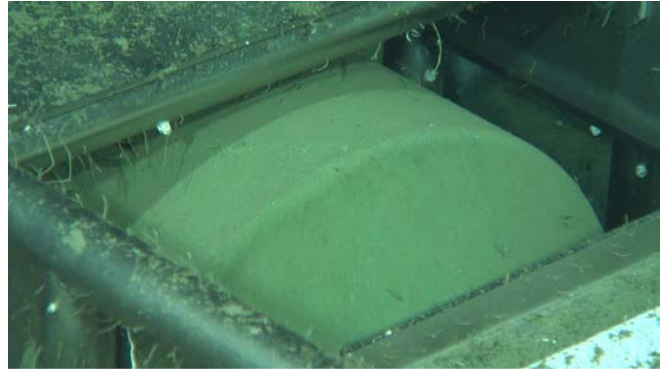
Photo 3.2-2 Main body of TU-1E (Offshore side)

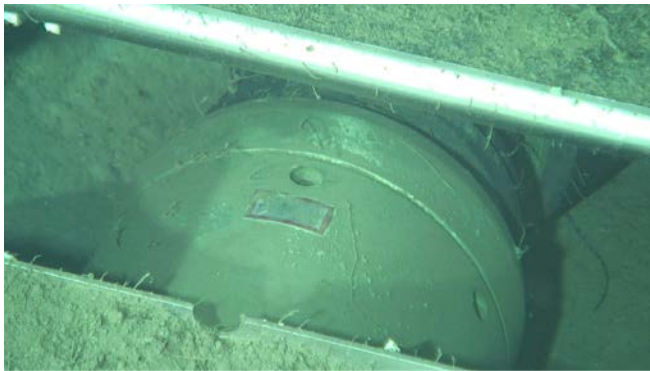
Photo 3.2-3 Main body of TU-1E (Land side).

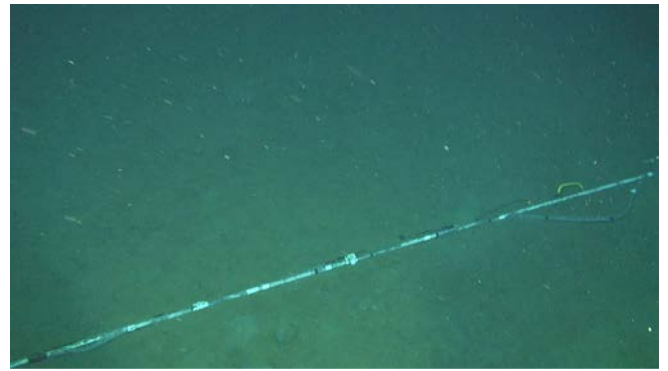
Photo 3.2-4 Submarine cable near TU-1E (Land side)

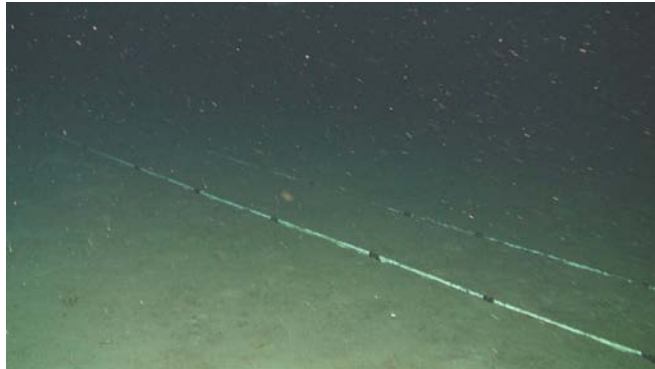
Photo 3.3-1 Branch cable

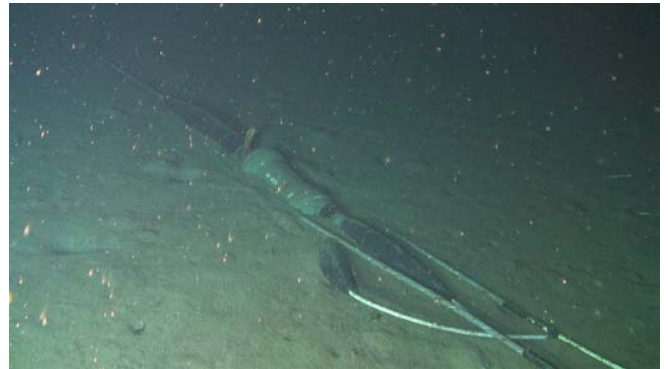
Photo 3.3-2 BU-1E

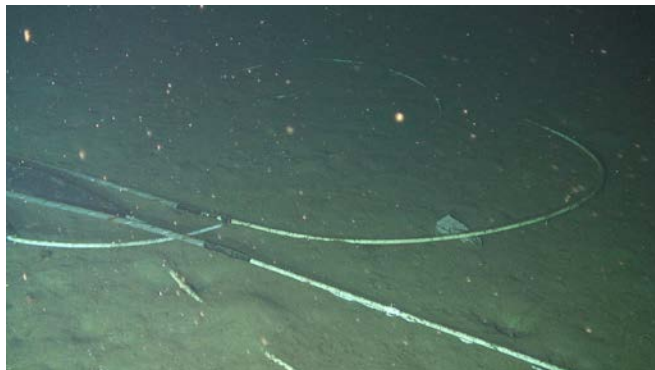
Total 150m long laid cable was checked and we confirmed that the cable was laid normally except brunch side of looped cable.

Photo 3.3-3 Looped cable at brunch side

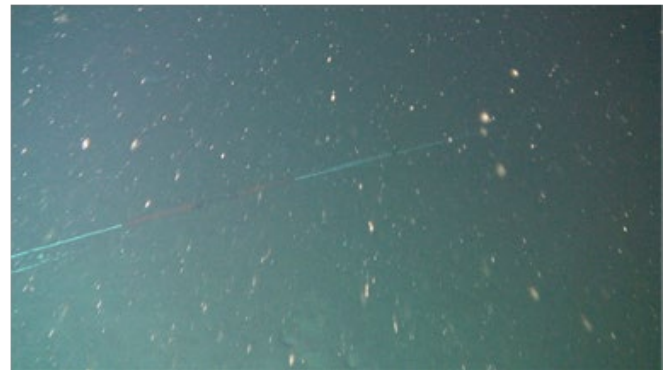
Photo 3.3-4 Universal Joint (branch cable)

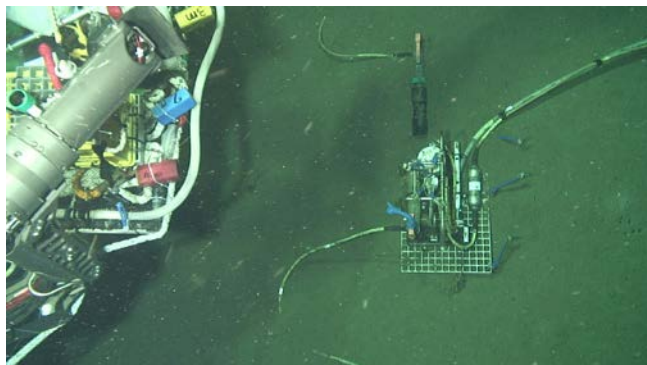
In this dive, the DONET Sensor unit that consists of the ground motion sensing system and the pressure sensor package was recovered due to the trouble in the wide band seismometer. The pressure sensor package is linking with the ground motion sensing system by a cable, and the extension cable from the science node and the cable from the battery equipment connected to the pressure sensor package by using underwater mateable connectors (UMC). After landing on the seafloor, the ground motion sensing system was pulled out from the caisson and then the connectors for extension cable and the battery equipment were pulled out. After that, the rope for recovery was hooked on the ground motion sensing system and the pressure sensor package respectively. Lastly, the ROV Hyper-Dolphin left the seafloor at 15:20.

Photo 3.4-1 Pressure sensor package

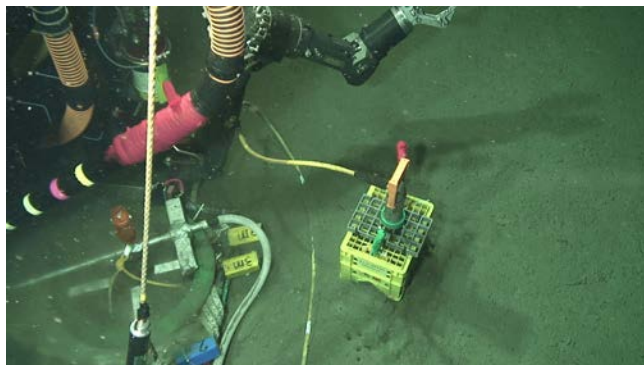
Photo 3.4-2 UMC (Extension cable)

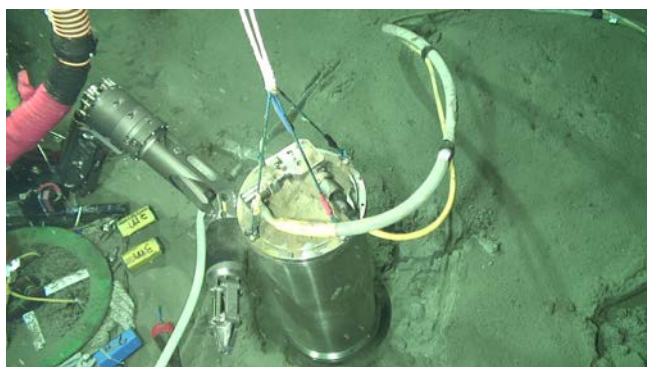
Photo 3.4-3 ground motion sensing system
