# CRUISE REPORT

(KY08-03 R/V 'Kaiyo')

**JAMSTEC**

**June 2008**

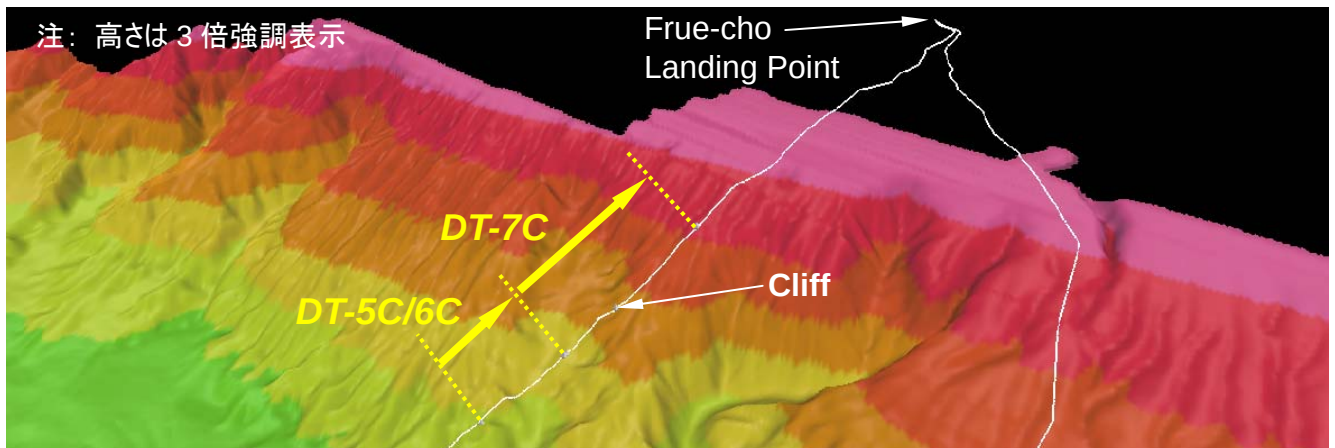
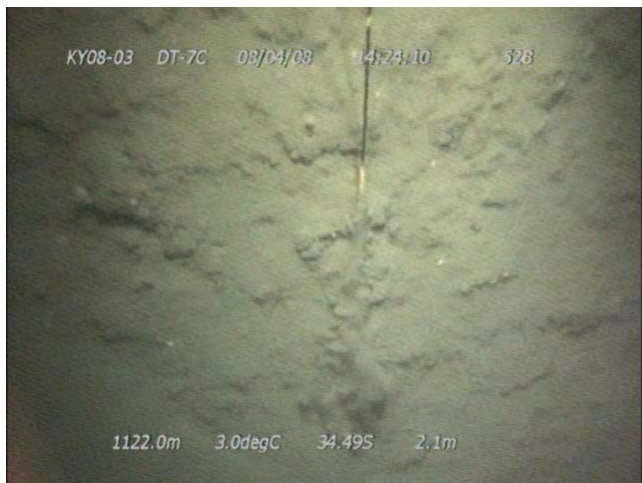
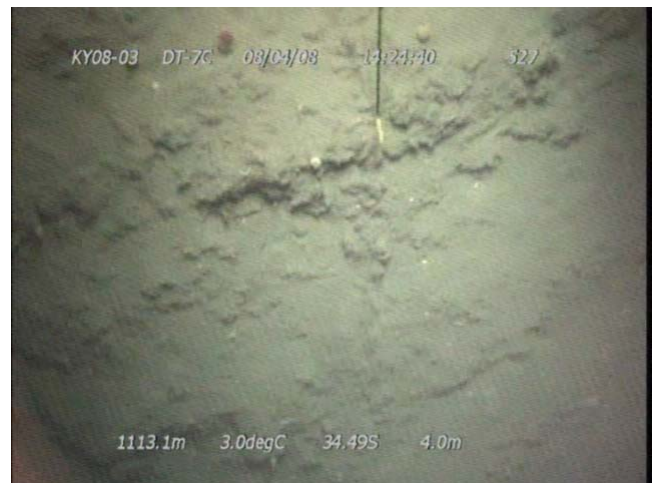
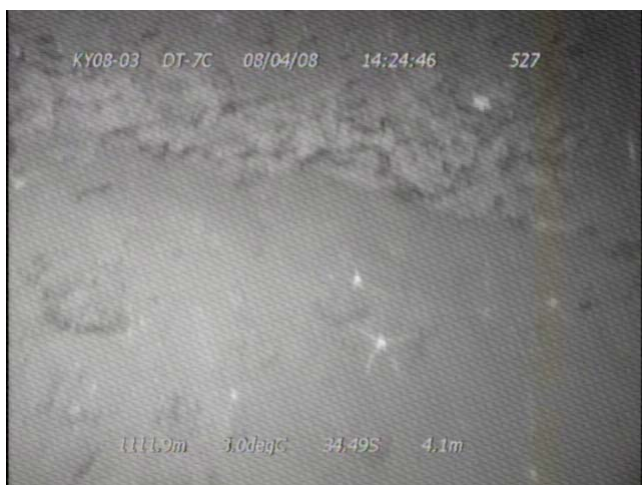
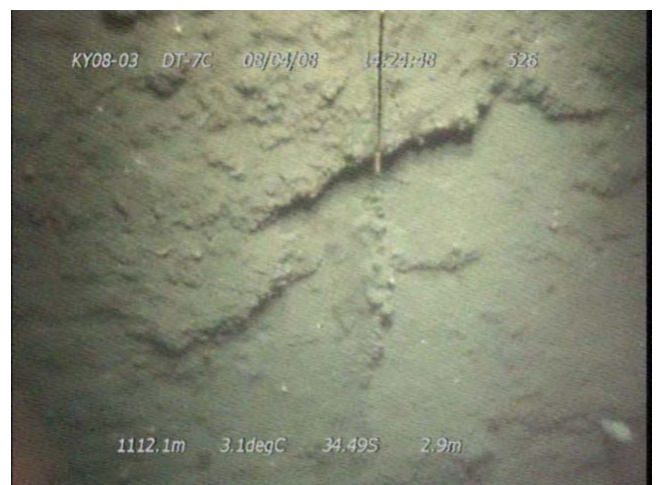
(2) DT-5C (2008/04/07), DT-6C/7C (2008/04/08)

DT-7C で、基幹ケーブルルート上に崖の存在確認。

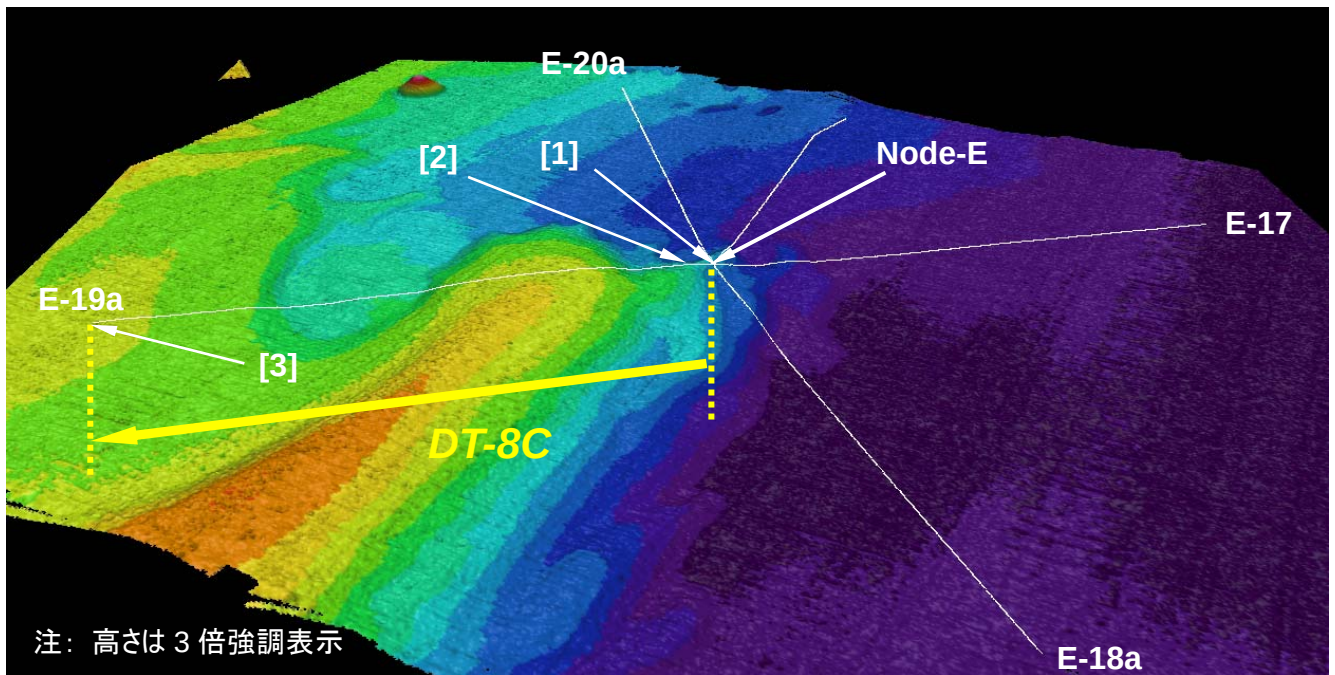
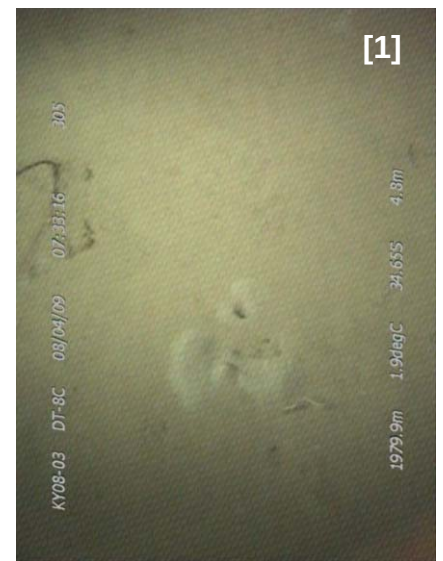
(3) DT-8C (2008/04/09)

Node-E～E-19a 間は展張ケーブルルートとして適。

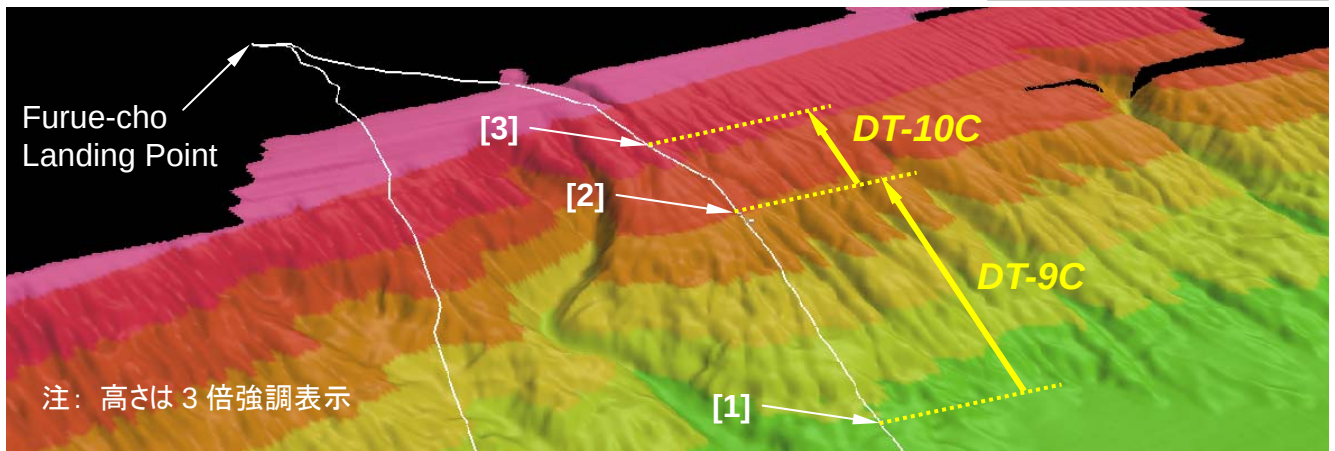
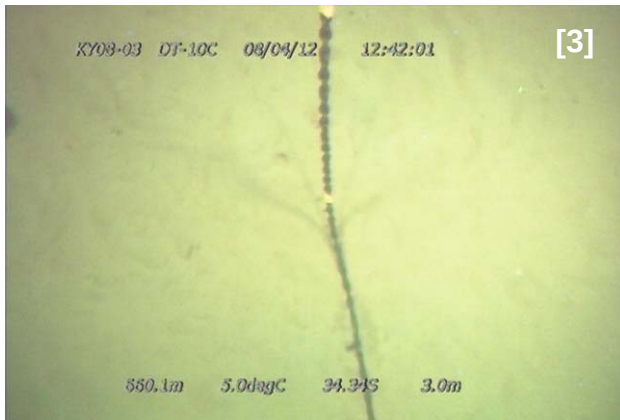
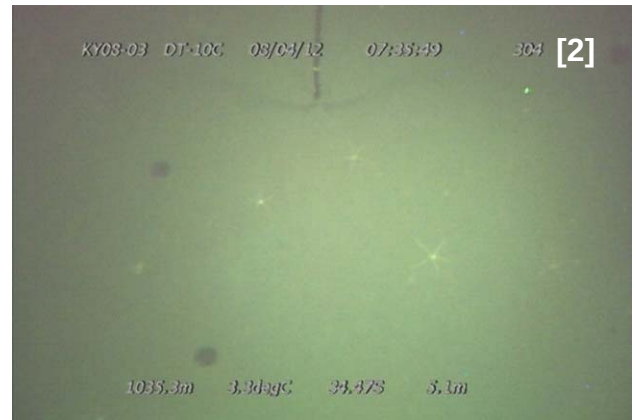
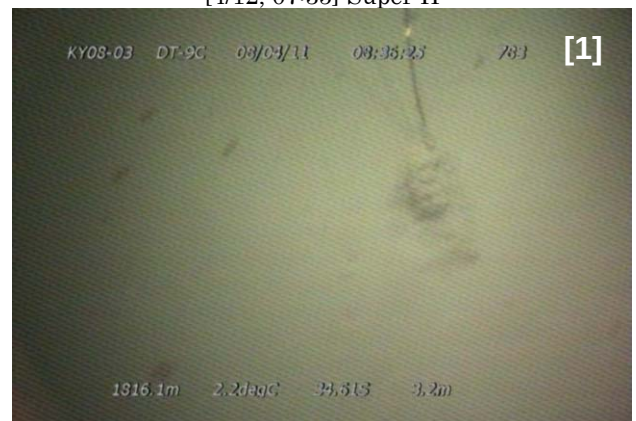
(4) DT-9C (2008/04/11), DT-10C (2008/04/12)

基幹ケーブルルートとして適。

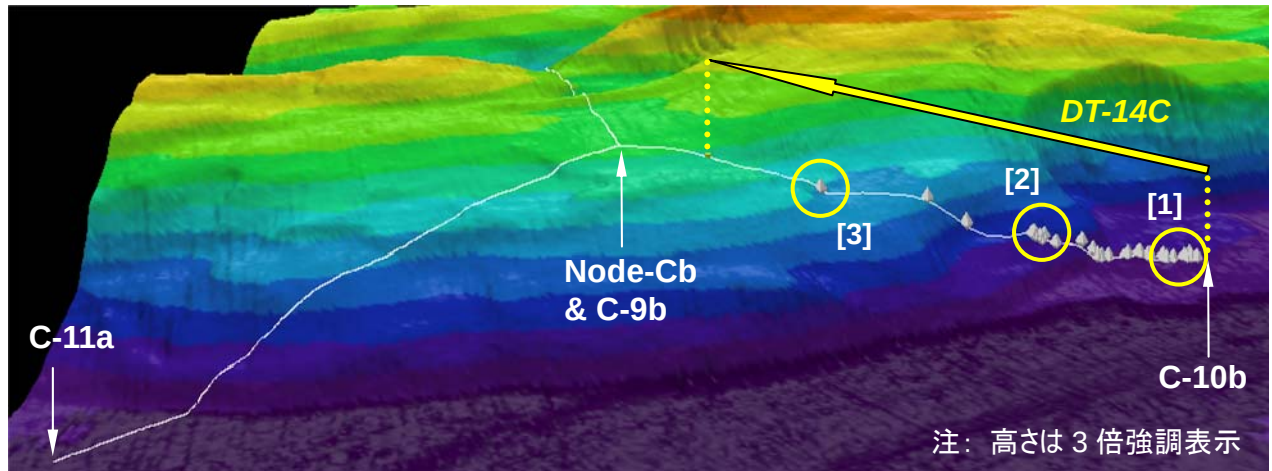
### (1) DT-14C (2008/04/16)

C-10b から Node-Cb に向う展張ケーブルルートは継続して検討する必要あり。

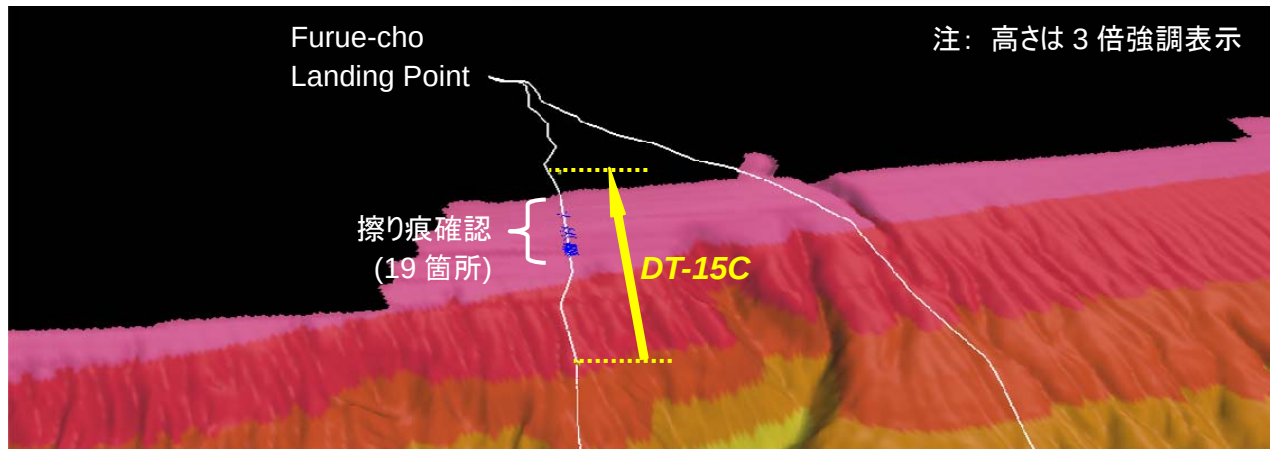
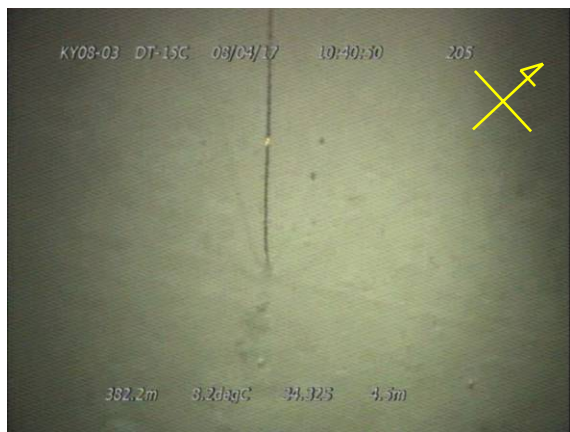
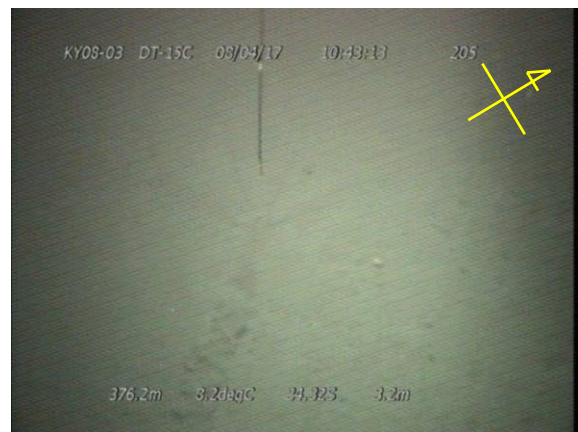
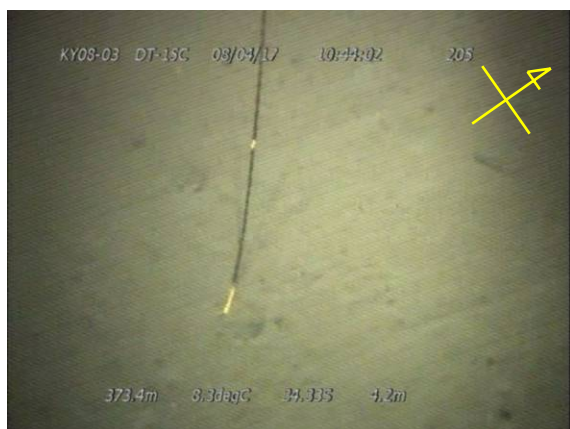
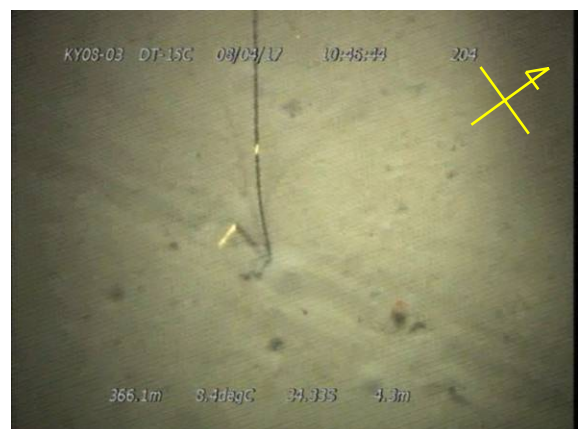
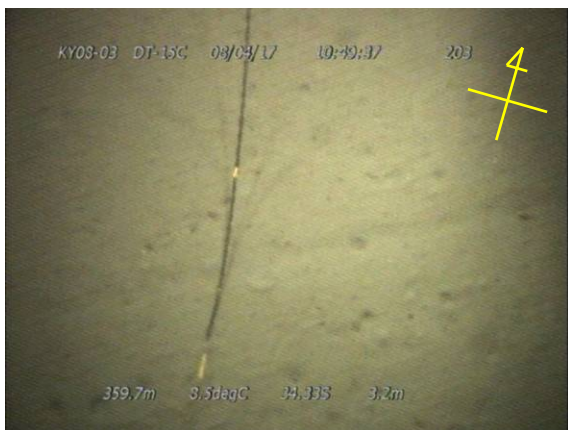
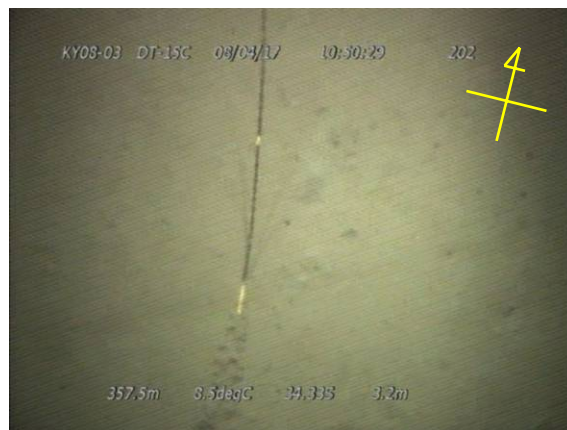
(2) DT-15C (2008/04/17)

水深 250m~390m 区間に人的活動の痕跡(19箇所)を確認。

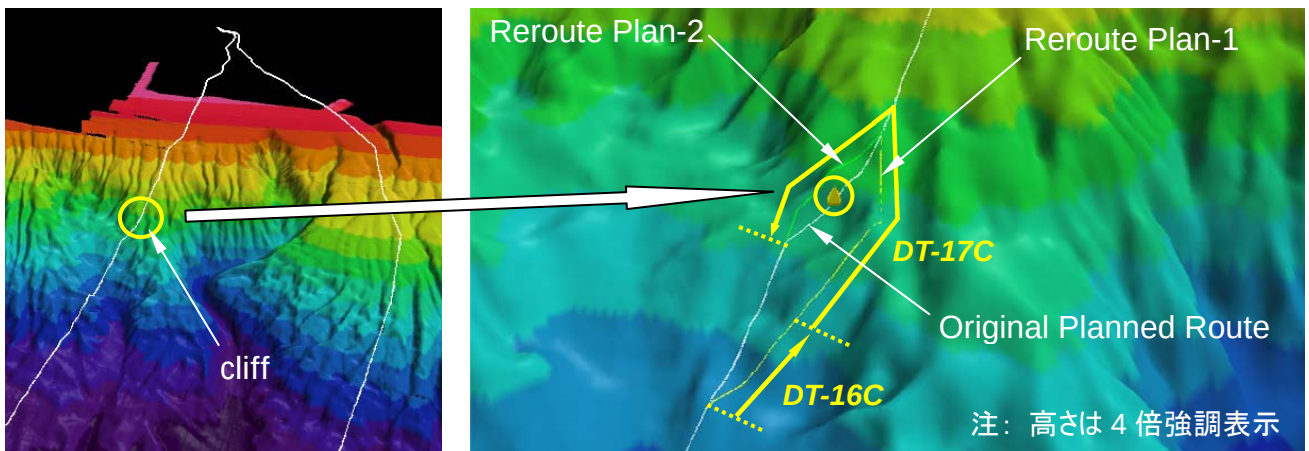
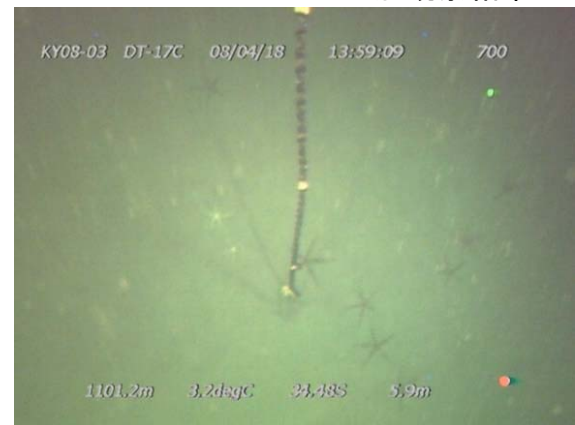
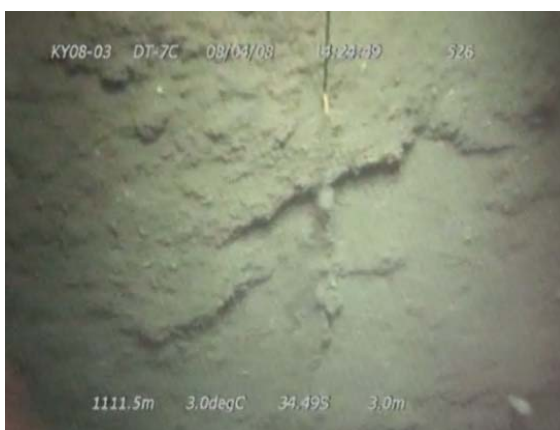
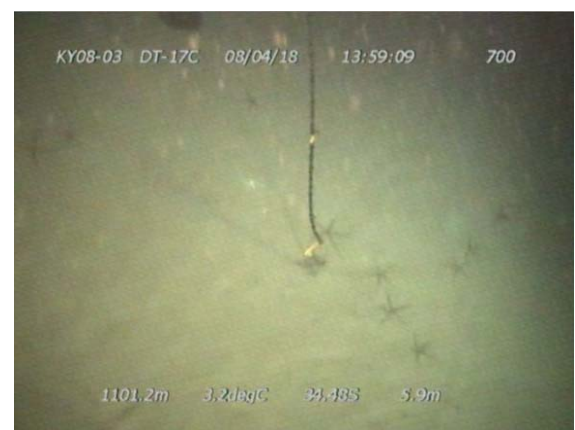
(3) DT-16C/17C (2008/04/18)

DT-7C で確認された急峻の迂回ルートを確認。

DT-7C で観察された急峻

Reroute Plan-1 での地形観察結果

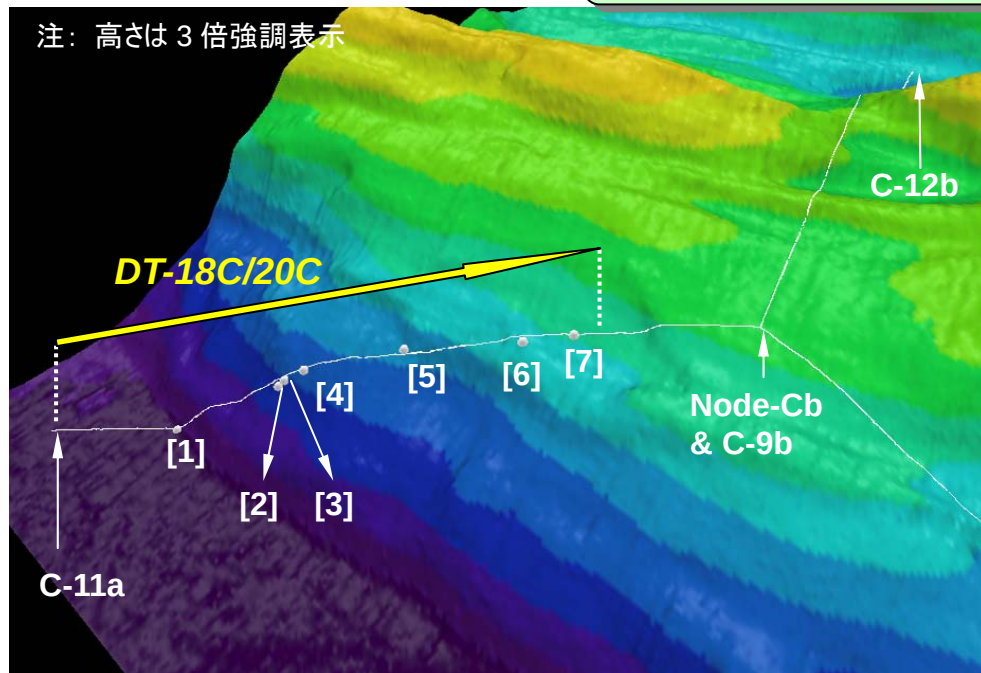
(4) DT-18C (2008/04/19), DT-20C (2008/04/21)

C-11a から Node-Cb に向うルートは、海底面が粗いものの展張ケーブルルートとして採用。

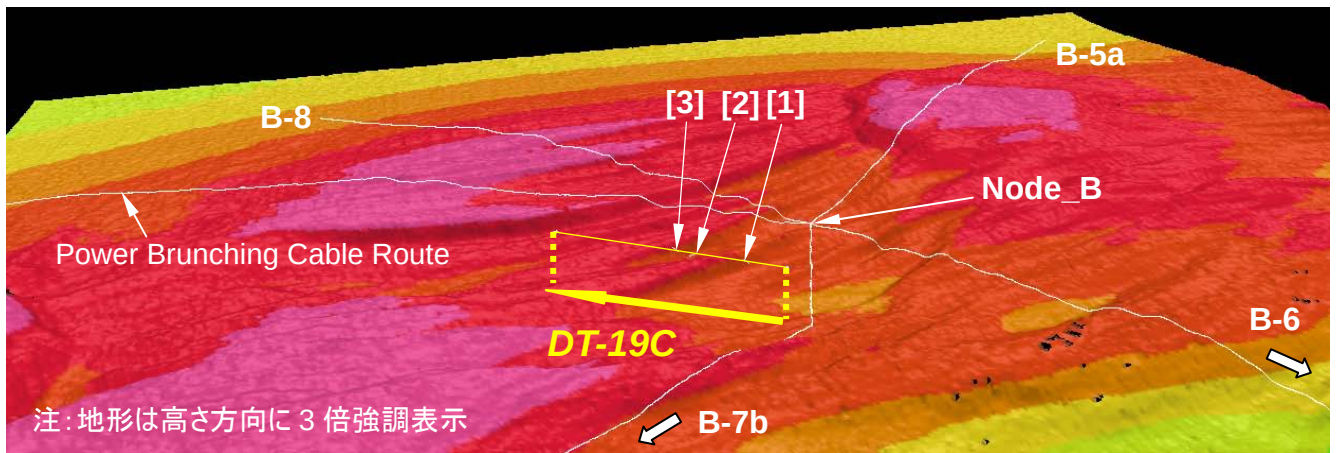
(5) DT-19C (2008/04/20)

B 海域の旧給電帰路ケーブルルート上に、急峻の存在を確認。

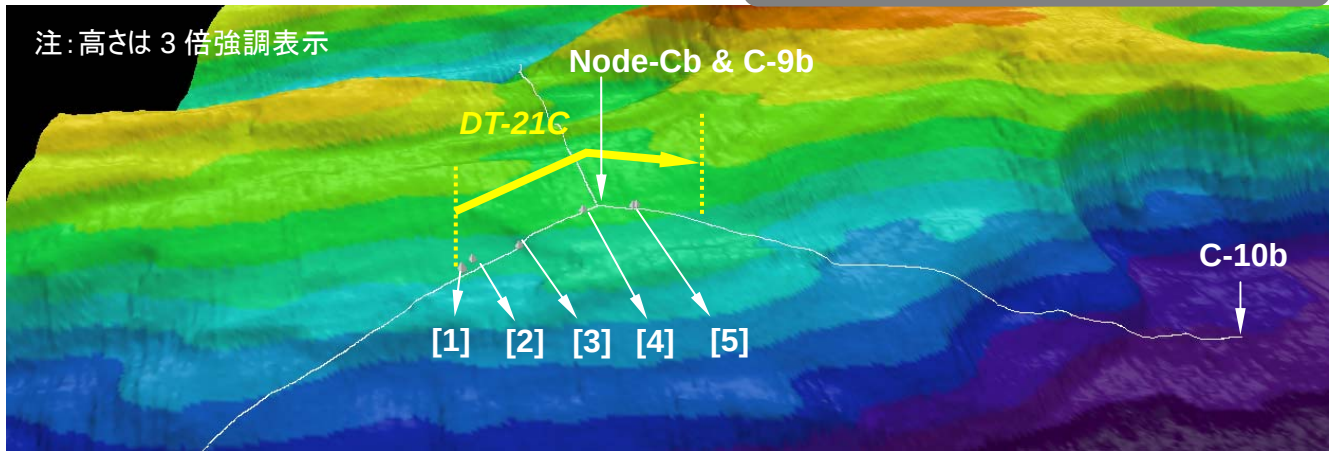
(6) DT-21C (2008/04/22)

Node-Cb/C-9b 付近は海底面が粗いため、観測装置設置場所の微修正を検討する必要があります。

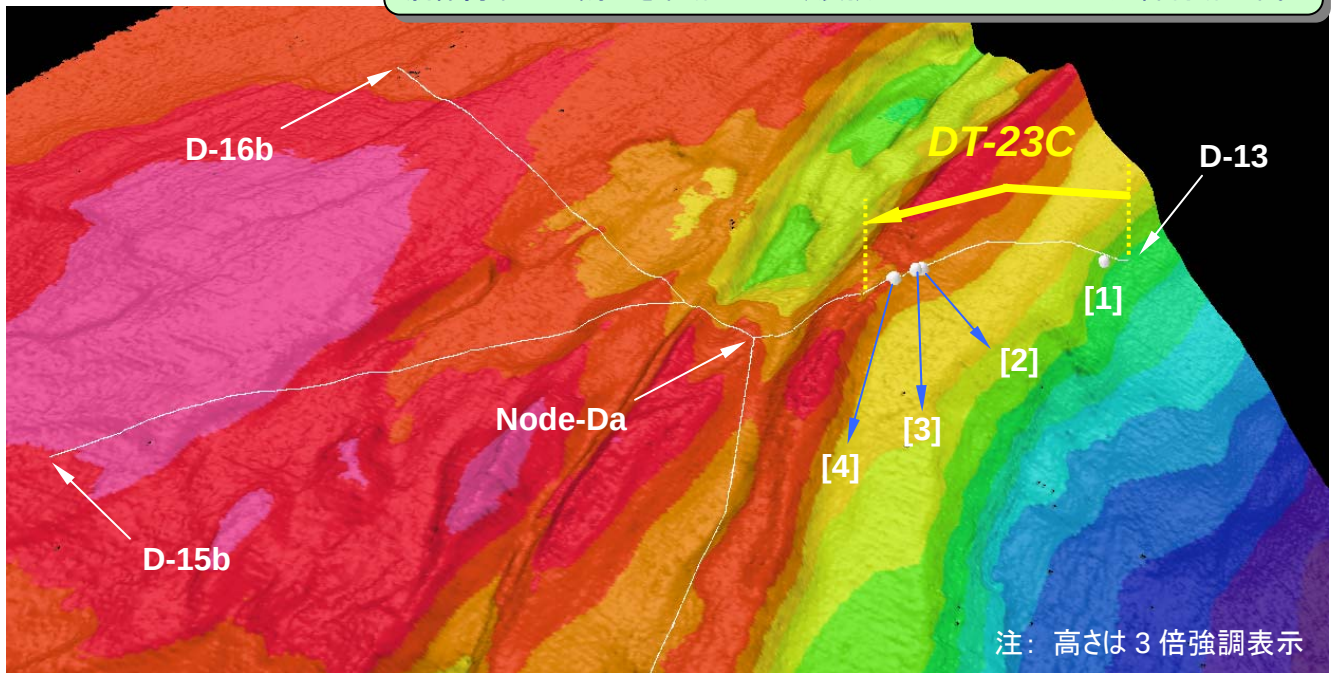
(8) DT-23C (2008/04/23)

D-13～Node-Da 方面に向う展張ケーブルルートは、粗い海底面が続く。途中曳航体拘束により調査を中断したため、展張ケーブルルートとしての適否判断は未。

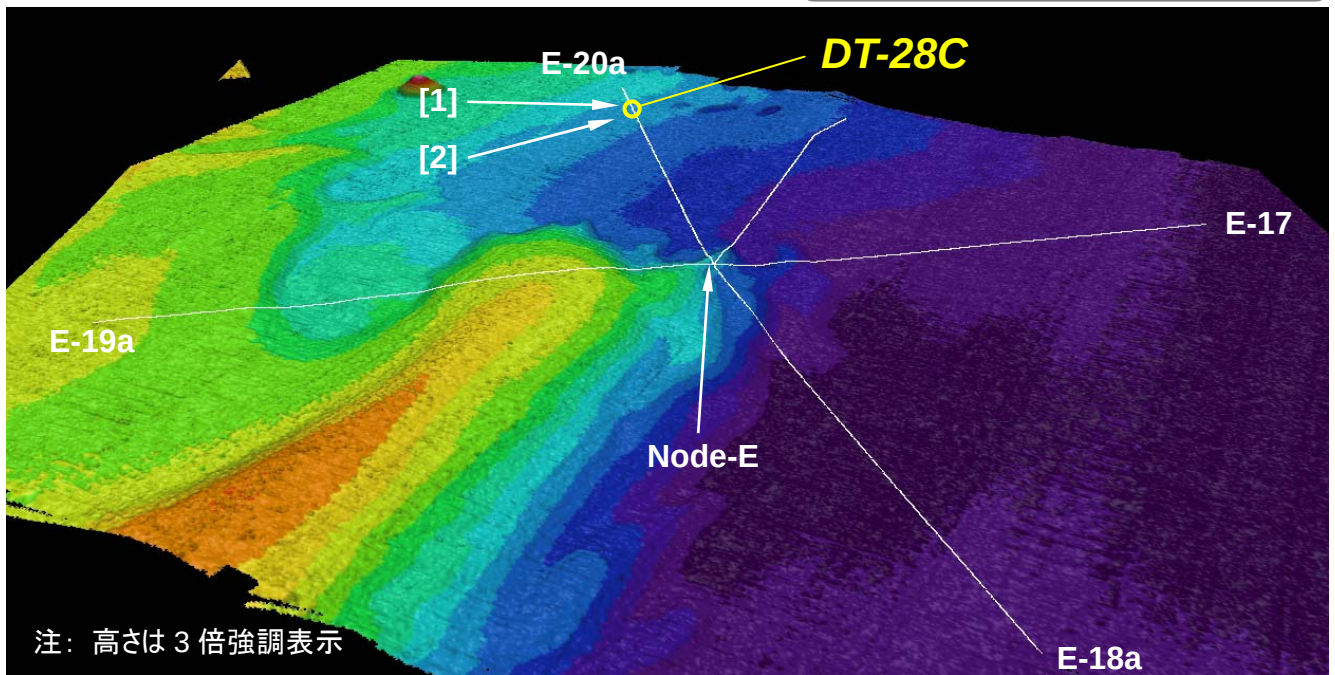
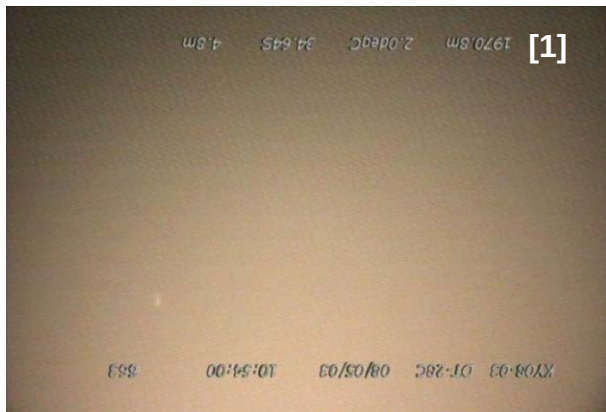
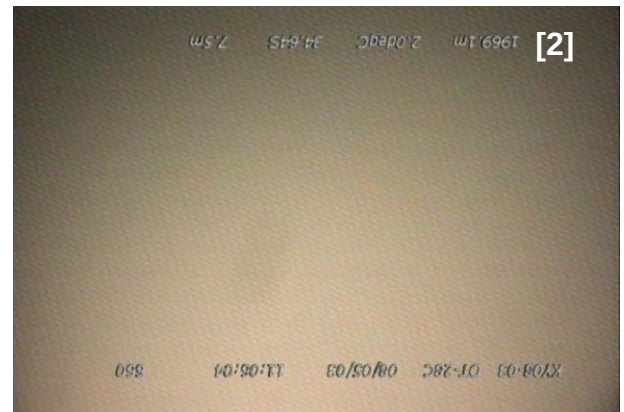
(1) DT-28C (2008/05/03)

E-20a～Node-E の展張ケーブルルートの調査は、濁りが激しく視界不良のため中断。

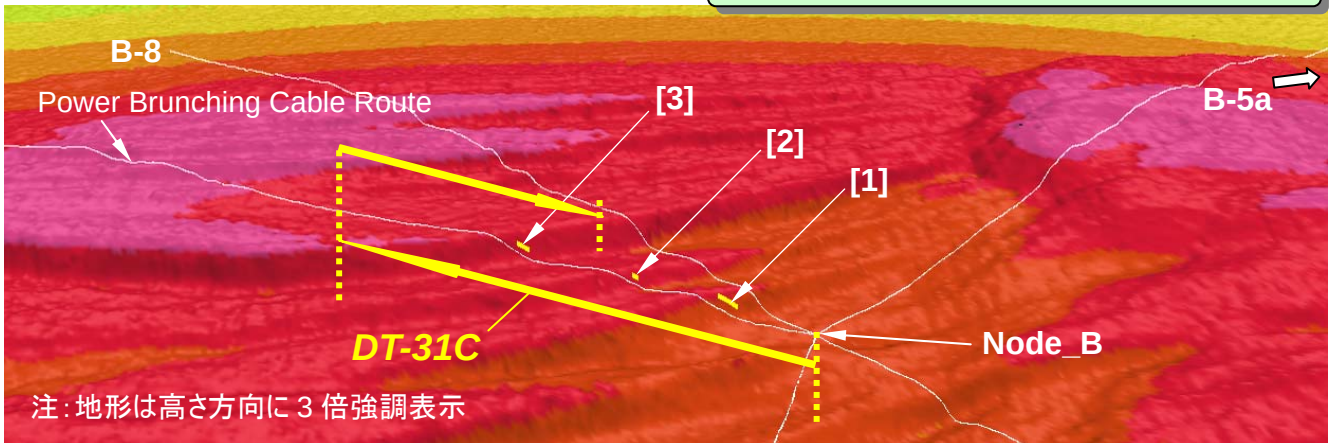
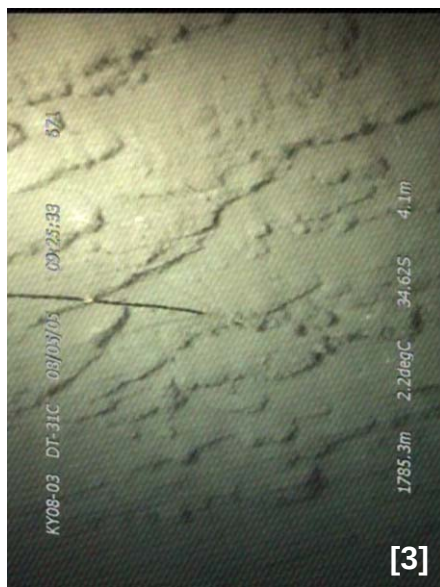
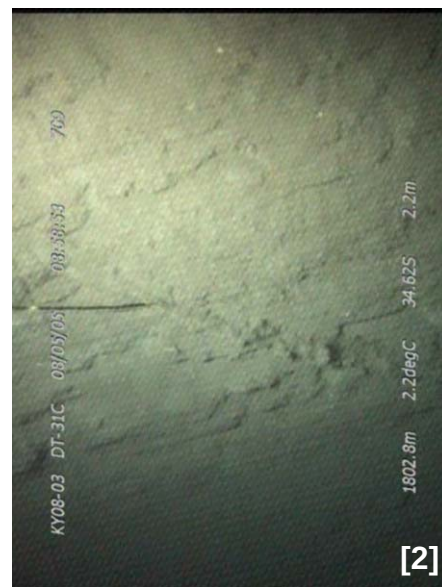
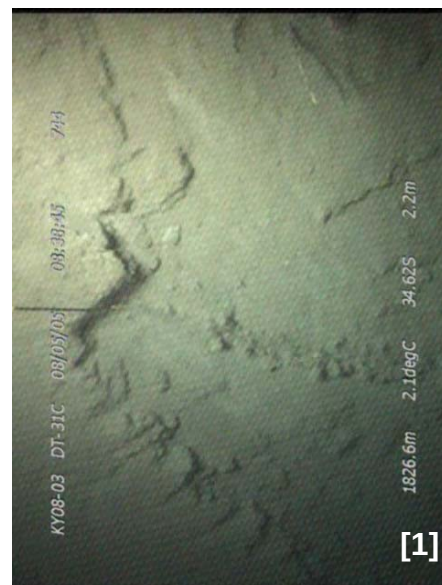
(4) DT-31C (2008/05/05)

B 海域の給電岐路ケーブルルート上に急峻を確認。

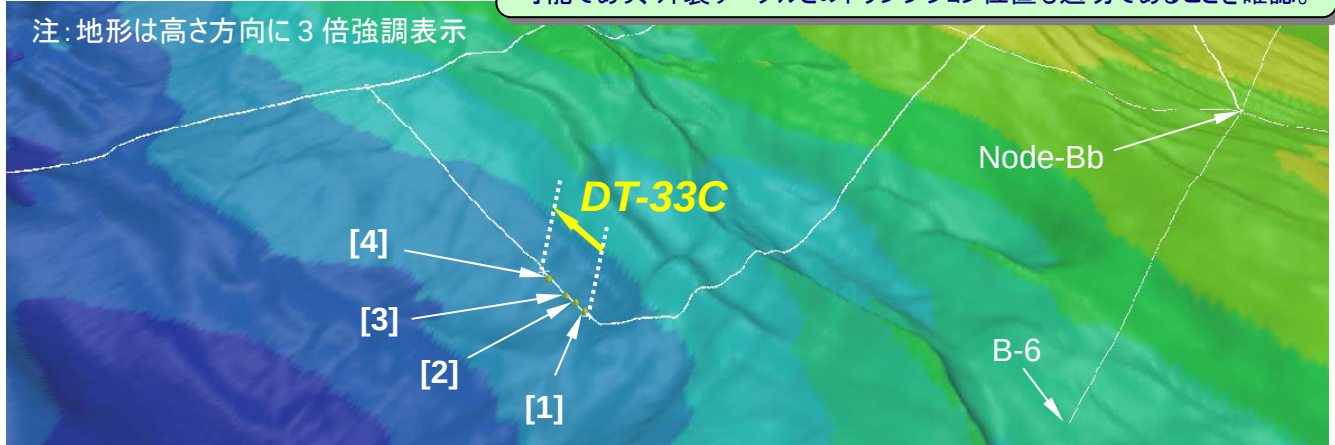
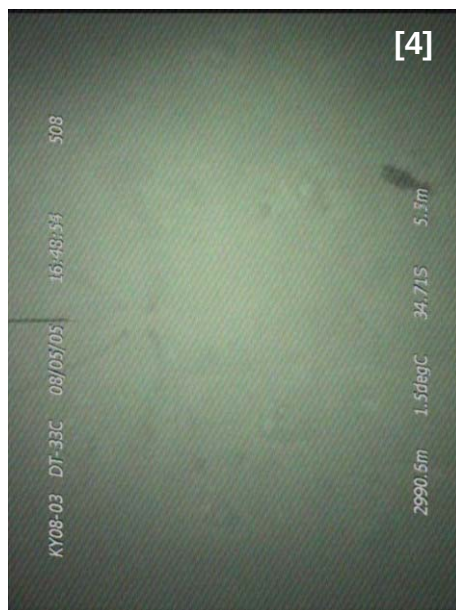
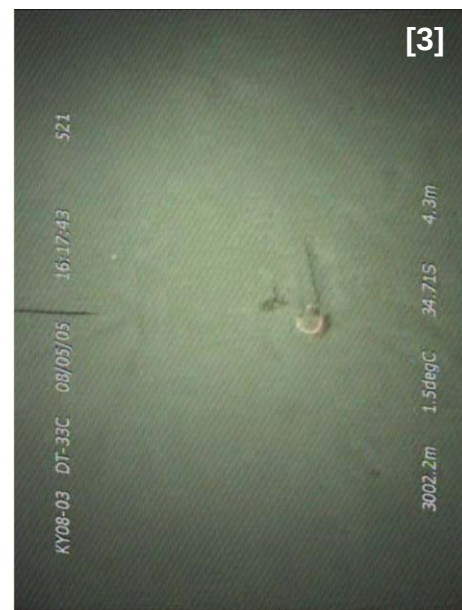
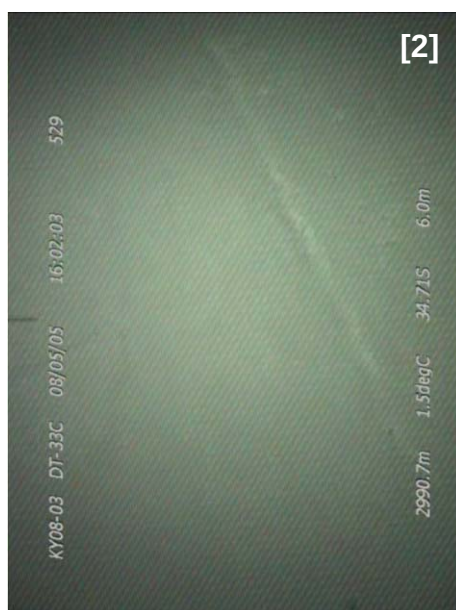
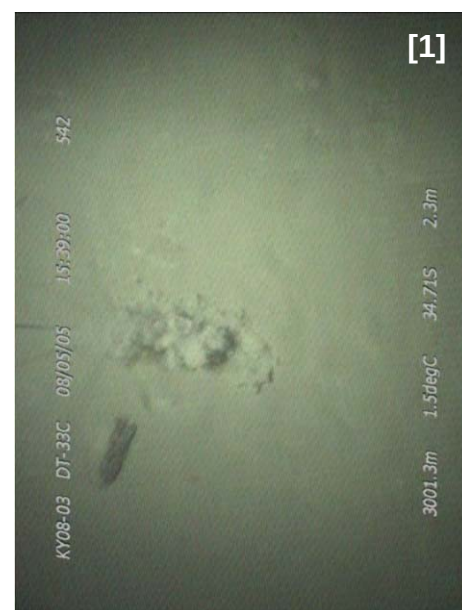
(5) DT-33C (2008/05/05)

熊野舟状海盆から南海トラフに降りる斜面は、無外装ケーブルの適用が可能であり、外装ケーブルとのトランジション位置も適切であることを確認。
