Kaimei Cruise Report KM18-09

Development of continuous real-time observation system for crustal deformation

Kumano-nada

13 October 2018 - 20 October 2018

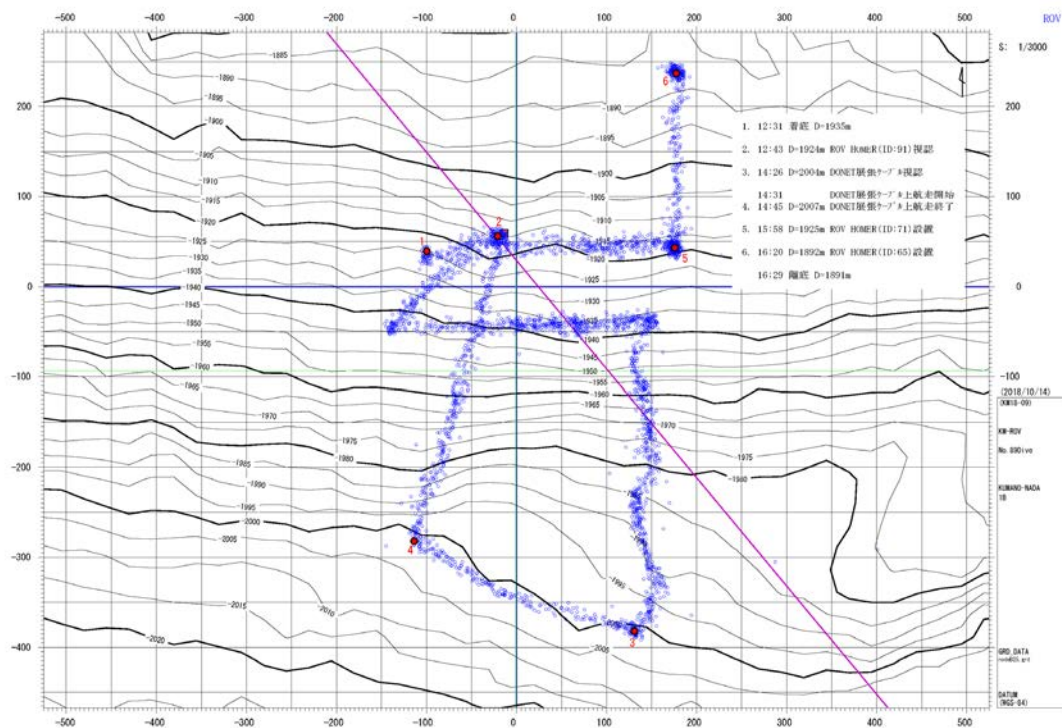
Fig.3-1 Trace line of KM-ROV Dive#89

In this dive, site survey was carried out. At first, KM-ROV moved to point-2 in figure 1 where the miniature transponder #91 was put by HPD in DIVE#2069 KS-18-J06 and we started search the extension cable of observatory site 1B-6 of DONET1. The extension cable was confirmed from point-3 to point-4 where is almost 200m away from planed line that is showed by purple line in fig.1. And KM-ROV back to the point-2 to observe the condition of the seafloor. The condition of the seafloor from point-2, point-5 to point-6 was tight sand and almost flat. We decided the drilling point where is also observation site of tilt meter. KM-ROV was leaved from point-6 of seafloor at 16:29.

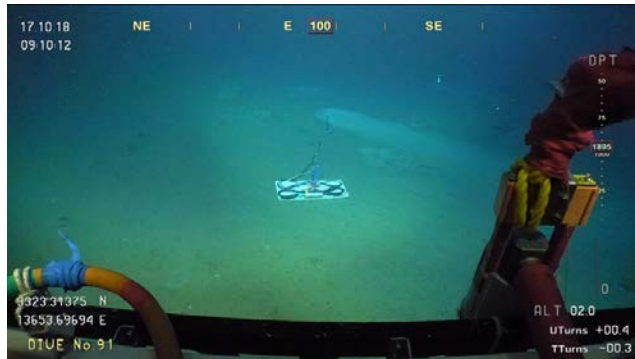
KM-ROV arrived at the borehole BMS#7 at 9:13 and started to check the tiltmeter that was installed in Dive#90. (Fig. 3-7) When the tiltmeter turned on, the alarm of insulation failure was issued. Though the underwater mateable connector was unplugged/mated three times (Fig. 3-8), the fault did not improve. So, we decided to recover the tiltmeter. The underwater mateable connector, cable and tiltmeter were recovered to the sample basket. KM-ROV leaved the sea floor at 11:11.

Fig. 3-7 the borehole and underwater mateable connector

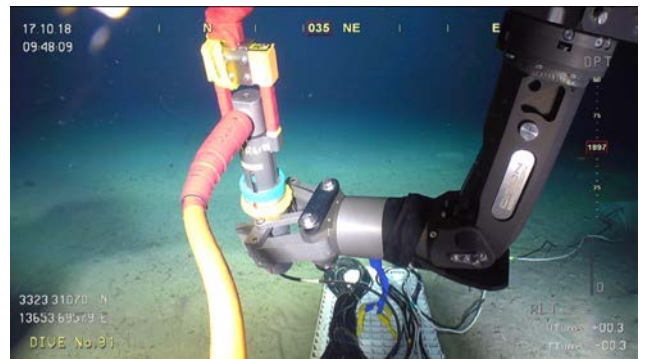
Fig. 3-8 Connect to check the tiltmeter

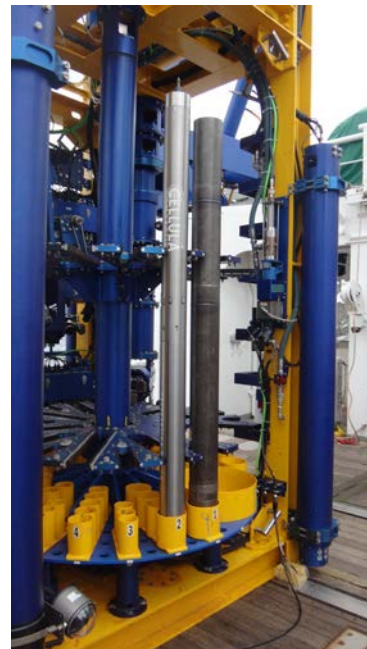
Inside the deployment module contains three section. From bottom to top, there are a sensor unit, cable storage, and the underwater mateable connector with float. The deployment module is lowered to the bottom of the borehole using wireline system after usual drilling operation. The module releases a sensor at the bottom and payout the cable inside the borehole when the module is recovered. At last, the connector is unfastened when the recover work is finished, and the connector with float appears over the borehole.

Figure 3-11 shows the deployment module set in the carousel of the BMS. (fig. 3-11)

Fig. 3-11 The deployment module was set in the carousel (Silver cylinder)

The function of the deployment module was checked in this dive. The deployment module was developed to install a sensor into the borehole after the drilling operation at single dive.

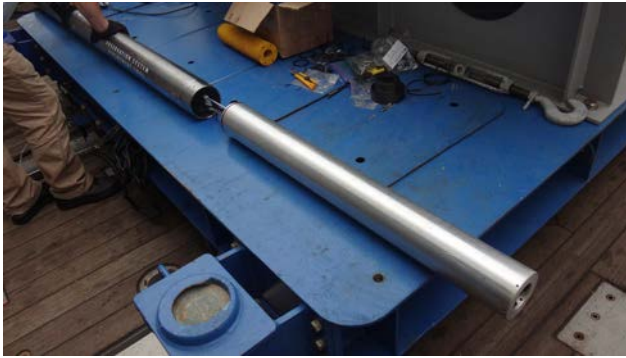
Fig. 3-12 Dummy sensor

BMS was landed at 10:00, and started drilling operation at 10:11 after the status of the attitude was confirmed. The borehole of 2.589mbsf was drilled using 146T drilling tools and the sea trial of the deployment module was conducted. The dummy sensor (Fig. 3-12) and connector were successfully installed as planned. (Fig. 3-13) The operation time was 2 hours and 25 minutes and BMS leaved the sea floor at 12:44. The position of the borehole is 33-23.340N 136-53.938E at 1879m depth.
