R/V Kaimei Cruise Report  
KM21-11

Development of continuous real-time monitoring  
technology for seafloor deformation

Kumano-nada, off Kii-suido and off Hatsushima

Japan Agency for Marine-Earth Science and Technology  
(JAMSTEC)

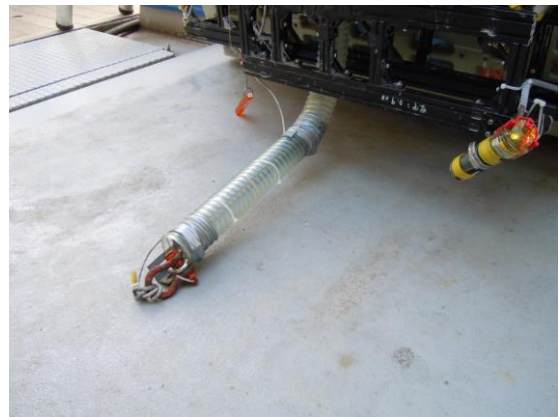
Fig. 2 Hopper and attachment tube on KM-ROV

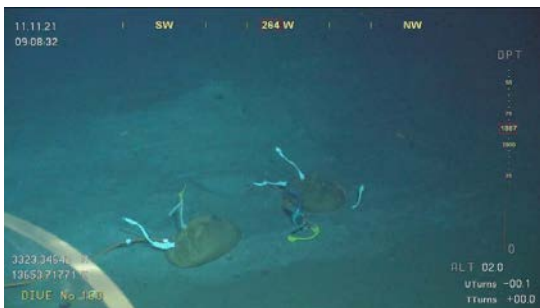
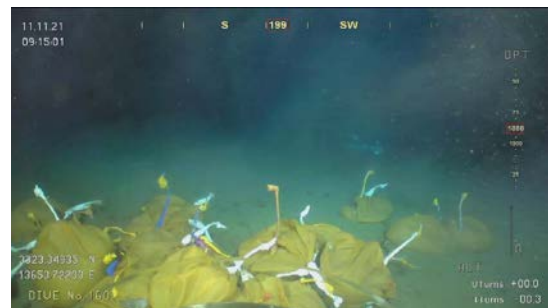
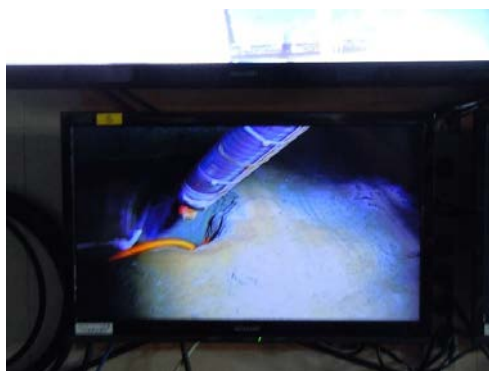
Fig. 3 KM-ROV #160 dive operation

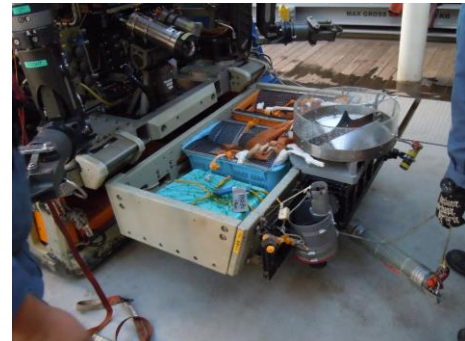
Fig. 5 Recovery of the mortar sample

At the last dive i.e., KM-ROV #162 dive, one of the mortar samples was recovered (Fig. 6).

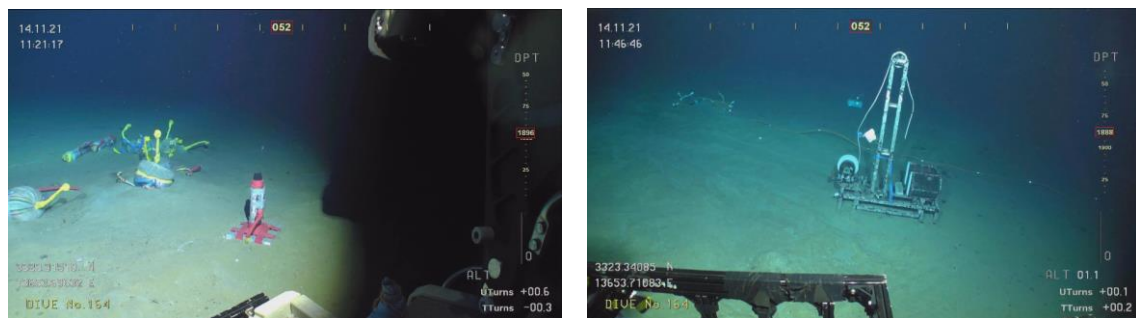
Fig. 7 The Lily tilt-meter site (left) and the equipment for deployment

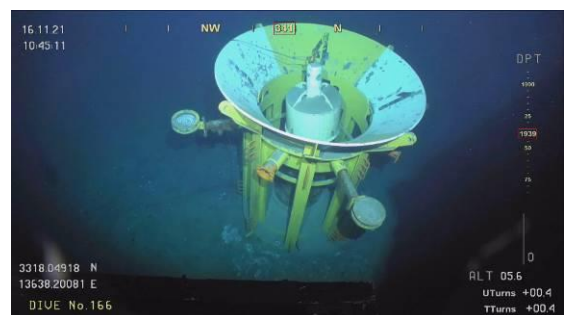
Fig 11. Photo taken at C0002 site
