KAIMEI Cruise Report  
KM21-E01

Development of continuous real-time observation system for  
crustal deformation

Kumano-nada

19-31 January 2021

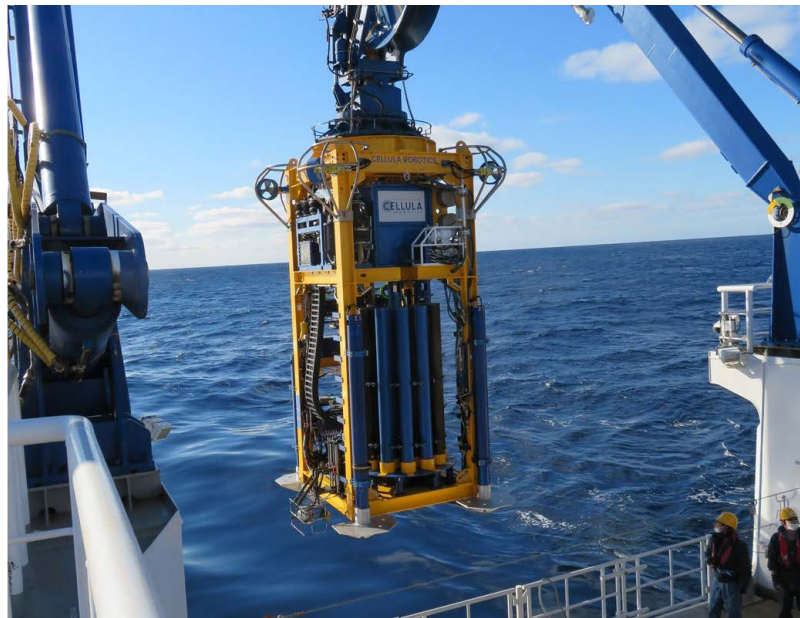
Fig 3-1 Boring Machine System (BMS)

Drilling operation was conducted to construct the borehole for the tiltmeter. The BMS landed at 33-23.344N 136-53.716E where the depth is 1,881m. The distance between the DONET connection interface unit and the landing point was 67.3m that was measured using the miniature transponder ID:68 on the interface unit. The BMS started drilling operation at 10:58 using the customized drilling tools. The depth of borehole BMS#13-1 was 19m below sea floor. The drilling tools recovering operation was finished at 22:24. Then the BMS shifted to the next drilling point named BMS#13-2. The position of the BMS#13-2 is 33-23.343N and 136-53.686E, the depth is 1880m. The second drilling operation was started at 23:19 and finished the drilling operation at 02:51 in 21<sup>st</sup> Jan. the borehole BMS#13-2 was made using 5 drilling pipes, and the depth of the borehole is 12m below sea floor. The drilling tools was recovered at 05:27 and the BMS leaved the seafloor.

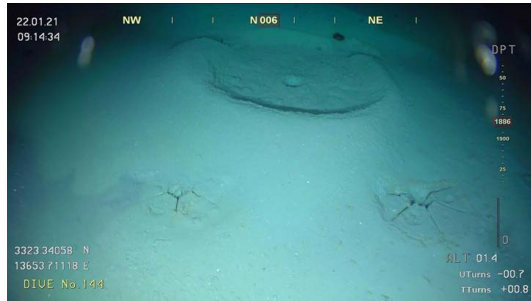
Fig. 3-2.1 Borehole BMS#13-1

In this dive, KM-ROV had made flat place on the seabed to place the sensor installation device. in addition, weights were put near the borehole for weight adjustment of KM-ROV when the sensor will be installed. At first, KM-ROV landed southern side of the borehole, and cleared the mud using a suction pump named Dorothy. KM-ROV put two 20kg-weights and a miniature transponder ID:57 and moved toward the borehole BMS#13-2. We glanced at the BMS#13-2 and KM-ROV leaved the seafloor.

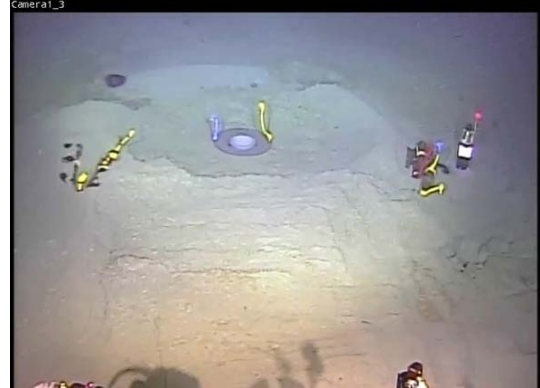
Fig. 3-4.2 borehole protector

Before dive, we started mortar mixing work from 8 am, and the mortar was pumped to the tank mounted on the back of KM-ROV from 2 pm to 4 pm. The dive was started at 16:51, and KM-ROV landed near the borehole BMS#13-1 at 18:05. The mortar was flow down into the borehole through the 20m hose using mortar pump and the borehole was filled with mortar up to 2m from the bottom. KM-ROV leaved the seafloor at 21:41 and back to the deck at 22:48.

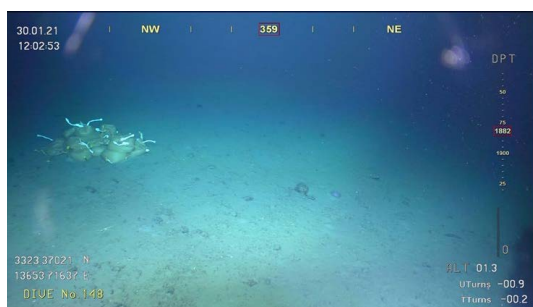
Fig. 3-6.1 Sandbags of Group #1

In this dive, the sandbags which were dropped on the seafloor on 26 January were moved near the borehole BMS#13-1. The sandbags were in two groups on the seabed. we found Group#1 at 33-23.377N, 136-53.704E in depth of 1,881m and Group#2 were in 33-23.377N, 136-53.713E in 1,883m depth. Miniature transponder ID:60 was put near the group#2. Three sandbags were located outside the two groups, so KM-ROV picked them up and carried them to the borehole BMS#13-1 and conducted trial of burial operation. 18 sandbags were carried near the borehole BMS#13-1, and then KM-ROV leaved the seafloor.

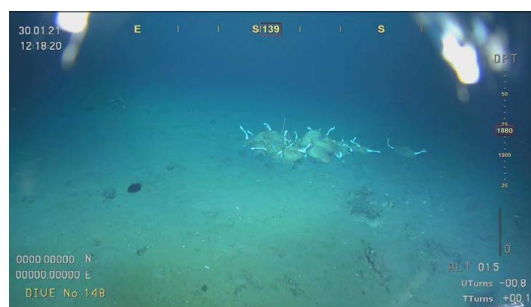
Fig. 3-6.2 Sandbags of Group #2

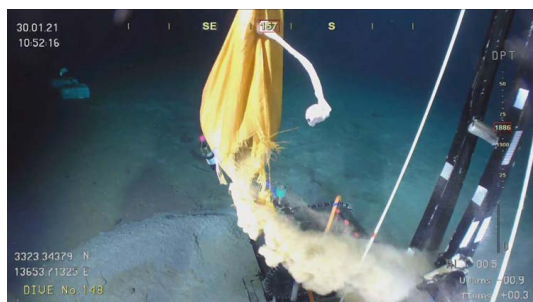
Fig.3-6.3 Backfilling trial

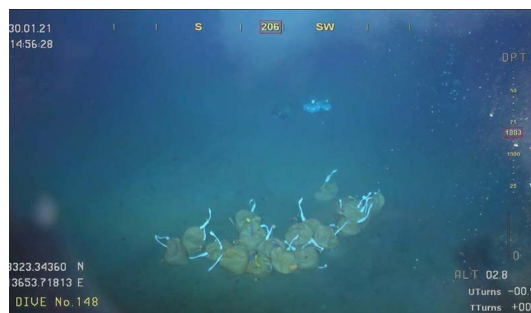
Fig. 3-6.4 Moved sandbags
