R/V Kaimei Cruise Report KM24-01

Real-time ocean bottom crustal movement observation

Kumanonada Sea, Off Kiisuido Strait, off Cape Muroto
East off Izu Oshima Island and Sagami Bay

Jan. 25th, 2024 – Feb. 9th, 2024

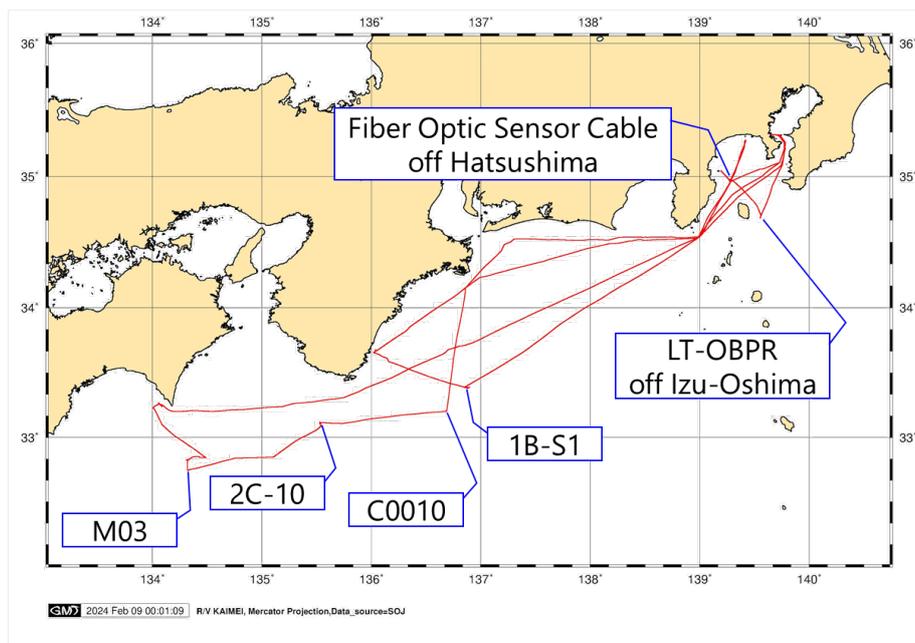
vessel tracks during KM24-01

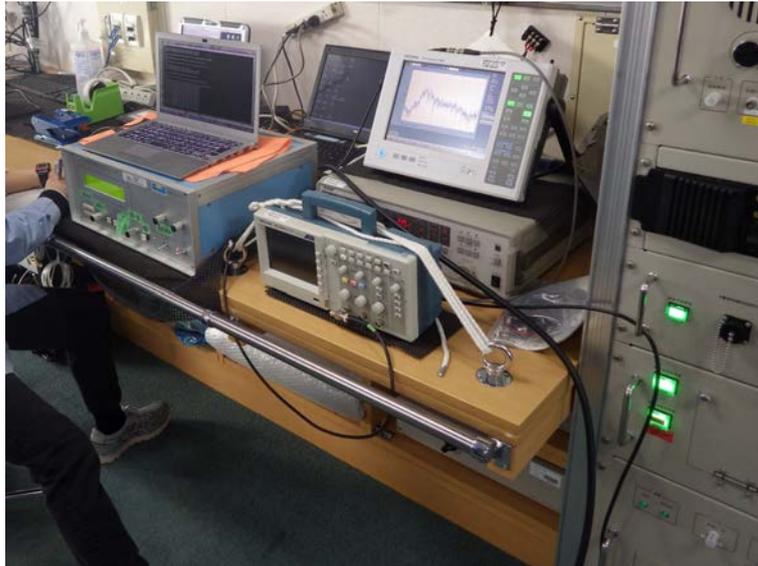
Acoustic communication equipment on board

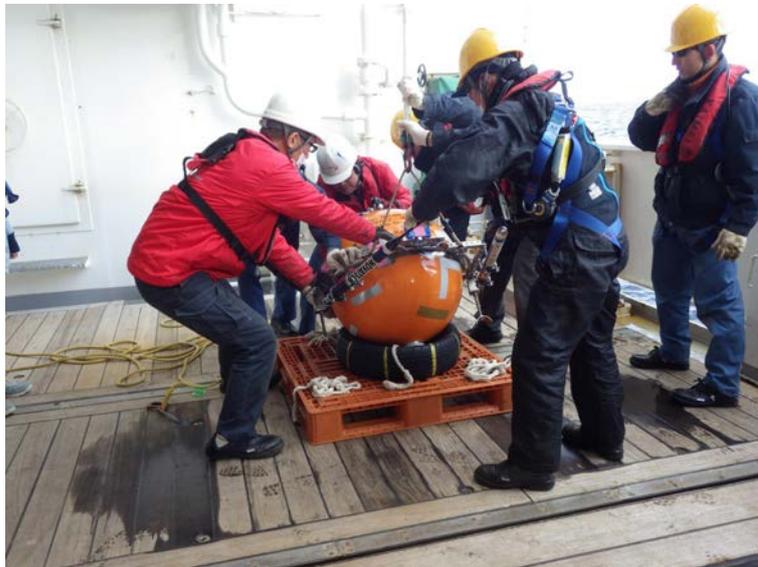
BBOBS recovered after surfacing from the seafloor

- A) The self-floating type broadband ocean bottom seismometer (BBOBS), installed deployed near LTBMS C0010 in the Kumano-nada Sea, was recovered by self-floating.

No.	Dive Num. Date	Site	Staying Time	Latitude	Longitude	Depth
	--- 2024/1/26	C0010	08:04	33-12.4462N	136-41.3354E	2564
			09:09	33-12.4068 N	136-41.1542E	2564
	Work Summary	A command to release the weight was sent to the BBOBS installed on C0010 on September 30, 2023, and the BBOBS was recovered by self-floating.

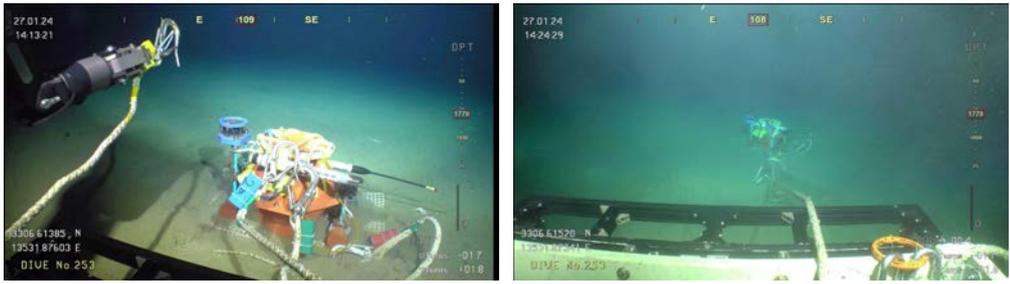
No.	Dive Num. Date	Site	Staying Time	Latitude	Longitude	Depth
	KM-ROV253 2024/1/27	2C-10 OBP	13:30	33-06.6088N	135-31.8634E	1778
			13:48	33-06.6154N	135-31.8746E	1779
	Work Summary	The self-floating type ocean bottom pressure gauge (OBP) with a self-calibration function deployed near DONET2C-10, off Kiisuido strait, was recovered. This OBP did not respond to acoustic commands during the KS-23-J07 cruise, so the ROV was used to dive and recovered it.

- B) The self-floating type ocean bottom pressure gauge (OBP) with a self-calibration function deployed near DONET2C-10, off Kiisuido Strait, was recovered. This OBP did not respond to acoustic commands during the KS-23-J07 cruise, so the ROV was used to dive and recovered it.

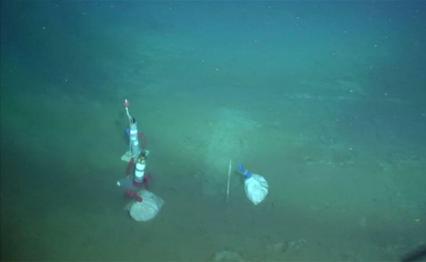
<p>The white line in the center of the photo is the submarine cable off Cape Muroto</p>					
3

- C) A thermometer (self-recording type) was replaced at the M03 area near submarine cable off Cape Muroto.
- D) The bottom pressure sensor was deployed and connected to the submarine cable system at the bottom crustal movement observatory 1B-S1. The bottom pressure observation has started in addition to the real-time tilt observation in the borehole at same area.

No.	Dive Num. Date	Site	Staying Time	Latitude	Longitude	Depth
	KM-ROV254 2024/1/28	M03	9:10	32-49.6121N	134-19.1832E	1700
			14:10	32-49.3950N	134-19.1615E	1701
	Work Summary	<p>The submarine cable off Cape Muroto was visually confirmed as a result of a search using the observation data from the DAS conducted on this cable as a reference.</p> <p>After that, the thermometer and current meter that had been installed at point M03-3 were recovered, and two thermometers were installed at M03-4, which is closer to the cable than M03-3, and observation was started.</p>

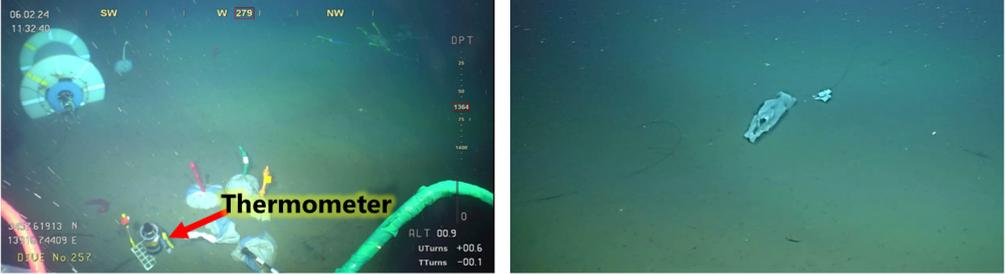
No.	Dive Num. Date	Site	Staying Time	Latitude	Longitude	Depth
	KM-ROV257 2024/2/6	HF-P3 ~ 900m	11:06	34-57.6125N	139-16.7389E	1363
			15:55	34-58.0805N	139-16.5229E	1374
	Work Summary	A thermometer was installed at the end of the optical fiber sensor cable. The grounding of the fiber-optic sensor cable was then visually checked at a section of approximately 900 m from the end point. The cables were almost entirely on top of the sediment. On the other hand, there were many sections where the cables were tangled in plastic bags or floating off the seafloor.

- E) A visual survey of the coupling between the fiber optic sensor cable installed off Hatsushima Island and the sediment was conducted for approximately 1700 m. When a visual survey was conducted on June 1, 2023, on a section of approximately 600 m from the end of this cable, there were many places where the cable was floating. However, during the current survey, the cable was almost on the seafloor. Especially, in a low sensitivity section of approximately 100 m, six sandbags were placed on top of the sensor cable to improve the coupling between the cable and the sediment.

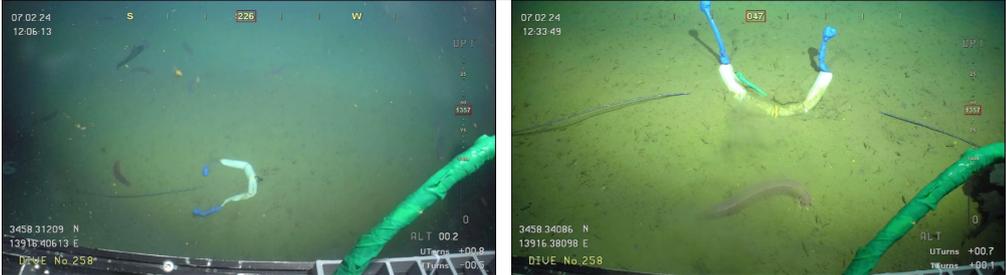
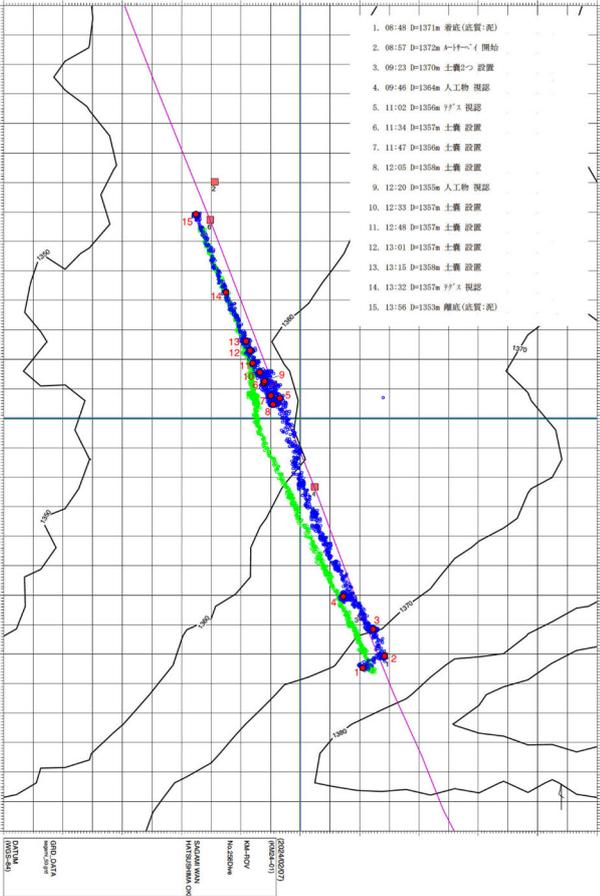
<p>The long thin sandbags were used, to reduce the height from the seafloor.</p>			
7

No.	Dive Num. Date	Site	Staying Time	Latitude	Longitude	Depth
	KM-ROV258 2024/2/7	HF-P8	8:48	34-58.0696N	139-16.4986E	1371
			13:56	34-58.4864N	139-16.3139E	1353
	Work Summary	<p>A visual inspection of the cable grounding was conducted in a section 800 m from the end position of the previous dive "KM-ROV257". (It is not possible to go northward anymore because of the cables laid by other organizations.) As in the previous dive survey, the cable was almost on the sediment, but the fiber optic sensing observation data suggested that the grounding was poor. Therefore, sandbags were put on the cable at 25 m intervals in a section of about 100 m to improve the grounding condition.</p>
