Preliminary Report on

# KR07-18 Cruise in the Nankai Trough off Muroto

Dec. 16-26, 2007  
Yokosuka - Yokosuka

Masataka Kinoshita (IFREE-JAMSTEC)  
KR07-18 Shipboard Science Party

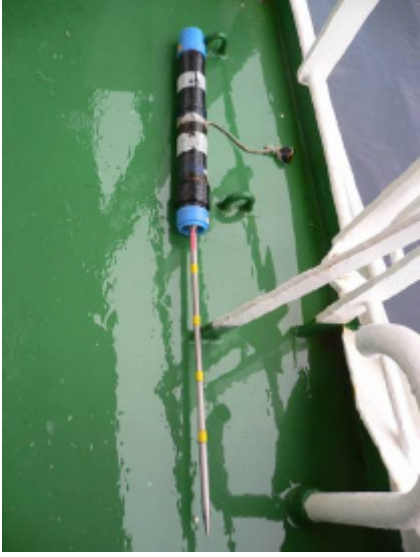
Fig2. 1 and 2 shows the photograph and graphical description of SAHF. The following is description of SAHF.

Stand-Alone Heat Flow meter (SAHF) is designed to measure heat flow by manned submersibles or ROVs. Five thermistors situated within the probe at 11 cm intervals. Since SAHF takes measurements as “OFF LINE” system, heat flow can be measured while observer is conducting something else at that position or elsewhere. SAHF can also be used for long-term monitoring of sub-bottom temperature. We prepared three SAHFs, designated as SAHF1, 2 and 6. SAHF #2 and #6 are equipped with LED, which flashes during operation.

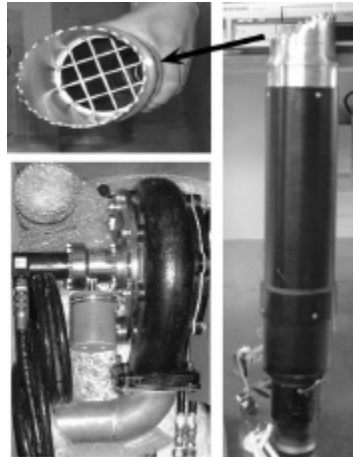
To remove muddy sediment inside and outside of the ACORK 808i, the oil hydraulic suction pump “Dorothy” were equipped on the front of ROV KAIKO. Because this suction pump is heavy weight for KAIKO, left manipulator was unloaded and some floats were equipped. The specification of “Dorothy” is as follows;

Max depth	6000m
Max hydraulic pressure	14MPa
Max oil feed rate	14.7 lit/min
Max suction rate	1000 lit/min
Weight (in air)	50kg
Weight (in water)	43kg
Suction hose	65mm
Outlet hose	90mm

Suction pump “Dorothy” mounted on the ROV KAIKO.

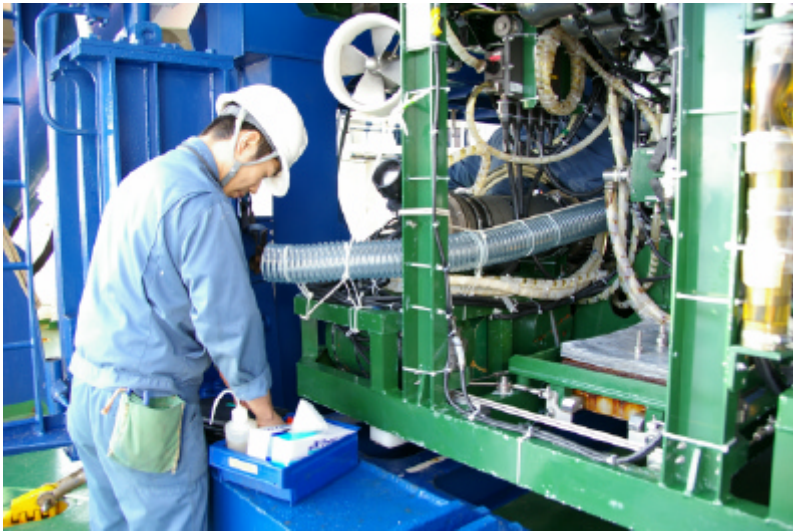
Outlet hole in the back of ROV KAIKO.

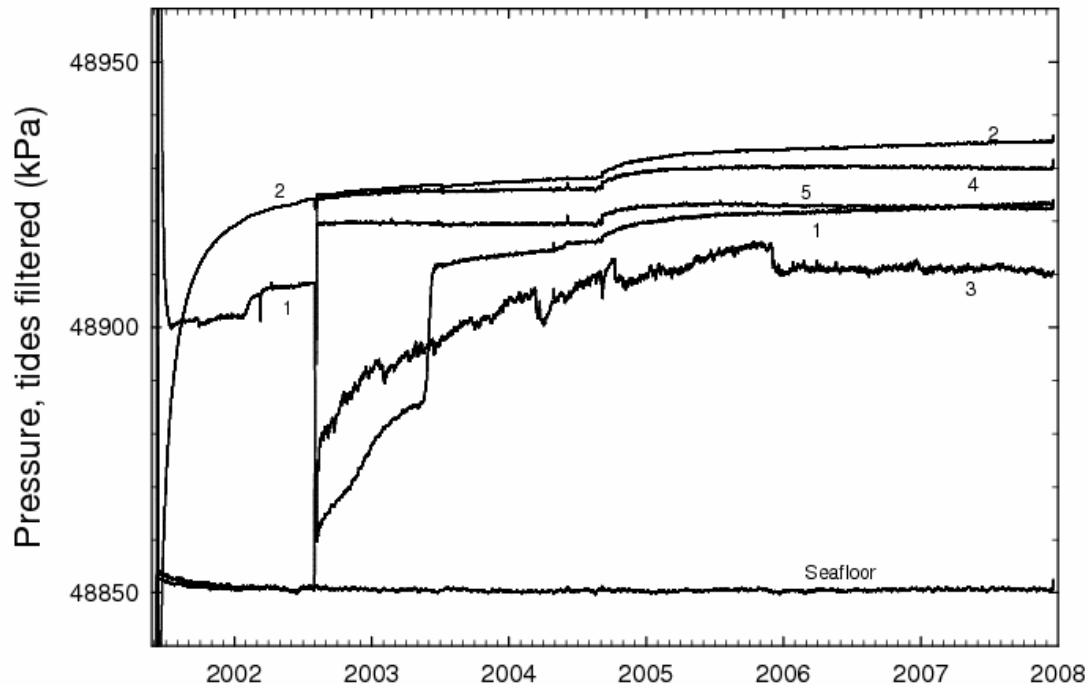
## ODP Hole 1173B ACORK

Figure 4. Full recording history of pressures from Hole 1173B, including the data from August 2006 to the present, recovered during Kairei cruise KR-07-18. The records have had tidal components, typically 5-10 kPa in amplitude, filtered.

While not fully free of complications, the pressure records at Hole 1173B, screens 1, 2, 4, and 5, show smooth long-term trends punctuated twice by transients contemporary with a very-low-frequency (VLF) earthquake swarm off Cape Muroto in July, 2003, and a sequence of large earthquakes (up to  $M_w = 7.5$ ) off Kii Peninsula in September, 2004 (Fig. 4). The transients are believed to be the consequence of local co-seismic and post-seismic strain, and the rising trends the consequence of slowly accumulating strain of the Philippine Sea plate between great thrust earthquakes. By the final recording interval recovered this cruise, pressures at screens 4 and 5, closest to the top of the Lower Shikoku formation, were relatively stable, while at screens 1 and 2 in the most isolated, undrained part of the drilled section, pressures continued to rise steadily. It is noteworthy that no transient is resolved at the time of a VLF earthquake swarm off Cape Muroto in September, 2006. This swarm was larger than the one in 2003, suggesting there is little correlation between seismic energy release and strain moment.

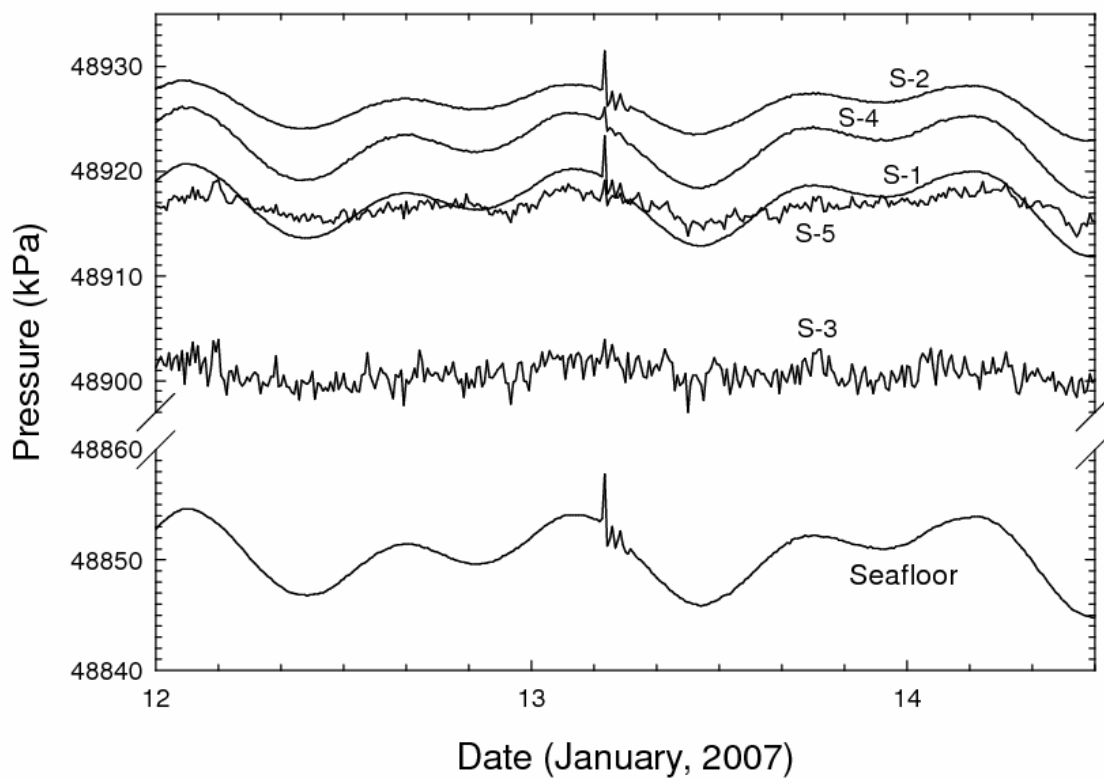
Fig. 6

While the 10 minute sampling rate that we used in these long-term autonomous observatories is hardly adequate to capture seismic signals, a total of six earthquakes was detected, five at both sites. The largest amplitude event is shown in Figure 6. The amplitude of the response to the seismic ground motion (Rayleigh waves) varies from screen to screen systematically with tidal loading response. In this plot of raw data, the relative amplitudes of tidal signals can also be seen, as well as noise that is characteristic of the records from screens 3 and 5 at Hole 1173B and to lesser degree from all screens Hole 808I. This noise, which has been noted previously, is coherent among levels at each of the sites; the source is unknown.

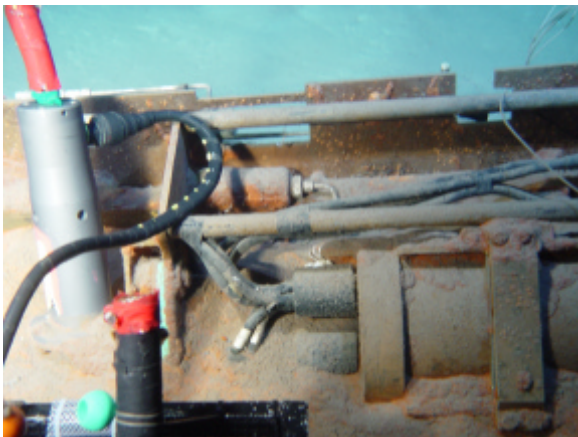
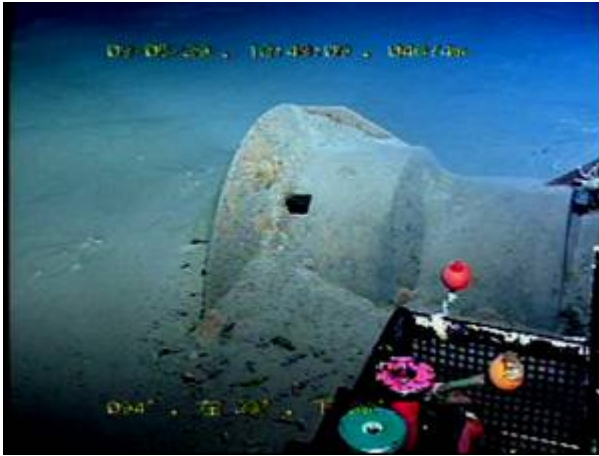
Fig. 5-1. Comparison of 808I ACORK head (side view).

Fig. 5-1 compares the head part (side view). The depositional level seems to have increased since 2001, but seems to remain constant in the recent two years. Fig. 5-2 compares the inlet of ACORK head at 808I.

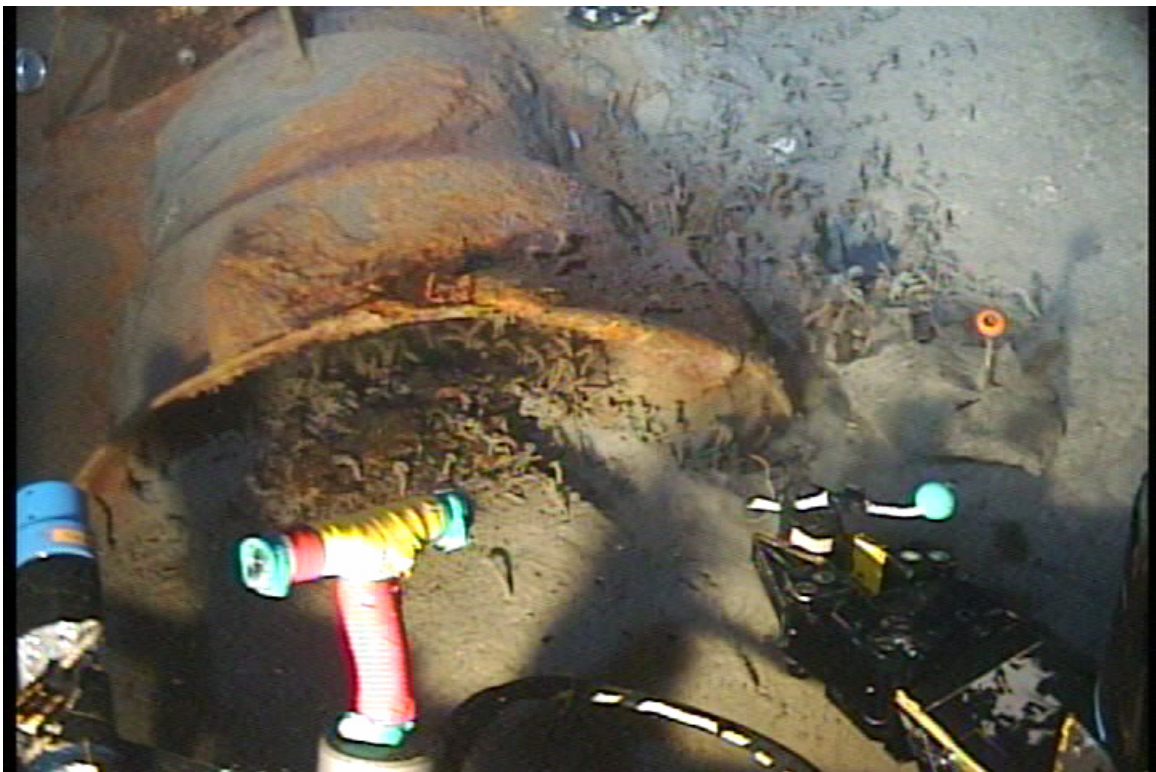
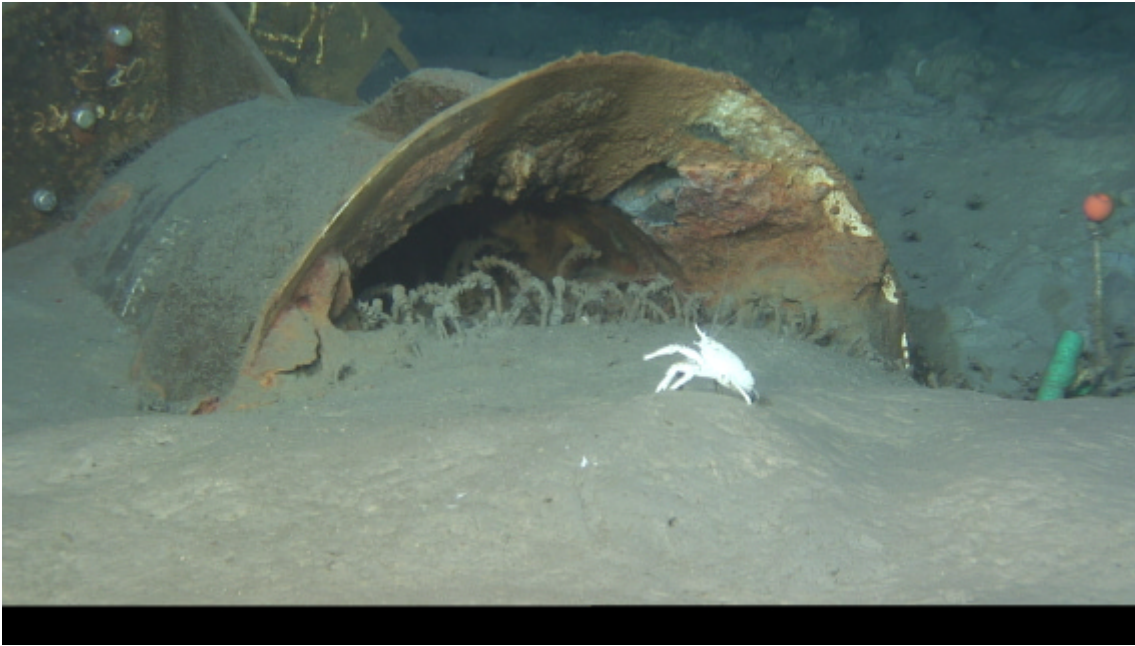
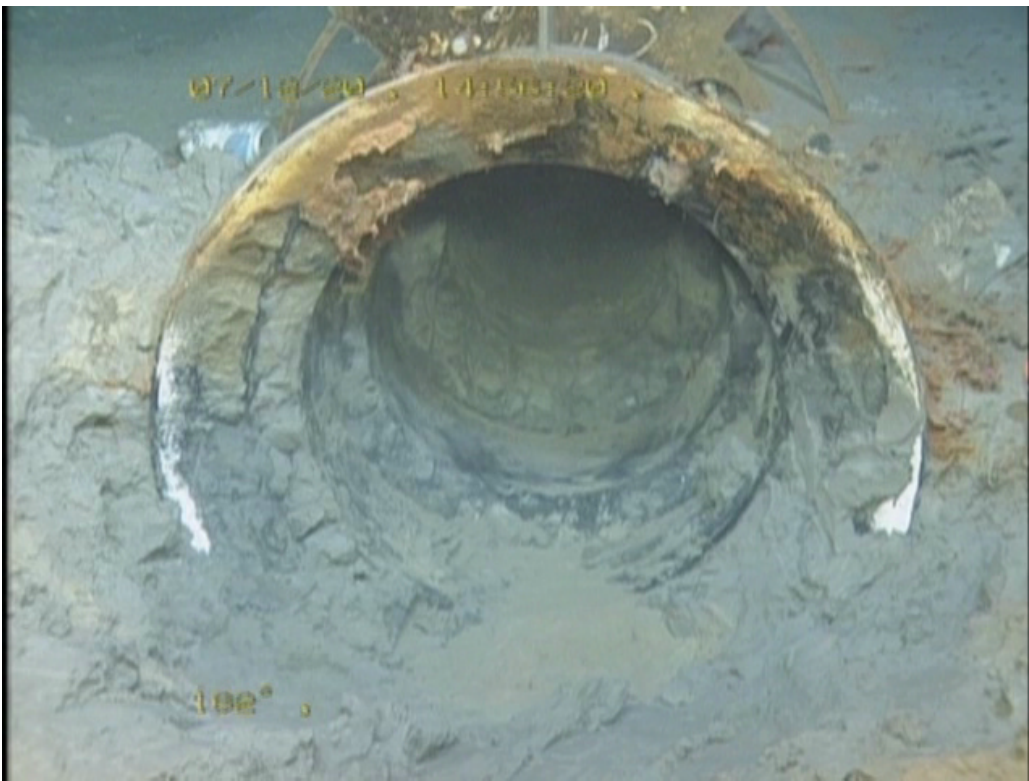
Fig. 5-2. Comparison of the inlet of ACORK at 808I.

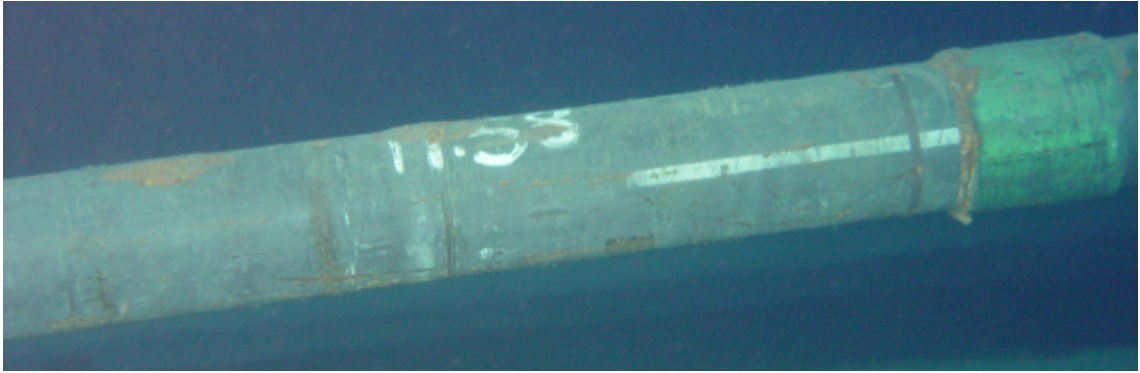
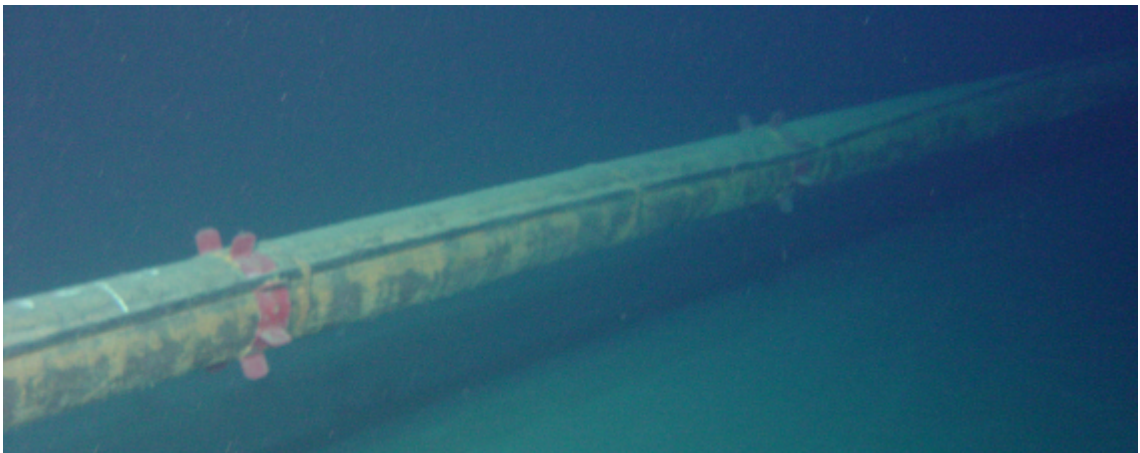
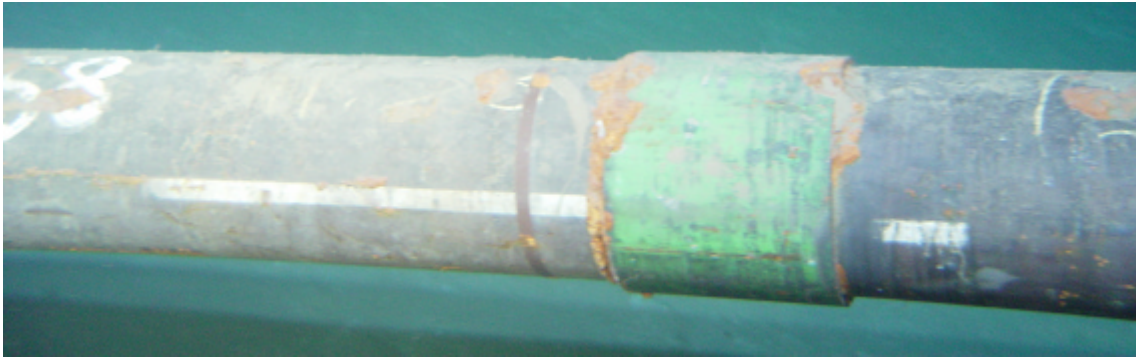
Fig. 5-5 Close-ups for ACORK at 808I.

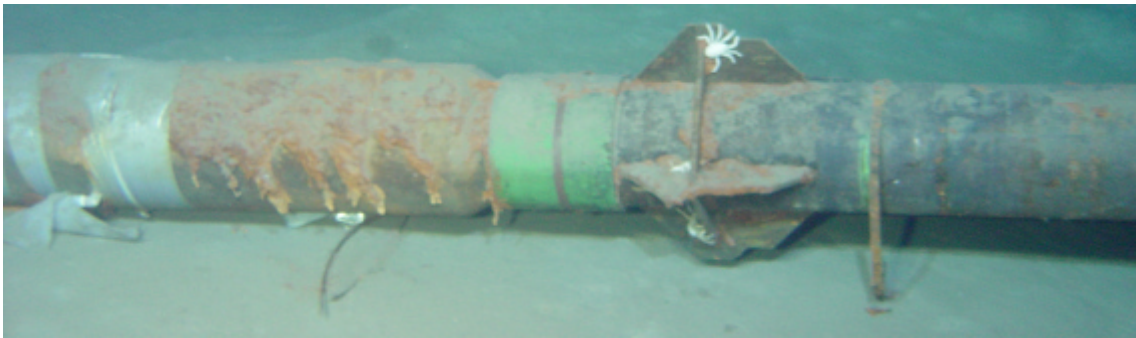
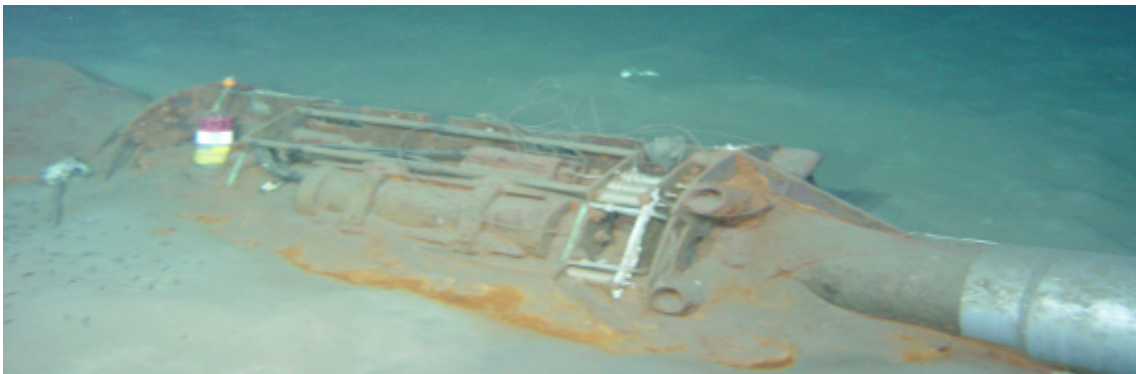
As noted in Chapter 1 of this report, the ACORK at 808I was accidentally placed on the seafloor in 2001. Since then the sediment has been deposited around the ACORK, and also into its head. During the KR06-10 and KR07-18 cruises we inspected carefully the mouth of ACORK part.
