KAIREI Cruise Report

KR12-04

13 Feb. – 17 Feb. 2012

Japan Agency for Marine-Earth Science and Technology (JAMSTEC)

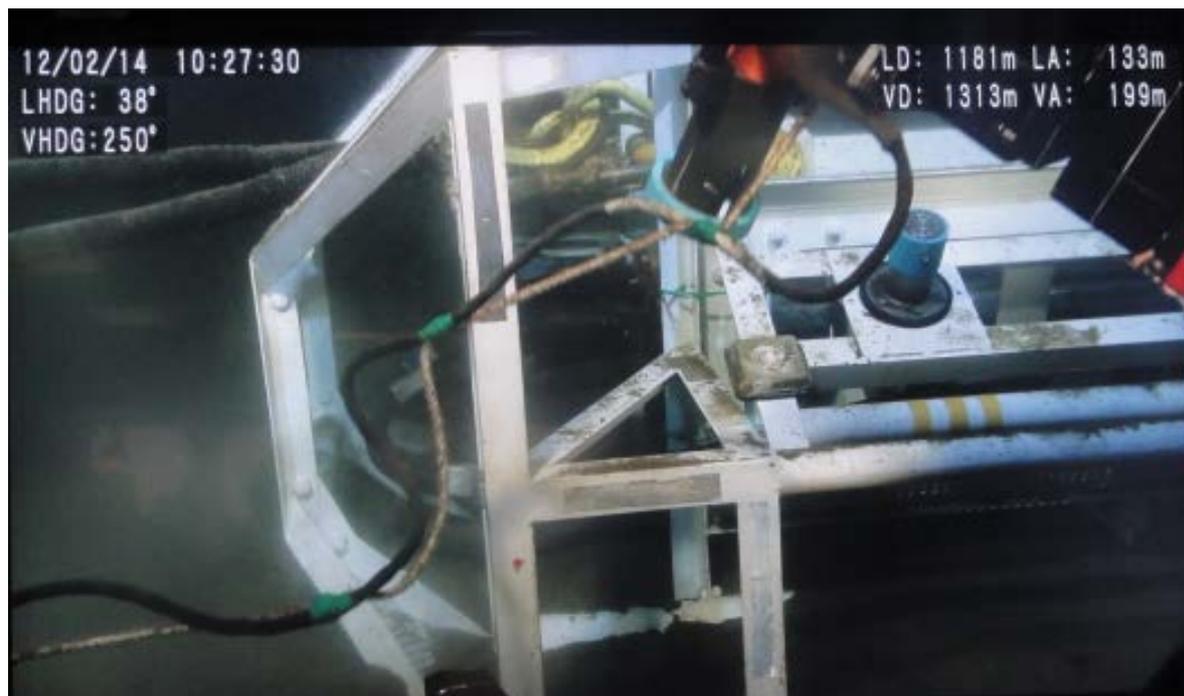
Fig. 4.1.1 Photo of the remove operation the ROV connector from a junction unit.

The dive 540 was carried out to recover Electromagnetic observation system (DOMES). At first, we operated to disconnect the underwater mating connectors of our instruments (Fig. 4.1.1) and attached dummy caps to connectors of the junction unit. After this operation, the KAIKO moved to the DOMES (Fig. 4.1.2). Before recovery operation, a signal cable of the overhauser magnetometer was cut to make a recovery operation easy. KAIKO picked it from the DOMES, and put it on the payload stage of the vehicle. Then, we fucked the recovery line to the recovery rope of the DOMES. After confirmation the connection of recovery line, we finished this dive operation at 11:45. We could recover this instrument safety (Fig. 4.1.3). Recovered DOMES almost keeps clean condition after about 5 years settle.

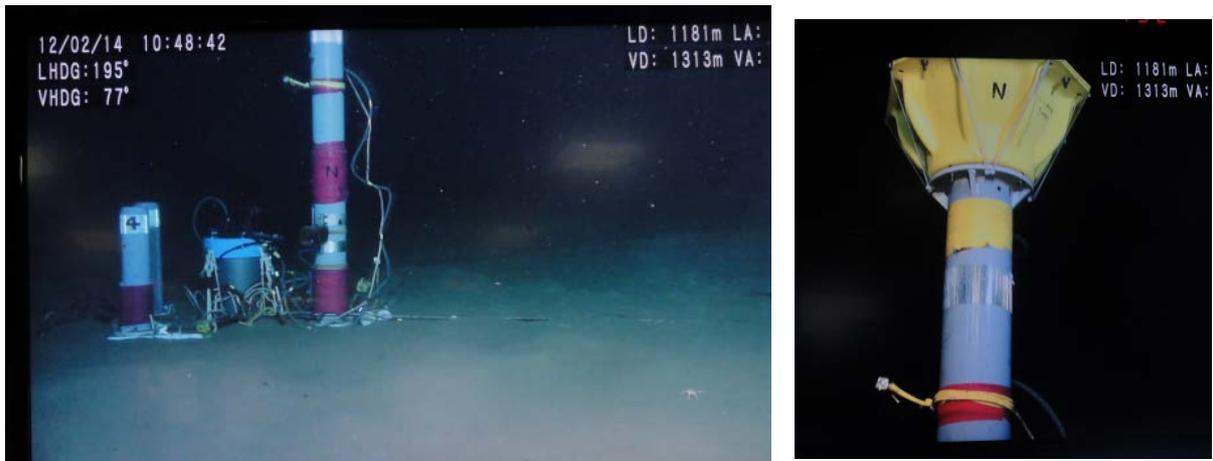
Fig. 4.1.2 Left panel shows the main unit of DOMES. Right panel shows the overhauser sensor unit with the 13 inch glass sphere.

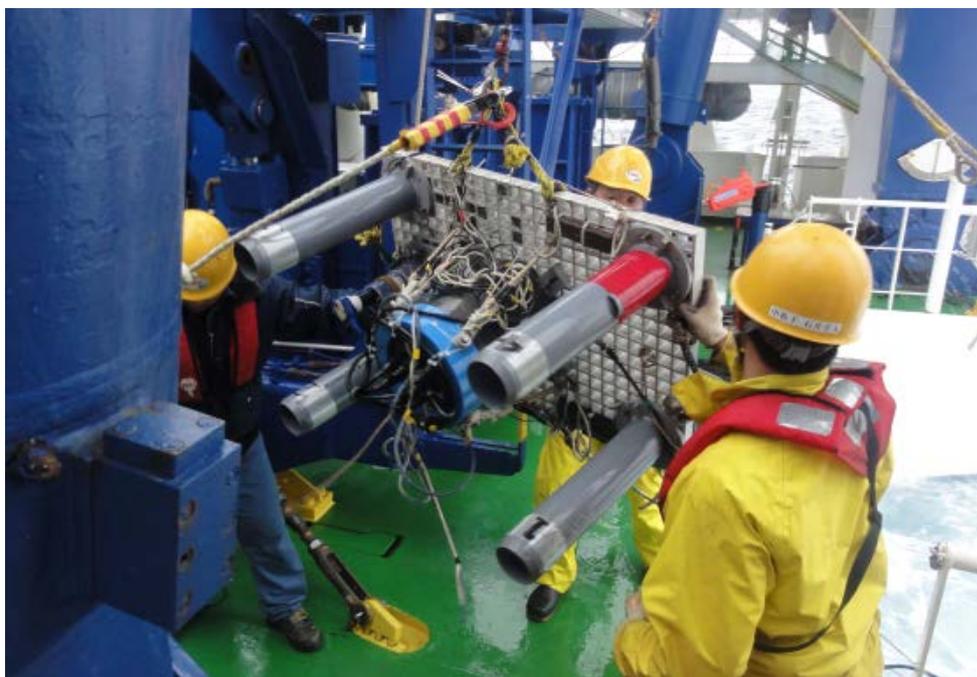
Fig. 4.1.3 Photo of the recovered DOMES main unit.

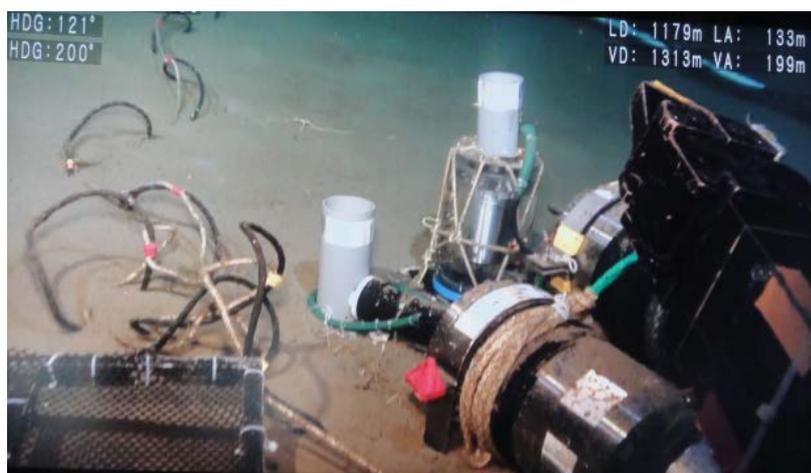
Fig. 4.2.1 Photo of the recovery operation of the S-SMAD.

The purpose of the dive 541 is to recover S-SMAD (seismic sensor monitoring and acquisition device) from the off Toyohashi cable. Kaiko dove to the observation node of the cable and disconnected the underwater mating connector for the S-SMAD. Then Kaiko hooked a recovery line to a ring attached to the S-SMAD for recovery purpose. Kaiko vehicle left the seafloor and docked to the launcher and came on the surface. When Kaiko came on the surface, the S-SMAD was lost from the recovery line. It seemed that the ring was unlatched from the hook by chance.

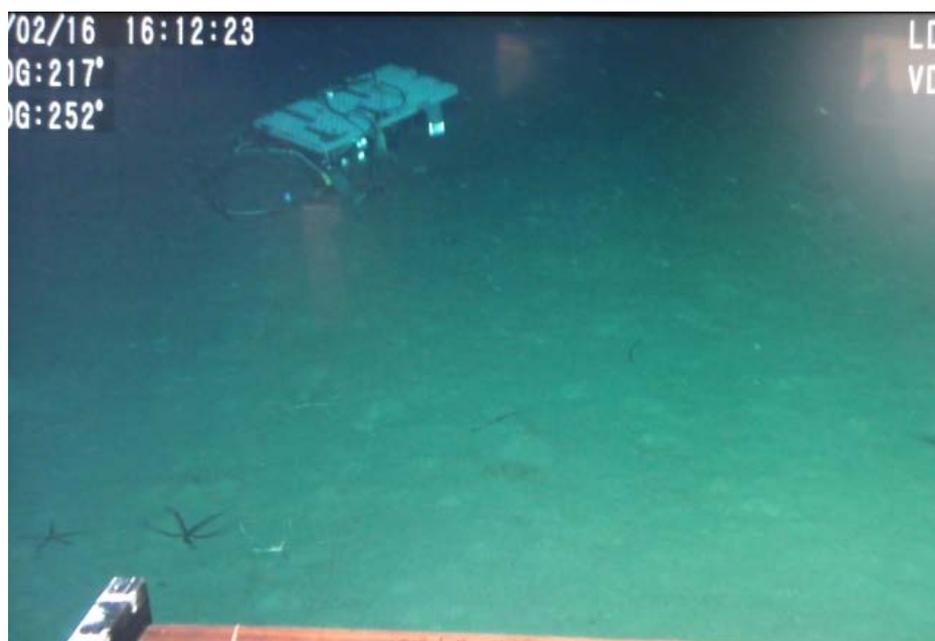
Fig. 4.3.1 Photo of the S-SMAD when HDV camera caught.

We started to seek for the S-SMAD in the seafloor around 13:15. Firstly, we took east to follow the Kaiko vehicle track during the Dive 541. Then we started to take west to west-north-west direction and sought the S-SMAD by sonar (with 100 and 150 m ranges) and cameras. After reaching near the suspected lost point we went around the route. It was not until 16:12 to identify the S-SMAD by camera, before we planned to shut down the seek dive on 16:15. We tried to recover the S-SMAD but it took more than a half hour to put the S-SMAD on the sample basket of the Kaiko vehicle and hooked at two points, because of bad visibility from very muddy seafloor condition. Finally we left the seafloor on 17:00 with the S-SMAD on the basket and safely recovered the instrument on deck (this time). The instrument was inspected by eye and it looked without any significant damage.
