## R/V Kairei Cruise Report

### KR18-14 Leg 1

Furtherance of pioneering scientific research on seafloor mineral resources using an artificial hydrothermal vent: Kuroko-ore cultivation, monitoring of hydrothermal fluid, deep-sea electric generation, ORP and resistivity measurements, and elucidation of electric ecological system

18th Oct. 2018 – 31st Oct. 2018

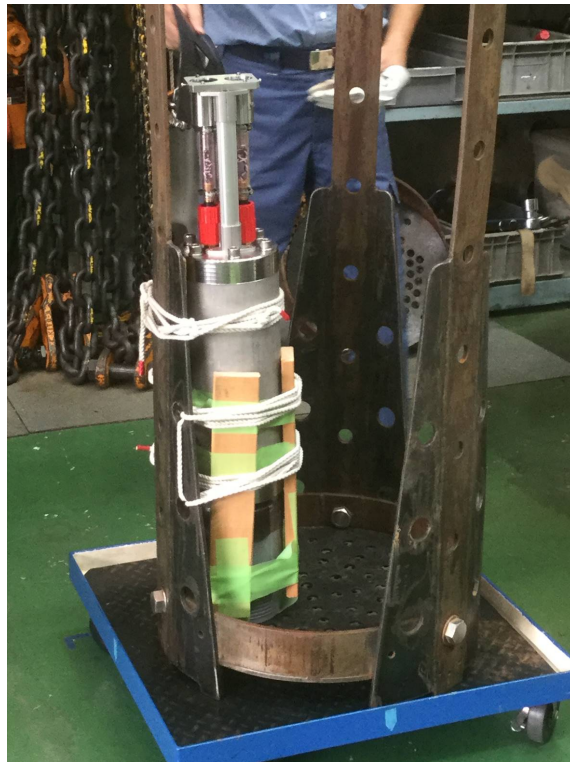
This apparatus was developed to measure the distribution of flow velocity of the hydrothermal fluid (Fig. 3-5) and flow rate can be estimated to be integrated the flow velocity distribution. This apparatus is equipped with transmitter and receiver of ultrasonic waves and sensor part, and flow velocity is calculated by the Doppler effect. Electric power of AC100V and 5A is supplied by ROV with data connection via the Ethernet cable.

Fig. 3-5 Hydrothermal flow rate measurement apparatus using ultrasonic waves.

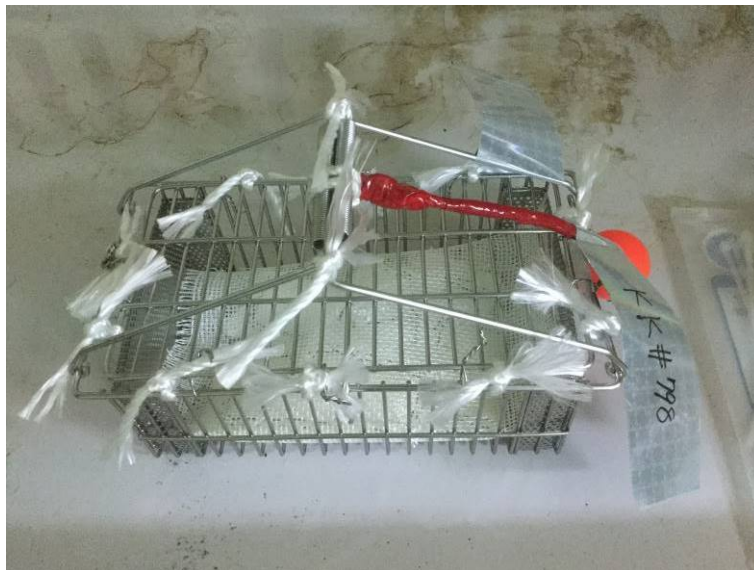
This apparatus contains a special gold adsorption material enclosed by a glass wool. This apparatus was installed at a natural hydrothermal vent to adsorb gold selectively from hydrothermal fluid.

Fig. 3-6 Gold adsorption apparatus.
