## Shinsei-maru Cruise Report KS-18-J04

### Development of continuous real-time observation system for crustal deformation

Kumano-nada

March.15,2018-March.30,2018

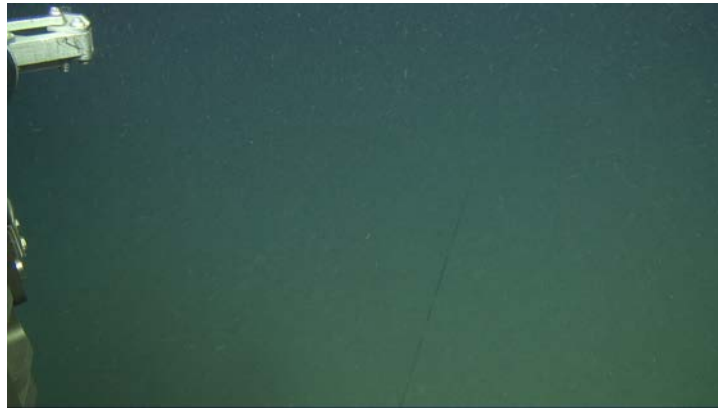
Fig.1-1 The extension cable of 1C-11 (Black line)

Before the cable laying operation, it is required that the route survey and clearance of the cable route. In this dive, the route clearance and the route survey were conducted from the en route of the cable route of 1C-11 observatory to the C0006G long-term real-time borehole observatory. At first, ROV Hyper Dolphin (HPD) was dive to 33-02.005N 136-48.446E where is near the 1C-11 cable route and started route survey. Soon, at 33-02.000N 136-48.454E, we confirmed the extension cable of 1C-11 (Fig.1-1) on mud sea floor. When HPD moved along the extension cable, the operation was interrupted because the ground fault was occurred at 400m from the start point.

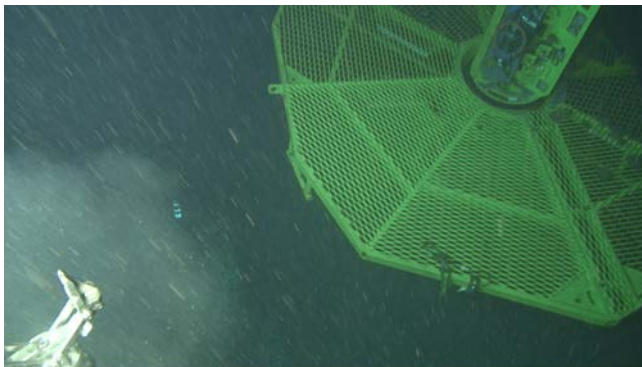
Fig.2-1 Wellhead and ROV Homer

The HPD started dive at 11:02 and approached to the wellhead. At first, we checked where to put a bobbin of extension cable and set the ROV Homer (ID:19) at the planed point. (Fig.2-1) Next, the HPD put the sandbags temporary on the ROV platform. The sandbags were used to prevent the bobbin rolling in later dive.

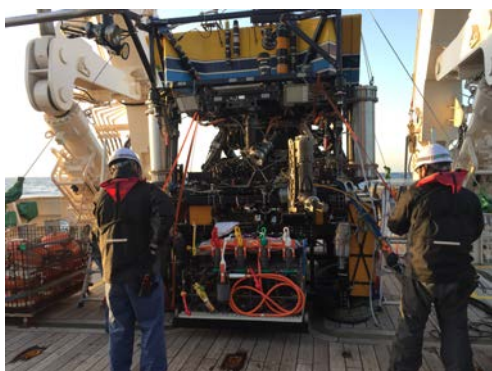
Fig.3-1 The interface on the HPD

Before this dive, the interface was loaded onto the HPD's payload space. (Fig.3-1) The HPD landed on the platform of wellhead at 8:52, and she placed the interface in the exact position of the planned place. (Fig.3-2) The three pins were pushed down on the interface not to shift the interface. After the placement work, the four jumper cables were connected to the port of the wellhead respectively. (Fig.3-3, Fig.3-4) We made the visual check around the wellhead, and left the sea floor at 10:07.

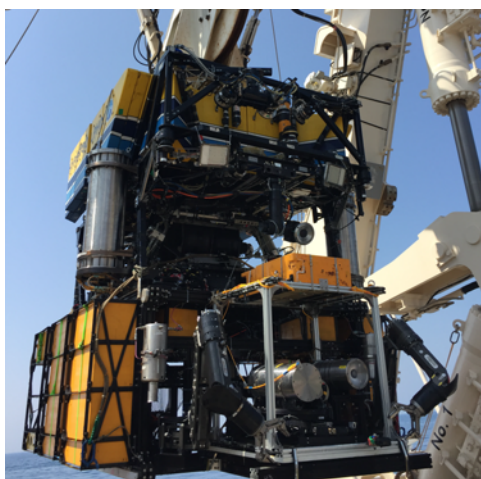
Fig.5-1 Mobile Pressure Calibrator  
on the sample basket of the HPD

The Mobile Pressure Calibrator is a device that can be carried while maintained verified precise pressure, and it calibrates a water pressure gauge installed on the seabed. The calibrator is equipped with a level adjustment mechanism that can change the position of the unit that maintained precise pressure.

In this dive, the function of the Mobile Pressure Calibrator was checked fixing on the sample basket of the HPD. But before the dive, since the ground fault had been occurred in the level adjustment mechanism, we disconnected the cable related to the mechanism from the HPD.

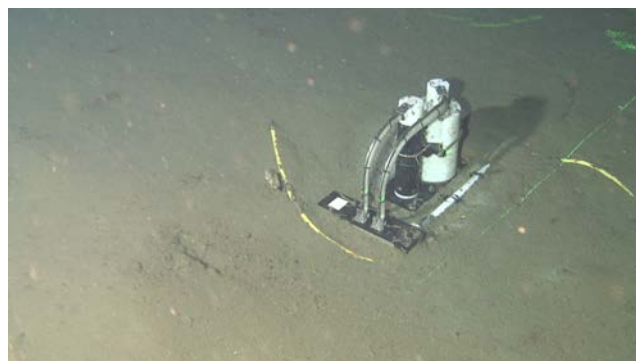
Fig.5-2 the pressure sensor unit of DONET1

The HPD started to dive at 7:09 and landed 3m from the pressure sensor unit of DONET1 at 8:37. The pressure sensor unit of 1A-2 observatory was irradiated with a laser that is equipped to confirm the level, and the condition of the irradiation was checked by cameras of the HPD. (Fig.5-2) Due to the arrival time of the next day, the HPD left the seabed at 9:52 and on the deck at 10:45.
