# Shinsei-maru Cruise Report KS-25-J06C

DONET maintenance

Kumano-nada  
Off Kii-channel

June. 6, 2025- June. 14, 2025

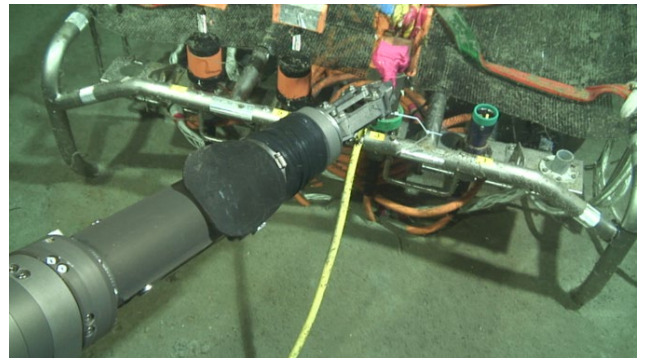
Photo 3.1-4 1A-3 disconnection from Port 3

Preparations for the recovery of Node-1A were carried out during this dive. The ROV *Hyper Dolphin* commenced its descent at 08:21 and reached TU-1A at 09:42. First, the connector on Port 8, which was connected to the DONET Sensor at observation site 1A-4, was disconnected and placed on the seafloor near NODE-1A. Subsequently, the connectors associated with observation site 1A-1 (Port 2), 1A-2 (Port 1), and 1A-3 (Port 3) were individually disconnected and placed on the seafloor. Finally, the connection between NODE-1A and the termination unit TU-1A was disconnected, then reconnected to the parking port on NODE-1A to complete recovery preparations. Miniature transponder ID 54 was successfully retrieved, and the ROV ascended from the seafloor at 13:15

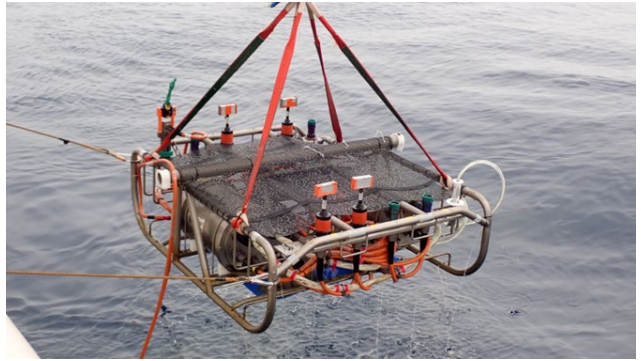
Photo 3.2-4 Recovered NODE (Unit A010)

The recovery of NODE-1A was conducted during this dive. The ROV initiated its descent at 08:33 and reached the seafloor at 10:11. A dust cap was first installed on the connector of the termination unit TU-1A. The ROV then proceeded to NODE-1A, where it connected its recovery line to the pre-installed sling. Departure from the seafloor occurred at 11:43

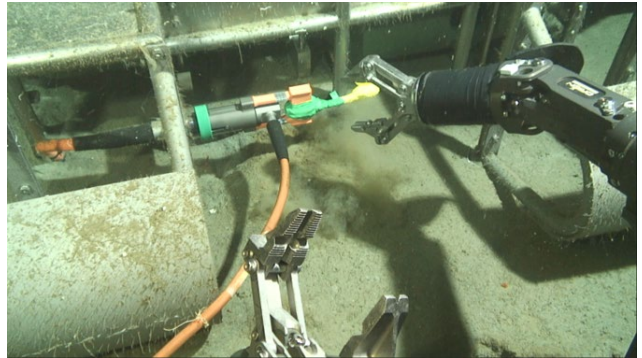
Photo 3.3-2 NODE A040 connected to TU-1A

The refurbished NODE (Unit A040), serviced on land prior to deployment, was installed during this dive to resume observation operations. The ROV began its descent at 08:28 and landed on the seafloor at 09:34. Upon reaching the designated installation site, the ROV operated its hydraulic cylinder to release and install the NODE. After connecting NODE-1A (Unit A040) to the termination unit TU-1A, the following observation devices were connected: 1A-4 to Port 8 at 11:37, 1A-1 to Port 2 at 12:02, 1A-2 to Port 1 at 12:24, and 1A-3 to Port 33 at 12:53. One parking port was recovered, and the ROV left the seafloor at 13:10.
