R/V *Shinsei-maru* Cruise Report  
KS-26-J04C

DONET maintenance

Kumano-nada and Off Kii-channel  
May 6 - 14, 2026

Japan Agency for Marine-Earth Science and Technology  
(JAMSTEC)

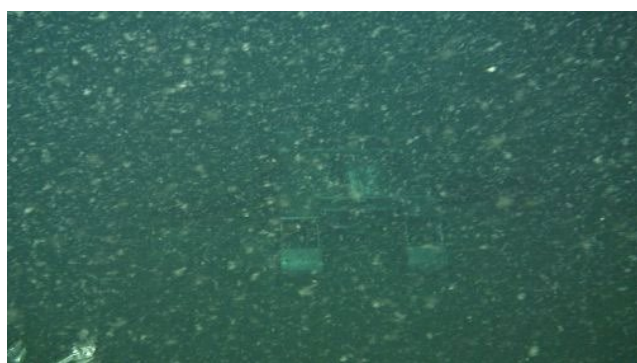
Photo 4.1-1 Termination Unit (TU-1A).

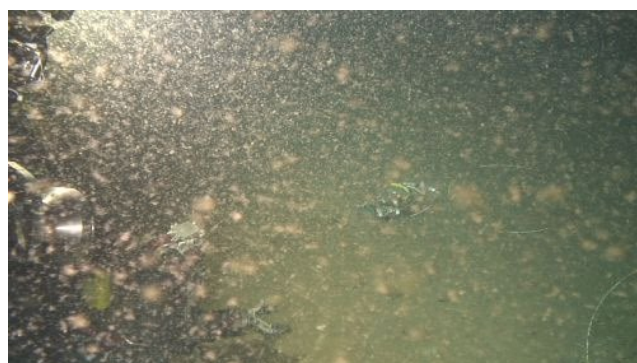
Photo 4.1-2 Junction Box seen through large snowflakes.

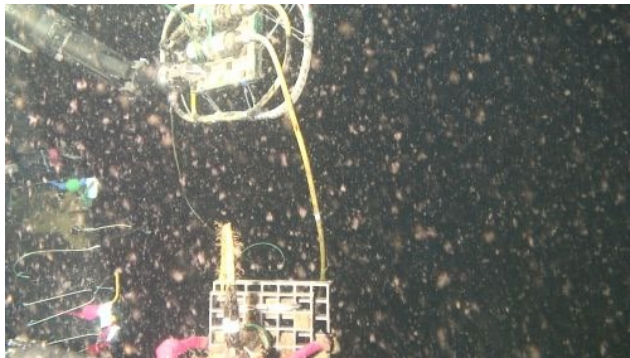
Photo 4.1-5 Start moving for relocation.

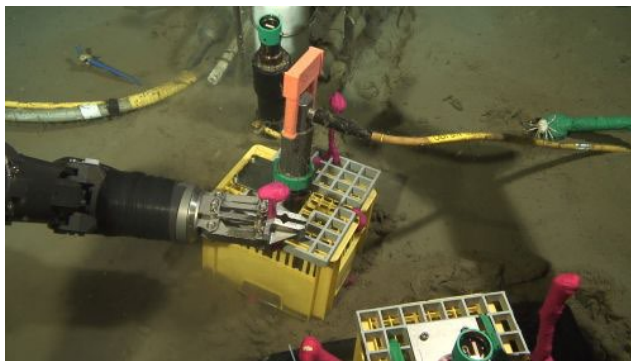
Photo 4.2-3 Connect to the loopback connector for investigation from the Yokohama Backup Site.

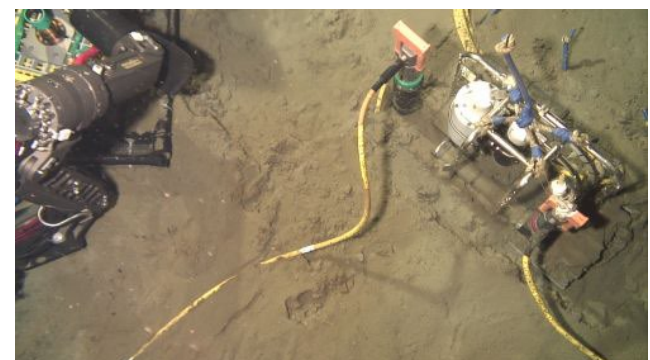
Photo 4.2-4 Return to the original connections.

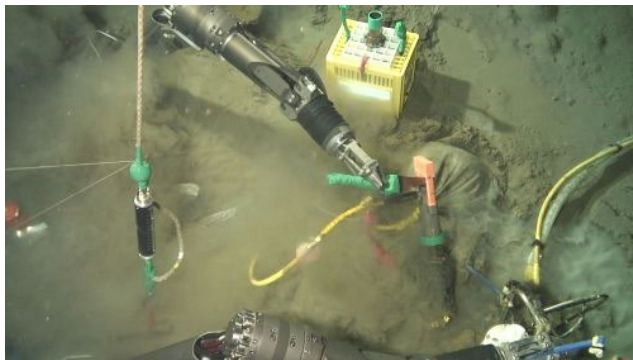
Photo 4.3-3 Connector removal.

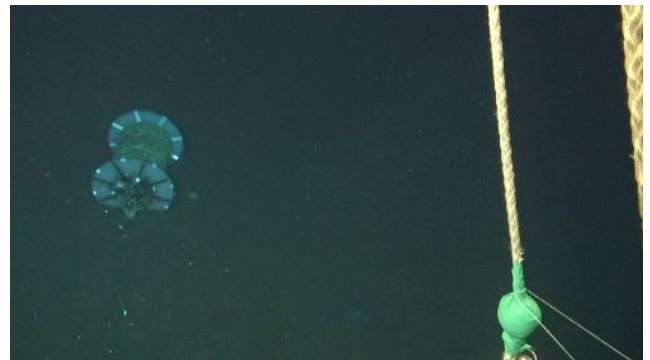
Photo 4.3-6 Extension Cable Bobbin No.30.

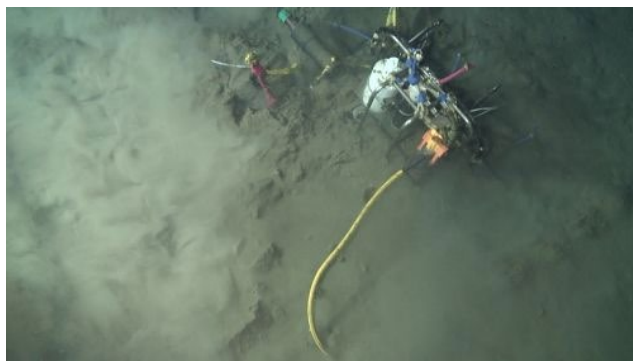
Photo 4.3-7 Confirming battery connector.

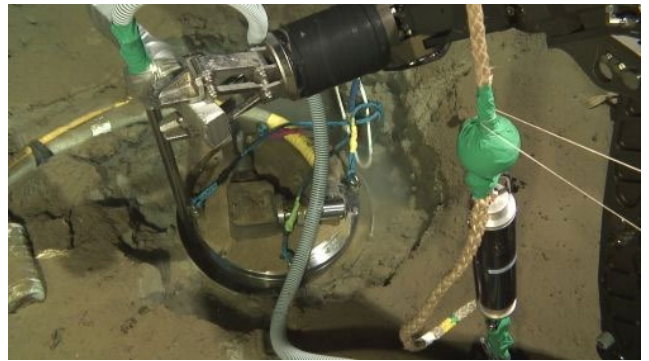
Photo 4.4-2 Sand removal by the "Dorothy".

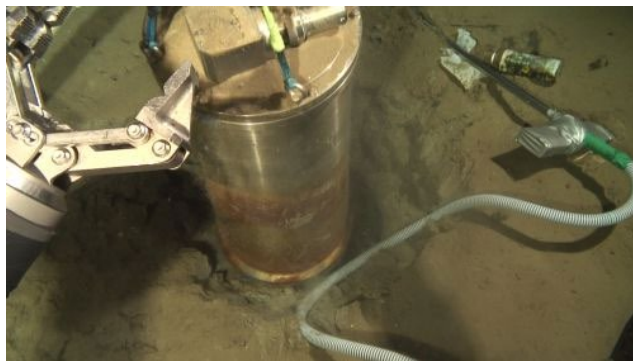
Photo 4.4-3 Lifting up the Ground Motion Sensing System (JB#29).

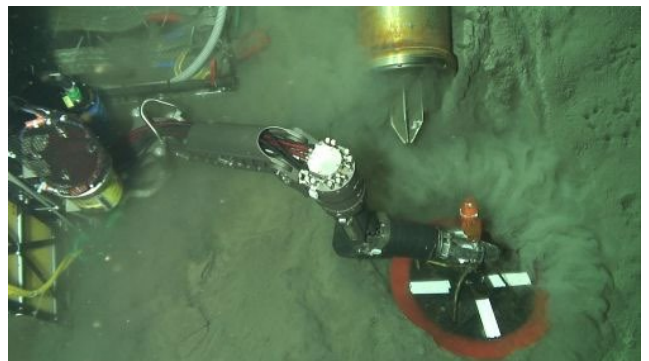
Photo 4.4-4 Casing cover.

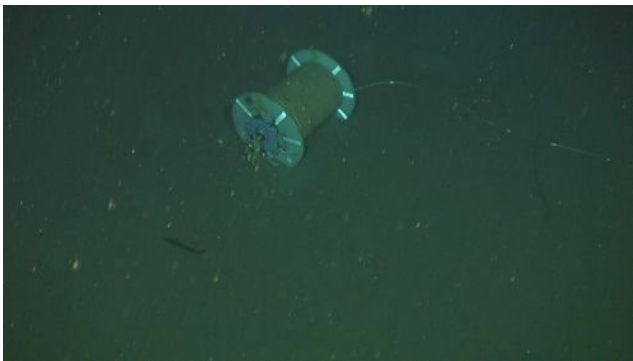
Photo 4.5-1 Recovery target, the Extension Cable Bobbin No.42.

The objective of this dive was to recover the Extension Cable Bobbin No.42 that had been left on the seafloor due to an extension cable failure. The ROV Hyper Dolphin started its descent at 08:26 and reached 2F-22 at 10:12 at a depth of 2,100 m. At 10:28, the ROV landed in front of the sensor unit connector on the remaining Extension Cable Bobbin No. 42 (orange cable). The ROV grasped the connector of Extension Cable Bobbin No.42 with its manipulator and began moving toward Bobbin No. 42. During transit, it was confirmed that the new extension cable (red cable, Bobbin No. 60) currently in use was laid over the old cable. Therefore, the ROV landed at the intersection and adjusted its position so that the cable to be retrieved would pass beneath Extension Cable No. 60 (red cable). At 10:44, the ROV landed in front of Extension Cable Bobbin No. 42 and inspected the surrounding area. At 11:16, the extension cable was cut with a Mantis-type cutter for retrieval. Afterward, to prevent the cable from unwinding during recovery, an extension cable catcher was attached to the end of the extension cable and stored inside the bobbin. A rope-like sandbag was placed on the remaining extension cable to prevent it from being carried away by the bottom current. The retrieval rope was carefully attached to both sides of the bobbin shaft, and the ROV left the seafloor at 12:46. After liftoff, it was confirmed that the Extension Cable Bobbin No.42 was hanging below the ROV. The ROV was recovered on deck at 14:37, and the extension cable bobbin was hoisted onto the deck at approximately 14:50. This marked the first successful recovery of an extension cable bobbin from the deep seafloor.

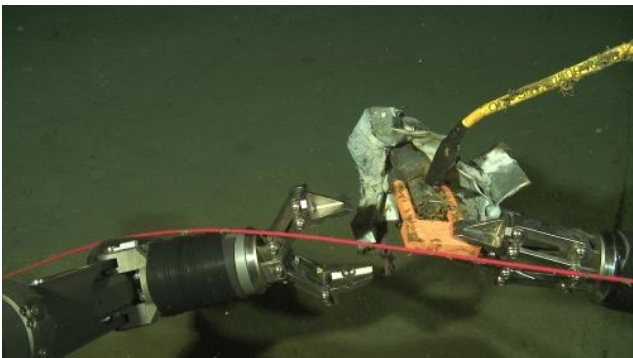
Photo 4.5-3 Pass the connector beneath the new extension cable (red cable).

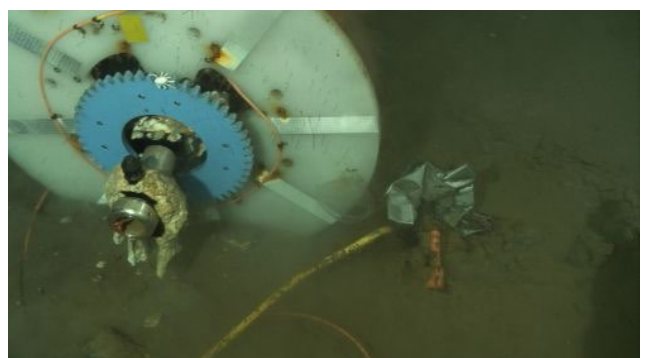
Photo 4.5-4 The connector was placed near the bobbin.

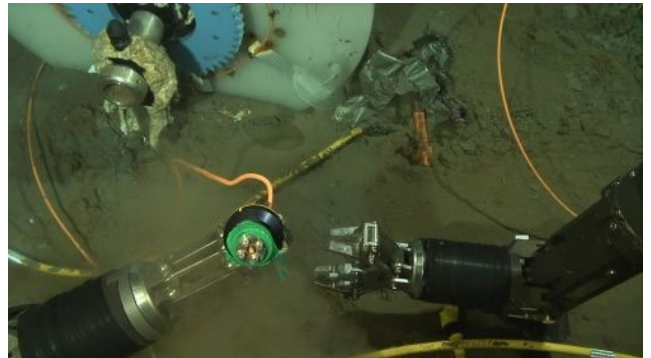
Photo 4.5-6 The extension cable (orange cable) through into the cable catcher.

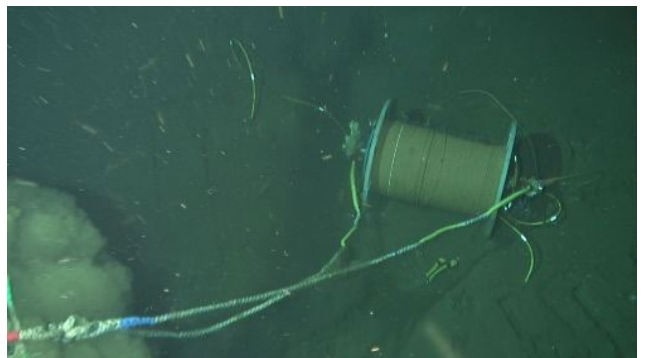
Photo 4.5-10 Connect a retrieval rope to the Extension Cable Bobbin No.42.
