**Cruise report of R/V Kaiyo KY10-07 cruise.**

**"Installation of Earthquake and Tsunami monitoring system"**

**Kumano-nada, off Shiono-misaki, the Nankai Trough**

**Earthquake and Tsunami research project for Disaster**

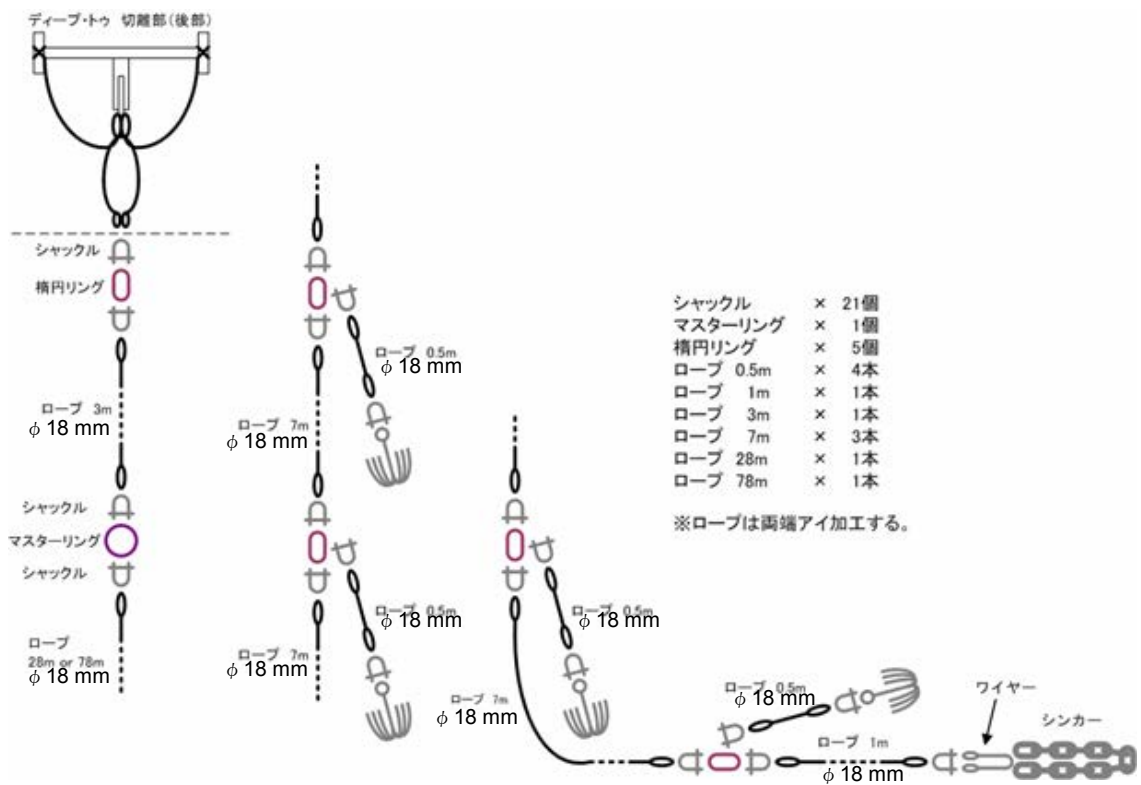
Figure 3. Towing system plan

Deep Tow survey used 6000m class Deep tow camera system to survey seafloor along the planned cable route between the science node of DONET and planned observatories. We prepared a towing system shown as Figure 3 to capture obstacle between the seafloor and the deep tow frame. The Deep tow camera system also equipped a ROV Homer acoustic transponder to measure distance to the ROV homer acoustic mini-transponder attached to the terminal unit of the DONET cable deployed by cable ship prior to the cruise.

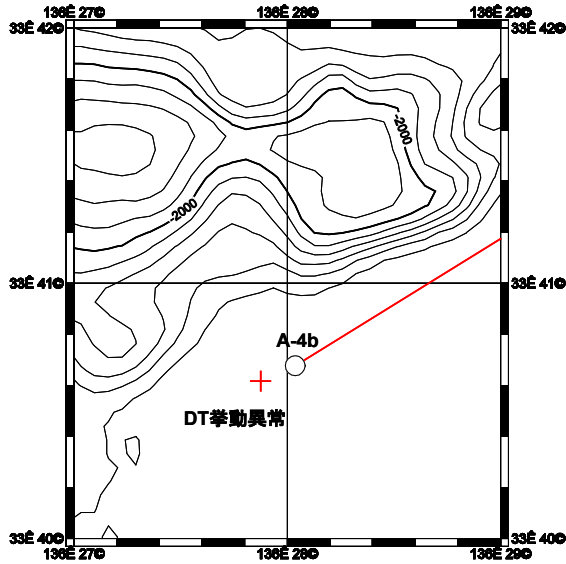
Plan DeepTow track

(4) DT-4C(2010/05/14) (A-4b area clearance)

Target: 33\_40.6171'N, 136\_27.8752'E D=2,054 m

A-4b: 33\_40.677'N, 136\_28.037'E D=2,056 m ROV-Homer ID: 23
