Cruise Report

KY11-E06

Condition Assessment of the riser wellhead of Hole
C9001D and the seafloor surrounding, off Shimokita

A Site Survey for IODP Expedition 337

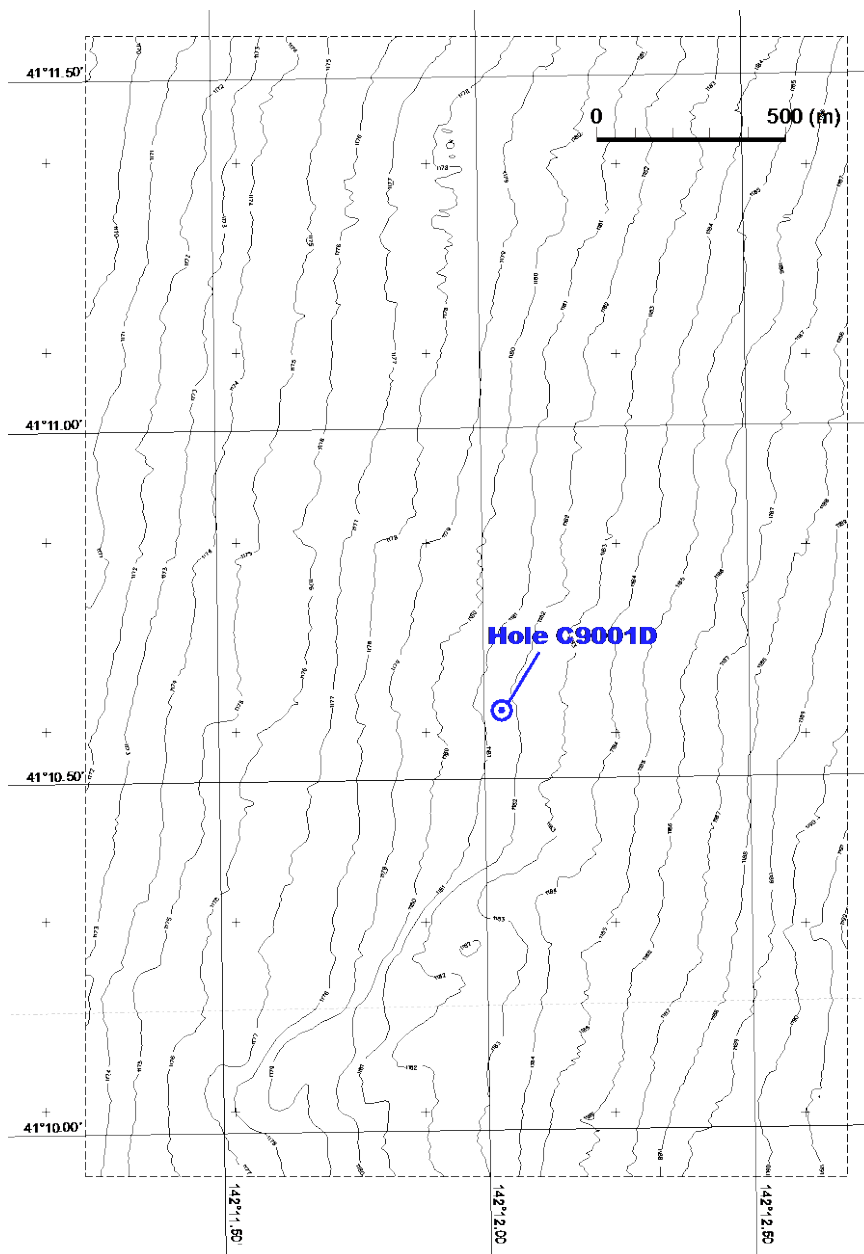
The survey area, Site C9001, is located 80 km away from the Shimokita Peninsula to the east, on a forearc basin of the northeast Japan (Fig. 1). Hole C9001D is a riser hole, which was drilled down to 645 meter below seafloor (mbsf) and cased down to 511 mbsf in 2006, situated on a muddy very gentle slope in 1180 m water depth inclined eastward (Fig. 2).

Figure 2. A high resolution bathymetry map around Hole C9001D. The bathymetry data is obtained by CDEX in 2004. The official water depth (1180 m) is, however, based on the length of drill string in the operations.

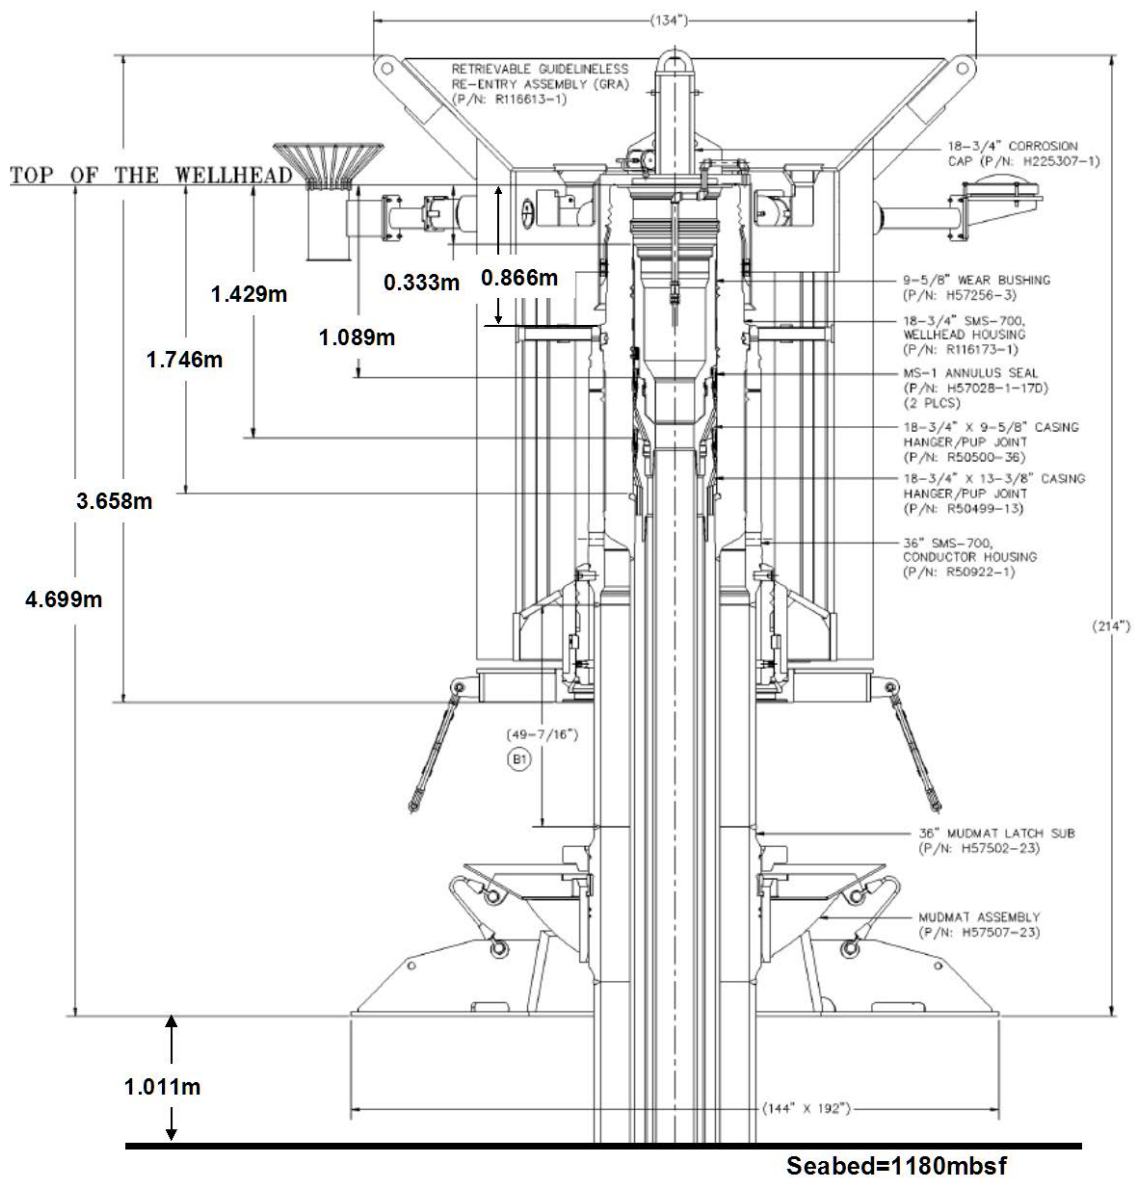
Figure 3. A drawing of the riser wellhead of Hole C9001D.

The wellhead is 6.5 m high and 3.4 m wide at a maximum, with a funnel and a corrosion cap at the top, and painted in yellow (Fig. 3). Two bull's eyes (levels) are equipped on arms projected from the funnel arranged perpendicularly each other. Those directing southward and westward showed 1° and 0.8° at the last observation in 2006, respectively. Besides, a mud pat, which is fit to the base of the wellhead, should be situated beneath the seabed mud with the wires that connect with the wellhead extending to full length. As a corrosion cap that was firstly tried to set dropped at the foot of the wellhead in the last operations, it should be there as it was.

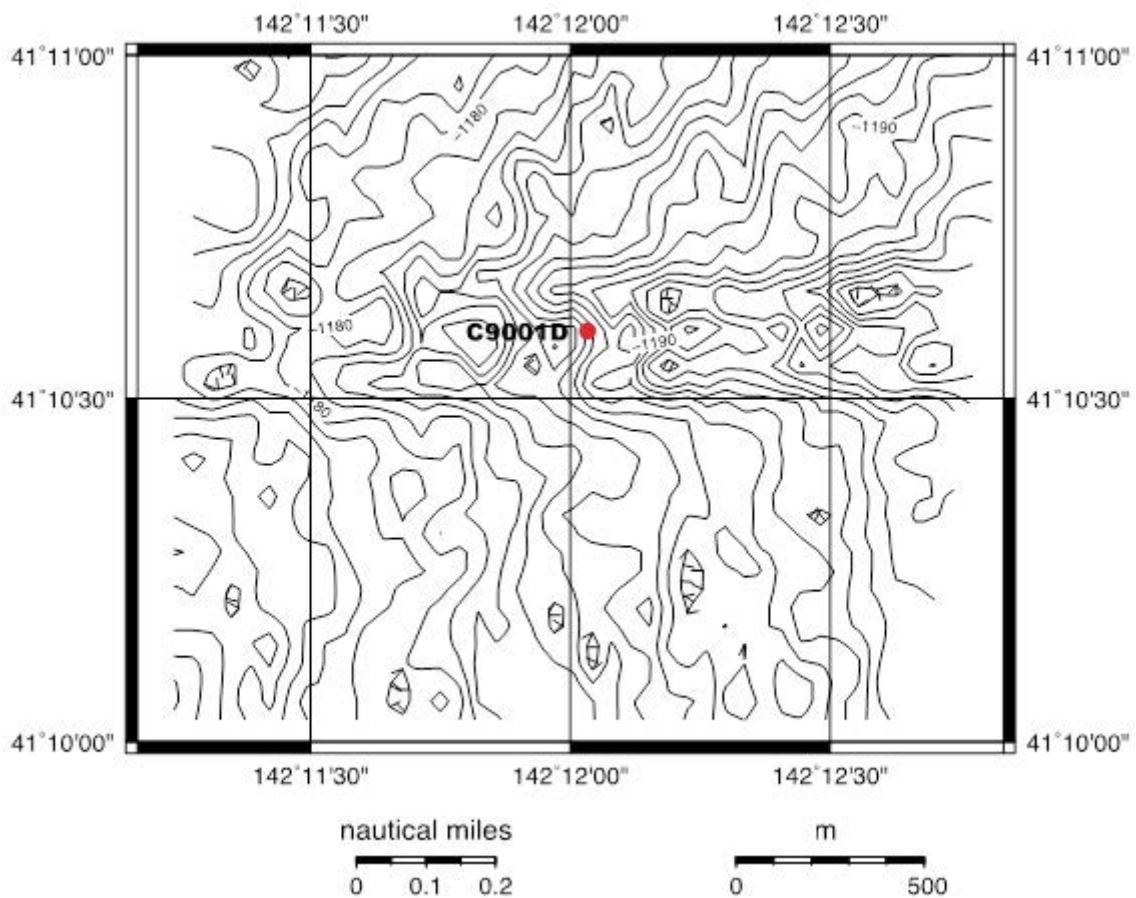
A bathymetry survey with MBES was carried out on 18 November before the dive for reconfirming the bathymetry around the wellhead. As a result, no obvious difference between the bathymetry this time and that of previous survey was recognized. A bathymetry map based the MBES survey is shown in Fig. 6.

Figure 6. A bathymetry map by MBES survey conducted before the dive.

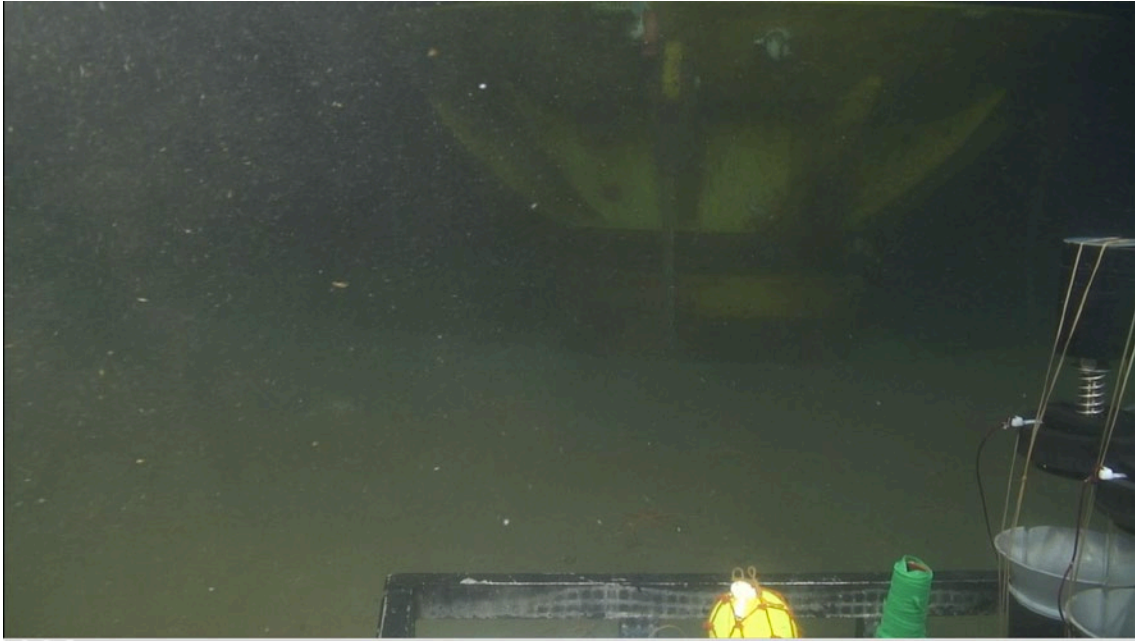
Figure 8. Base part of the wellhead.

- Covered by thin mud with macrobenthos.
- No significant change in tilting of the wellhead.
 - Bull's Eye in the south side: 1° (previous) to 1.5°W (present).
 - Bull's Eye in the west side: 0.8° (previous) to 1.0°SSW (present).
- Wires of the mudpat are fully stretched as they were in 2006.
- No damage in the surface coating except the uppermost part of the corrosion cap.
- The side face of the uppermost part of the corrosion cap was suffered significantly red rust.
 - The eye at the top was under a sound condition
 - The side face of the uppermost part was rusted and two guiding protrusions for the running tool on the face seemed to be rotting. The partial rust is probably caused by that the coating was removed when the running tool was rotated for releasing the corrosion cap.

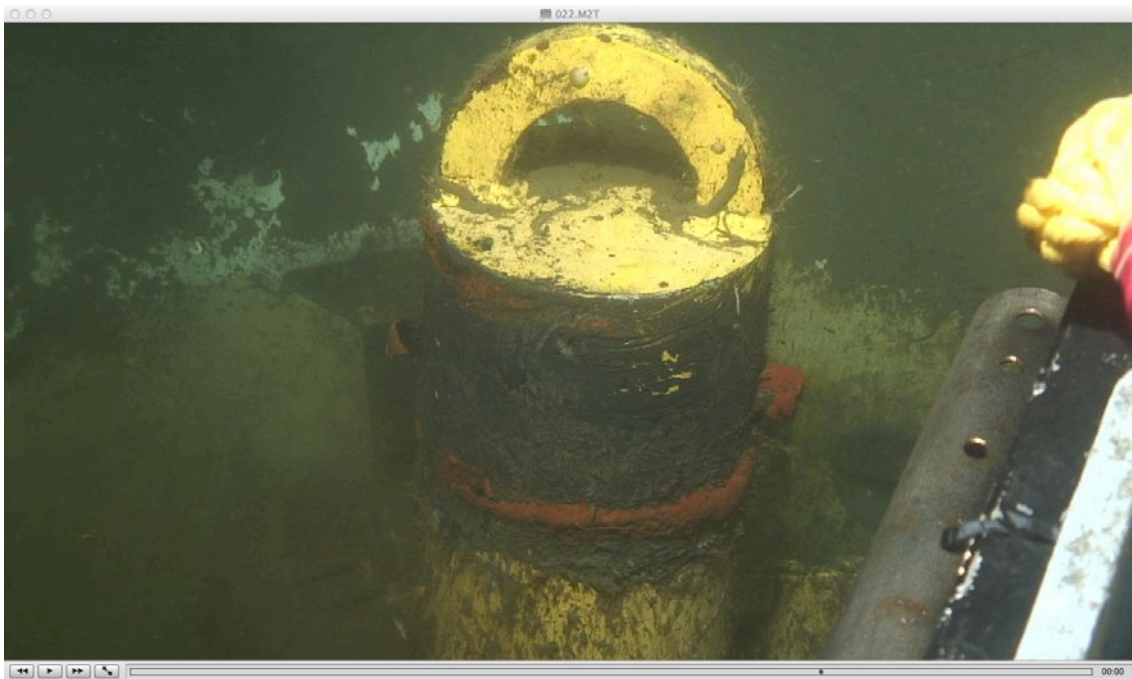
Figure 13. Close-up of the corrosion cap after sweeping with a broom. The part from which the coating was removed by the running tool during installation is only suffered by red rust.

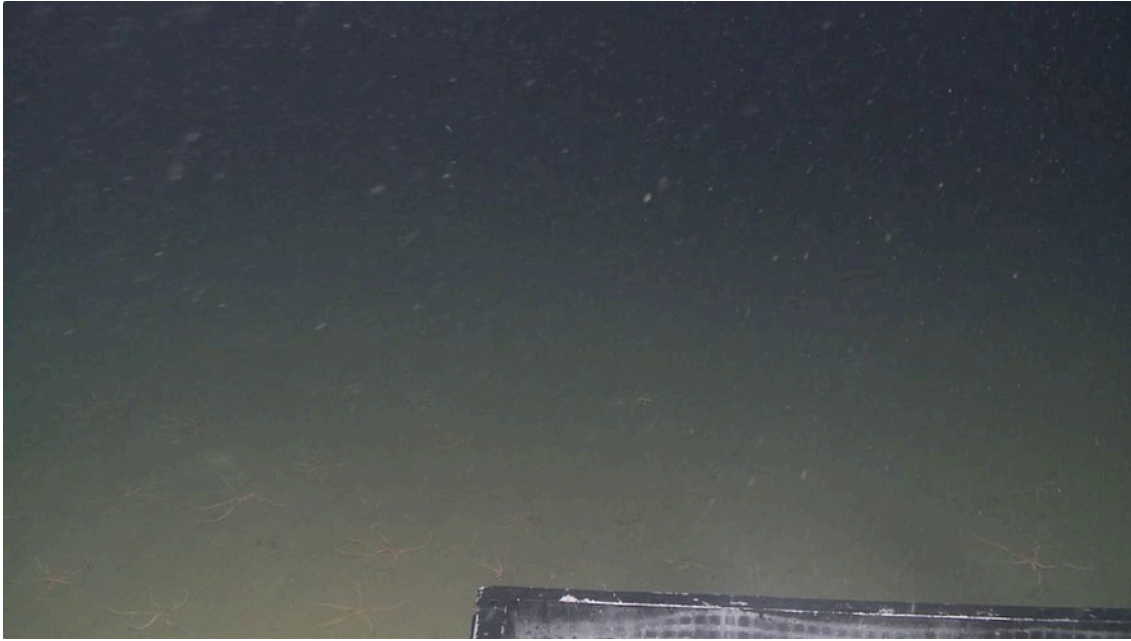
- A corrosion cap that was dropped on the seafloor at the foot of the wellhead in 2006 was lying as it had been.
- The seafloor around the site was flat, covered by soft mud with abundant asteroidean predominated by ophiuroidea, as same as 2006.
- No larger objects lying and abnormal sediment or structure were recognized on the seafloor at least within 50 m around the wellhead.

Figure 14. Flat muddy seafloor with abundant ophiuroidea.

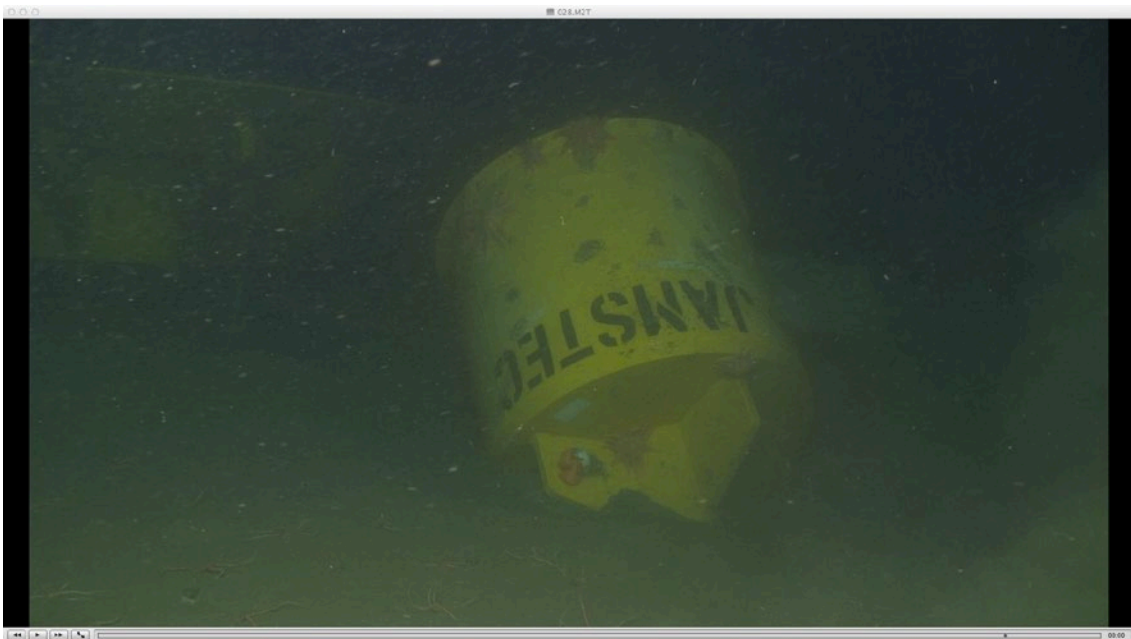
Figure 15. A dropped corrosion cap.

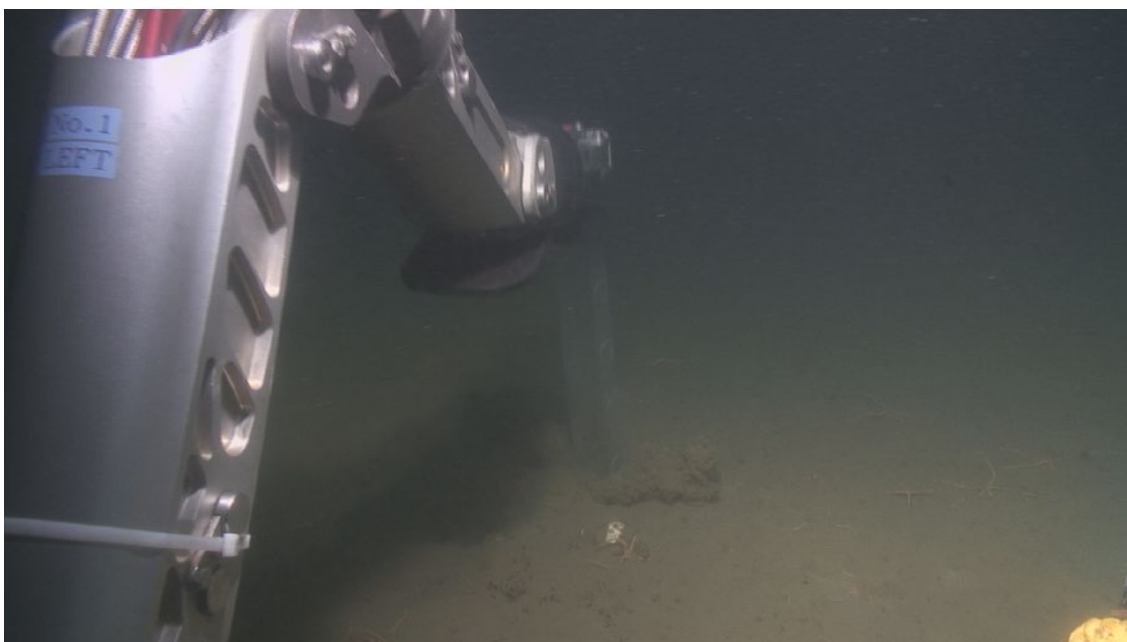
Figure 16. A photo of the push corer sampling at a location 50 m north of the wellhead.

Sediment core samples were taken with MBARI-type push corers at a point 50 m north of the wellhead where no cuttings were apparently distributed. The sampling was performed quite smoothly with obtaining enough amount of sediment inside the corers. The core samples were subdivided into short samples for cell count, RNA, DNA, anaerobic pack and pore water sampling. The sample treatments for taking pore water were performed on board with a centrifuge or a squeezer. A photo of sampling is shown in Fig. 16 and the sample list is shown in Table 3.
