# KAIYO Cruise Report

KY15-05Leg2

Construction of DONET2 system

March.12 – March.29, 2015

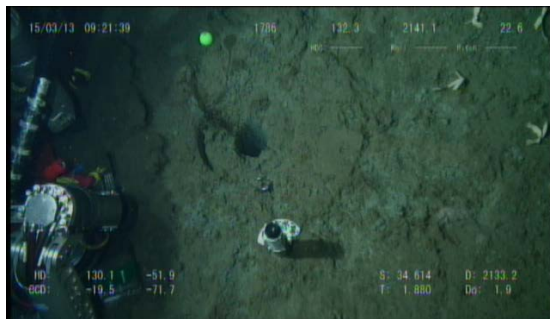
(a) Before operation

In this dive, the preparations which install measurement instrument in a caisson were carried out. The tilting angle of the caisson at 2G-29 was measured to make sure whether it is suitable for installation of the seismometer package. It was confirmed that the tilting angle is less than 10 degrees and this indicates that the caisson can be used for housing the seismometer package. After measuring the tilting angle, the sediments in the caisson were removed using the vacuum system mounted on the HPD and then a cover plate was placed on the caisson. The position of the caisson is (32-40.502N, 134-25.995E, Depth: 2142m).

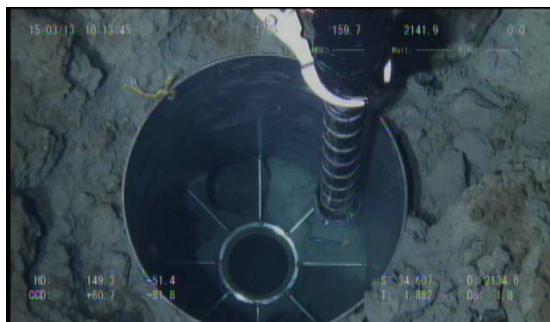
(c) After sediment removal

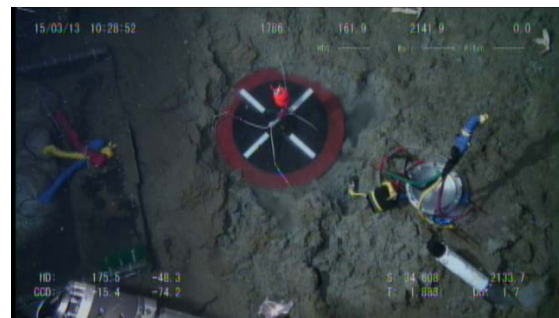
(d) Placing a cover plate on the caisson

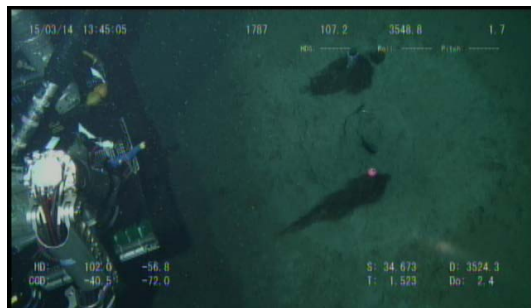
(a) Before operation

In this dive, the preparations which install measurement instrument in a caisson were carried out. The tilting angle of the caisson at 2E-18 was measured to make sure whether it is suitable for installation of the seismometer package. After landing, the ROV moved toward the caisson at 2E-18b (32-55.619N, 135-46.471E, 3,525m). It was confirmed that the tilting angle is less than 10 degrees and this indicates that the caisson can be used for housing the seismometer package. After measuring the tilting angle, the sediments in the caisson were removed using the vacuum system mounted on the ROV and then a cover plate was placed on the caisson. The position of the caisson is (2E-18c: 32-55.632N, 135-46.484E, 3550m).

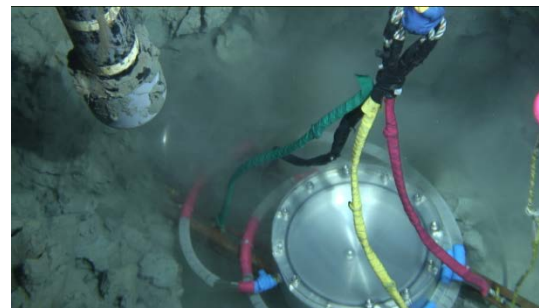
(b) Measuring the tilting angle

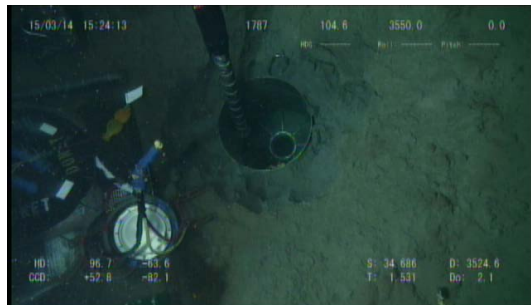
(c) After sediment removal

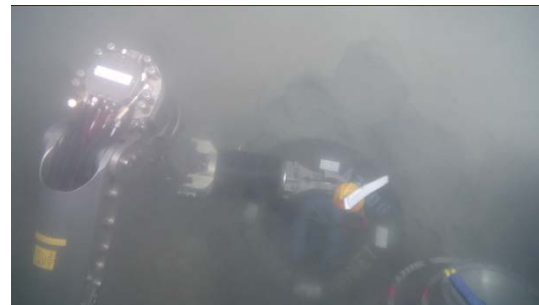
(d) Placing a cover plate on the caisson

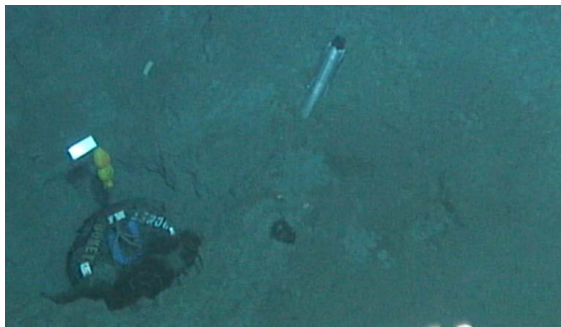
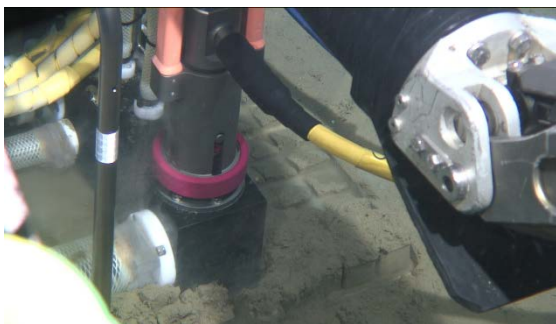
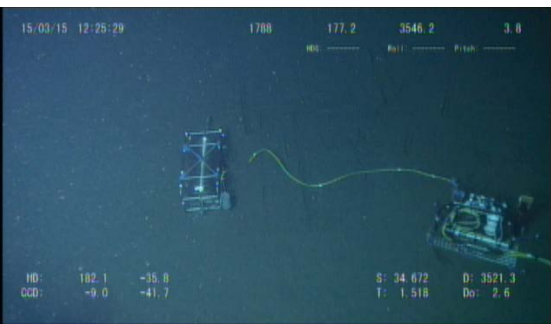
Fig 5.3. Installation of the measurement instruments at 2E-18

(a) Caisson and a cover plate before the installation

(b) Installtion of the seismometer

(c) The pressure sensor package and battery were connected.

(d) The pressure sensor package and battery

In this dive, we installed an observatory system at the caisson 2E-18. The observatory system consists of a seismometer, a pressure sensor package, and a battery package. First, the seismic sensor package was installed inside the caisson. Next, the pressure package was deployed next to the seismic package. These two sensors are initially connected. The battery package was then deployed next the pressure package and connected.

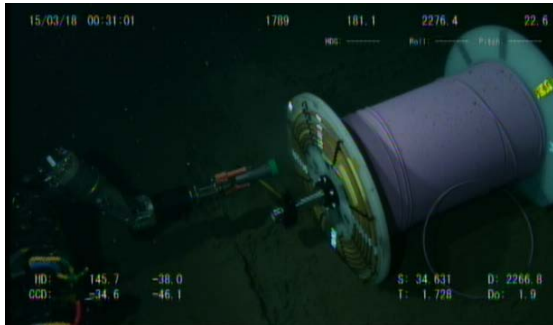
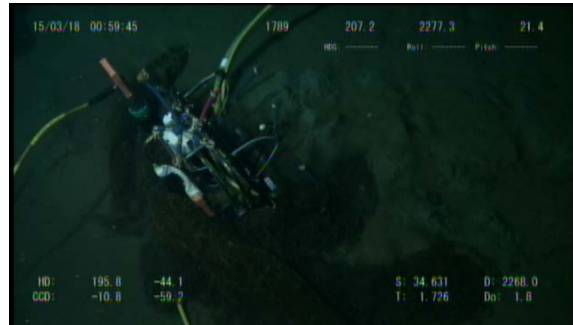
Fig.5.4. Cable Laying operation of the extension cable at 2F-15

(a) Connection with the node (Port No.5)

(b) Cable laying Operation

(c) Cable bobbin with cable on the seafloor

(d) Sensor package of 2F-15d

The cable laying operation from the Node 2F to the observatory 2F-15d was carried out using the automated cable laying system. After landing on near the node, the ROV first put the underwater mateable connector linking to the forefront of the extension cable into the port 5 of the Node 2F. After that, the junction box was put on the seafloor. Then, the cable laying operation was started. The ROV was lay down the cable from the Node 2F to the observatory 2F-15d, and then the cable bobbin was put on the seafloor near the observatory 2F-15d. At last, the ROV connected the extension cable from Node 2F to the observatory 2F-15d. The length of the laid cable was 10,136 [m], the traveled distance was 8,059 [m].

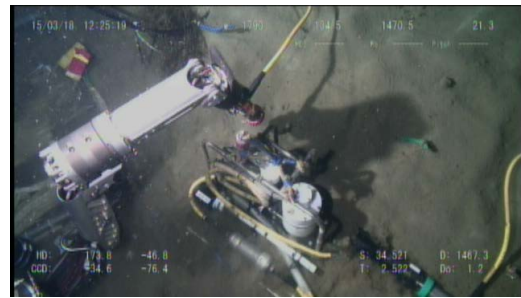
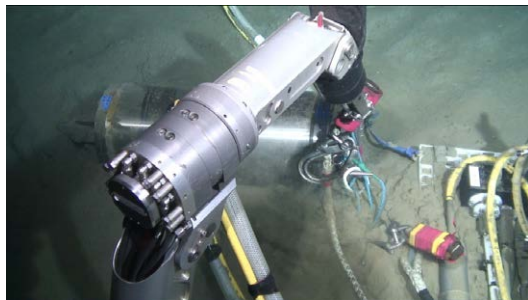
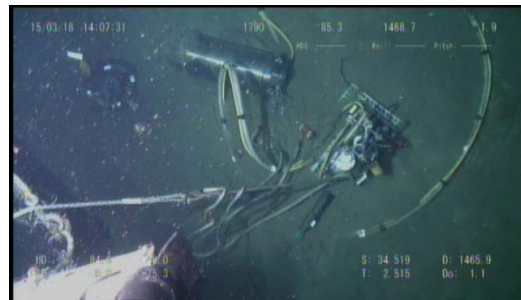
Fig. 5.5. Recovery operation of the measurement equipment at 2B-5.

In this dive, the seismometer package and the pressure sensor package were recovered because there has been a trouble on the gimbal control of the seismometer package. The pressure sensor package is linking with the seismometer package by a cable and the extension cable from the science node and the battery equipment were connected with the pressure sensor package by using underwater mateable connectors.

(a) Seismometer package

(b) Pressure sensor package

(c) Hooking the rope for recovery

(d) Ascending for recovery

After landing on the seafloor, the seismometer package was pulled out from the caisson and then the connectors for connecting the observation equipment with the science node and the battery equipment were pulled out. After that, the rope for recovery was hooked on the seismometer package and the pressure sensor package respectively. Lastly, the HPD ascended for recovery.

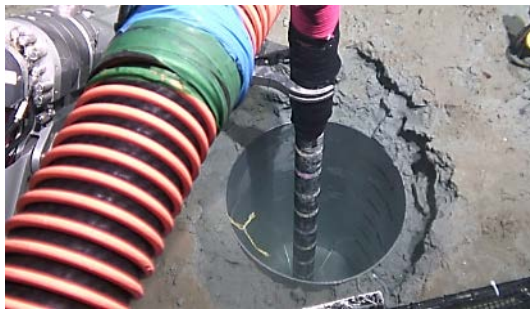
Fig. 5.6. Measuring the tilting angle and sediment removal at 2E-19

(a) Before sediment removal

(b) Measuring the tilting angle

(c) After sediment removal

(d) Placing a cover plate on the caisson

In this dive, the preparations which install measurement instrument in a caisson were carried out. After landing, the ROV moved toward the caisson at 2E-19b (32-53.496N, 135-50.000E, 3,438m). The tilting angle of the caisson at 2E-19 was measured to make sure whether it is suitable for installation of the seismometer package. It was confirmed that the tilting angle is less than 10 degrees and this indicates that the caisson can be used for housing the seismometer package. After measuring the tilting angle, the sediments in the caisson were removed using the vacuum system mounted on the ROV and then a cover plate was placed on the caisson.

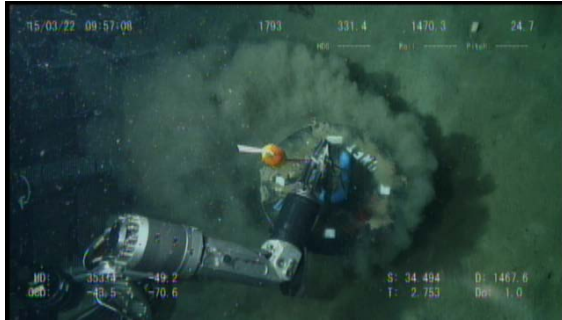
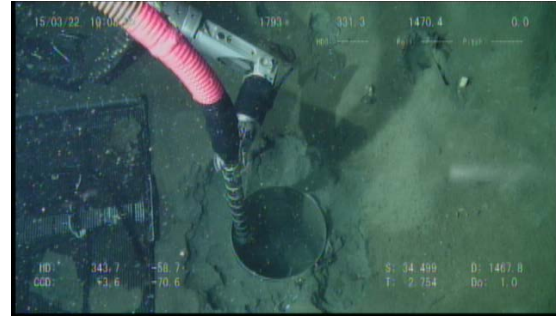
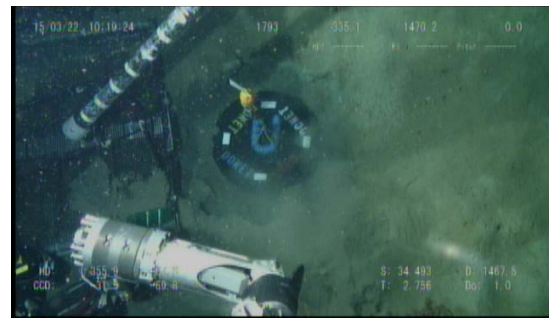
Fig. 5.8. Cleaning inside the caisson 2B-5.

The measurement instrument of 2B-5 was recovered Dive#1790 in this expedition. The sediment or objects fell into the caisson during the measurement instrument was operating. Cleaning was carried out before re-install the measurement instrument. At first, the lid which was put on the caisson in Dive#1790 was removed, and the inside of the caisson was cleaned by the vacuum system. After checking the inside of the caisson, the lid was put on the caisson again.

(a) The lid was opened.

(b) Cleaning inside the caisson

(c) After cleaning

(d) The lid on the caisson

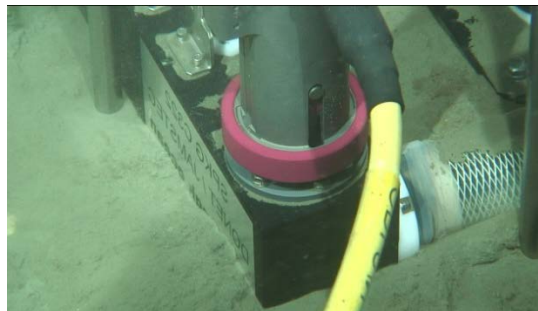
Fig. 5.9. Installation of the measurement instrument at 2B-5

(a) Installing seismic sensor package

(b) Pressure sensor package

(c) Battery package was connected to the pressure sensor package.

In this dive, we installed an observatory system into the caisson at the point 2B-5 using an ROV Hyper Dolphin (HPD). The observatory system consists of the three parts; seismic sensor package, a pressure sensor package and a battery package. First the seismic sensor package was installed inside the caisson. The pressure sensor package was then deployed on the seafloor next to the seismic package. The battery package which was already put on the seabed was connected to the pressure sensor package. These three packages are connected by cables. An ROV Homer (ID: 49) was shifted to the pressure sensor package. Finally the cover plate was collected before leaving the point.

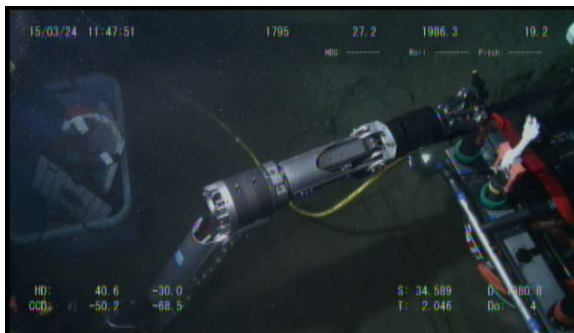
Fig. 5.10. Reinstallation of the node E

(a) Node E

(b) Connecting with the terminal unit

(c) Connecting with observatories

(d) re-installed Node E

The node E had a trouble and was recovered for repair. In this dive, the repaired node was reinstalled. After landing on the seafloor, the HPD moved toward the terminal unit installed by a cable ship and placed the node on the seafloor near the terminal unit. Then, the HPD pulled the underwater mateable connector from the node and took it to the terminal unit for connection. After the connection, it was confirmed in the landing station that the node is operated correctly. After that, four underwater mateable connectors linking with four observatories at 1E-17, 1E-18, 1E-19 and 1E-20 were connected with the node. It was confirmed that the connections between the node and the observatories were achieved successfully.

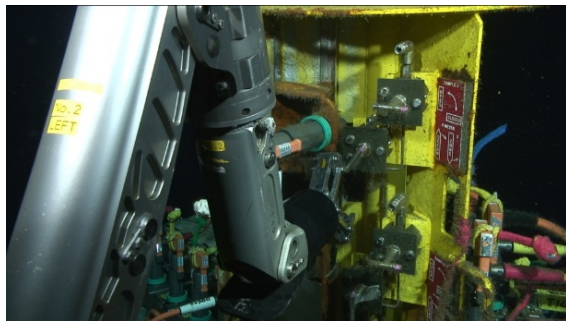
Fig. 5.11 . A measurement of a precise water pressure using a mobile pressure gauge

(a) C0002 platform

(b) Valve operations of the pressure sensors in the C0002 borehole

(c) Deployment of the mobile pressure gauge.

(d) The mobile pressure gauge on the C0002 platform.

In this dive, an ROV Hyper Dolphin (HPD) was operated for a measurement of a precise water pressure on the C0002 platform using a mobile pressure gauge. First, the HPD landed near the C0002 platform. Then we opened a valve of the pressure gauge, and stayed about 3 hours for a thermally stable measurement. Then we moved the pressure gauge onto the C0002 platform, and placed the mobile pressure gauge. After an hours of the water pressure measurement, we recovered the pressure gauge. During the measurements, we opened and closed three valves of pressure sensors equipped in the C0002 borehole for the correction.

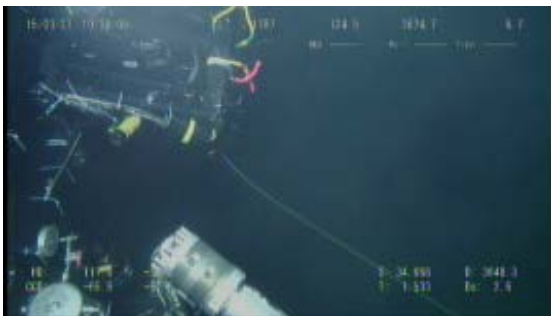
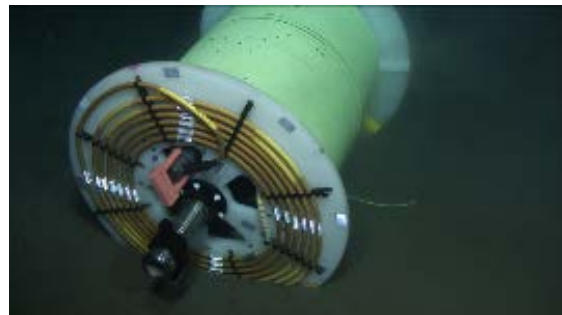
Fig 5.12. Cable-laying operation at 2E-18

(a) Connection with the Node 2E

(b) Installation of the junction box

(c) Cable laying operation

(d) Cable bobbin was putted on near the sensor

After landing near the Node 2E, the ROV put the underwater mateable connector linking to the forefront of the cable on the cable bobbin into the port 5 of the Node2E. After that, the junction box was put on the seafloor. Then, the cable laying operation was started. The ROV was lay down the cable from the Node2E to the observatory 2E-18d, and then the cable bobbin was put on the seafloor near the observatory 2E-18. At last, the ROV connected the cable from Node2E to the observatory 2E-18d.
