# KAIYO Cruise Report

KY15-09

Construction of DONET2 system

Japan Agency for Marine-Earth Science and Technology

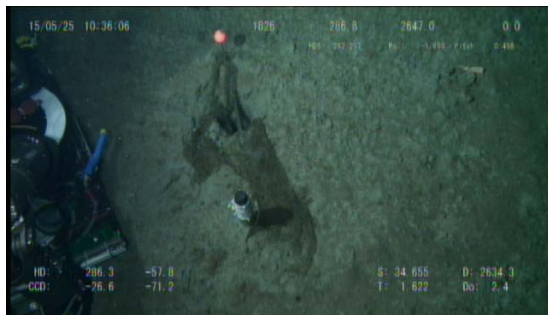
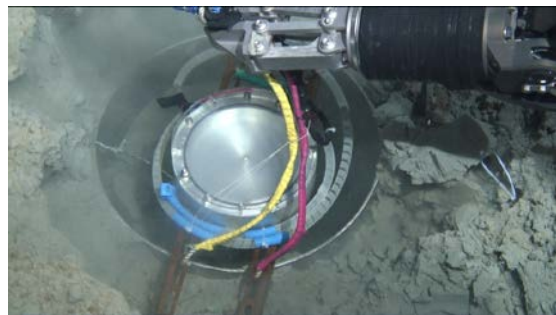
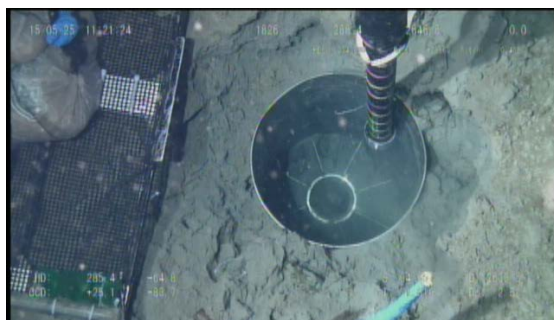
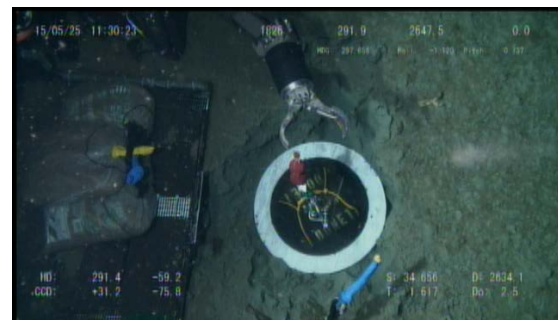
Fig. 5.1. Measuring the tilting angle and sediment removal at 2F-23.

In this dive, the preparations which install measurement instrument in a caisson were carried out. The tilting angle of the caisson was measured to make sure whether it is suitable for installation of the seismometer package. It was confirmed that the tilting angle is less than 10 degrees and this indicates that the caisson can be used for housing the seismometer package. After measuring the tilting angle, the sediments in the caisson were removed using the vacuum system mounted on the ROV Hyper Dolphin and then a cover plate was placed on the caisson. The position of the caisson is 32-52.961N, 135-18.495E, Depth: 2647m.

(a) Before operation

(b) Measuring the tilting angle

(c) After sediment removal

(d) Placing a cover plate on the caisson

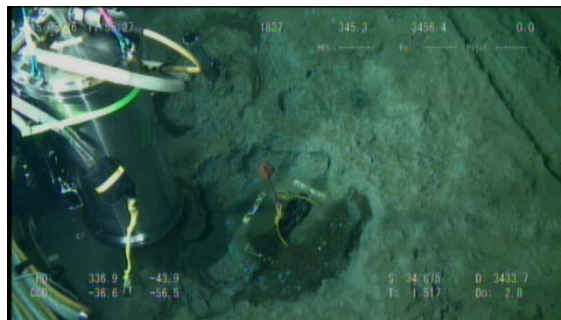
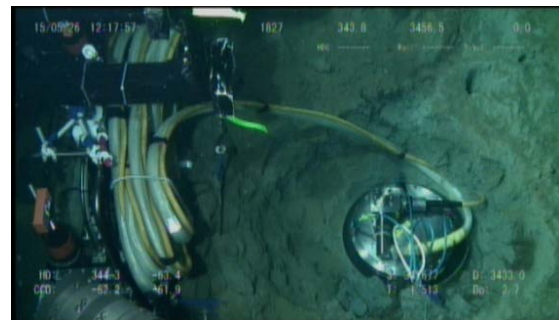
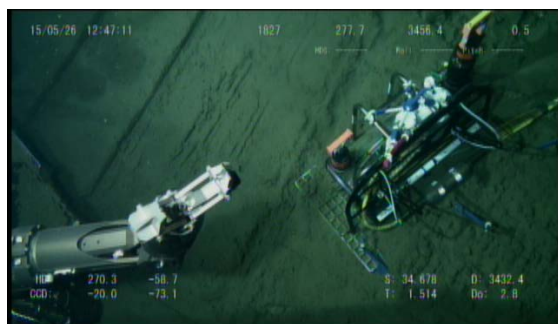
Fig 5.2. Installation of the measurement instruments at 2E-19

In this dive, we installed an observatory system at the caisson 2E-19. The observatory system consists of a seismometer, a pressure sensor package, and a battery package. First, the seismic sensor package was installed inside the caisson. Next, the pressure package was deployed next to the seismic package. These two sensors are initially connected. The battery package was then deployed next the pressure package and connected.

(a) Before installation

(b) Installation of the seismometer

(c) The pressure sensor package

(d) The external battery

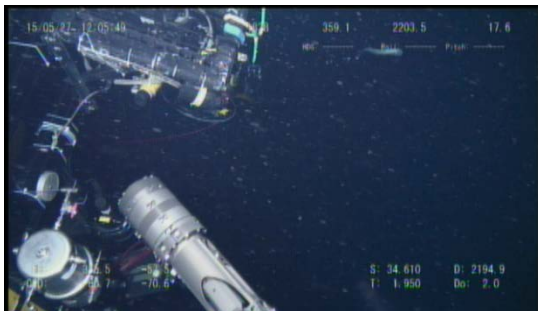
Fig.5.3. Cable Laying operation of the extension cable at 2G-26

The cable-laying operation from the “Node2G” to the observatory “2G-26” was carried out using the automated cable-laying system. After landing on near the node, the ROV first put the underwater mateable connector linking to the upper end of the cable on the cable bobbin into the port 5 of the “Node2G” (Fig.5.3 a). After that, the junction box was put on the seafloor (Fig. 5.3 b). Then, the cable laying operation was started (Fig.5.3 c). The ROV laid down the cable from the “Node2G” to the observatory “2G-26”, and then the cable bobbin was put on the seafloor near the observatory “2G-26” (Fig.5.3 d). At last, the ROV connected the cable from “Node 2G” to the observatory “2G-26” (Fig.5.4 e). The length of the laid cable was 8,116 [m], the traveled distance was 7,775 [m].

(a) Connection with the node (Port No.5)

(b) The junction box

(c) Cable laying Operation

(d) Cable bobbin

(e) The cable from “Node 2G” was connected to observatory “2G-26”

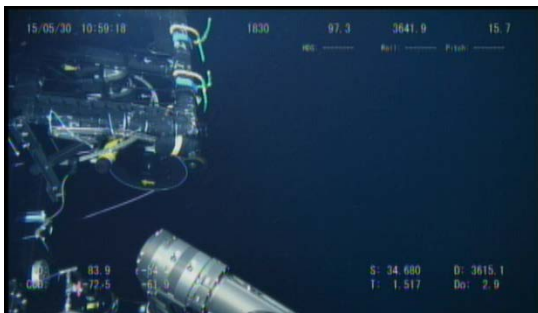
Fig.5.5. Cable Laying operation of the extension cable at 2E-19

The cable-laying operation from the “Node2E” to the observatory “2E-19” was carried out using the automated cable-laying system. After landing on near the node, the ROV first put the underwater mateable connector linking to the forefront of the cable on the cable bobbin into the port 6 of the “Node2E” (Fig.5.5a). After that, the junction box was put on the seafloor (Fig.5.5b). Then, the cable laying operation was started (Fig.5.5c). The ROV laid down the cable from the “Node2E” to the observatory “2E-19”, and then the cable bobbin was put on the seafloor near the observatory “2E-19” (Fig.5.5d). At last, the ROV connected the cable from “Node 2E” to the observatory “2E-19” (Fig.5.5e). The length of the laid cable was 8,477 [m], the traveled distance was 7,935 [m].

(a) Connection with the node (Port No.6)

(b) Installation of the junction box

(c) Cable laying Operation

(d) Cable bobbin with cable on the seafloor

(e) The cable from “Node 2E” was connected to observatory “2E-19”

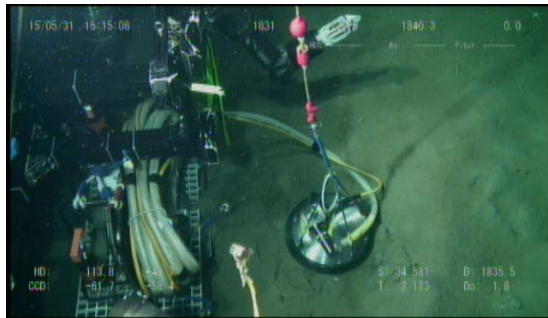
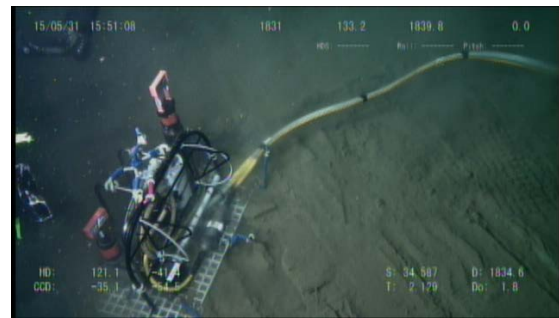
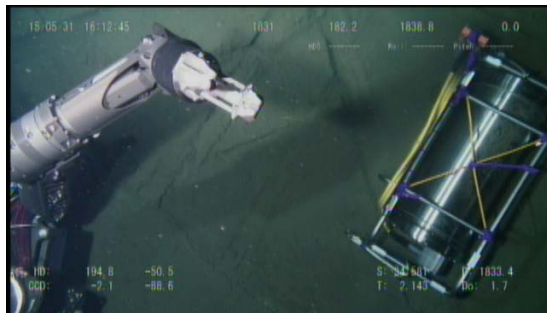
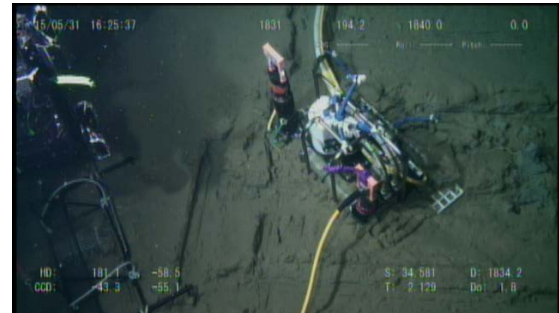
Fig. 5.6. Installation of the measurement instrument at 1E-22

In this dive, we installed an observatory system into the caisson at the point 1E-22 using an ROV Hyper Dolphin. The observatory system consists of the three parts; a seismic sensor package, a pressure sensor package and a battery package. First the seismic sensor package was installed inside the caisson. The pressure sensor package was then deployed on the seafloor next to the seismic package. The battery package was connected to the pressure sensor package. These three packages are connected by cables. An ROV Homer (ID: 54) was placed near the pressure sensor package. Finally the cover plate was collected before leaving the point.

(a) Seismometer package

(b) Pressure sensor package

(c) Battery package

(d) Connection with the battery package

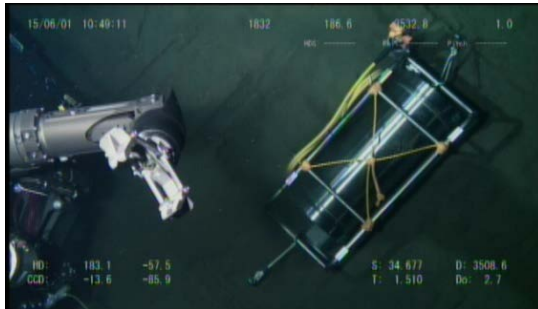
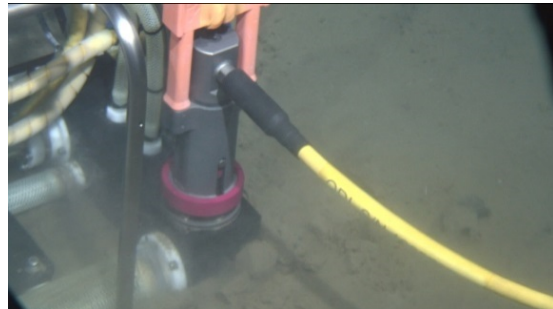
Fig. 5.7. Installation of the measurement instrument at 2F-22

In this dive, we installed an observatory system into the caisson at 2E-21 using an ROV Hyper Dolphin. The observatory system consists of the three parts; seismic sensor package, a pressure sensor package and a battery package. First the seismic sensor package was installed inside the caisson by using the ROV. The pressure sensor package was then deployed on the seafloor next to the seismic package. In addition, the battery package was deployed next to the pressure package. These three packages are connected by cables. The miniature transponder (ID: 59) was deployed close to the pressure sensor package. Finally the caisson cover was collected before leaving the point.

(a) Installing the seismic sensor package

(b) The pressure sensor package

(c) The battery package

(d) The battery package and the sensor was connected

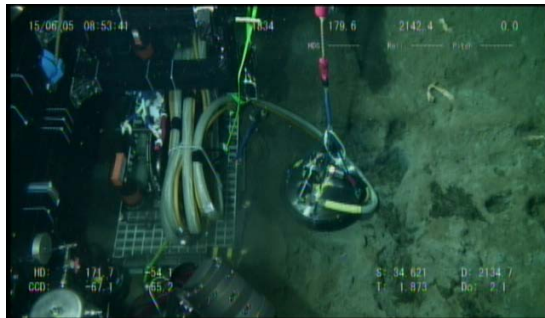
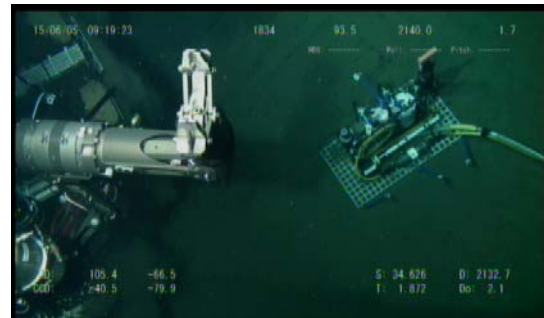
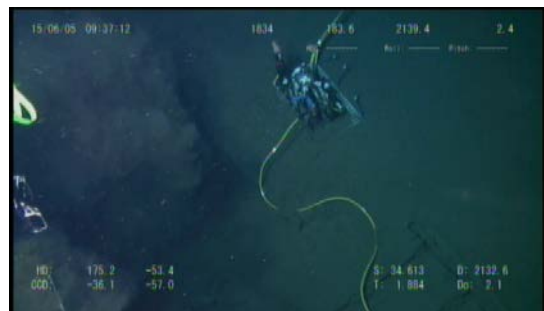
Fig. 5.8. Installation of the measurement instrument at 2F-23

In this dive, we installed measurement instrument at 2F-23. The measurement instrument is composed of a seismometer package, a pressure sensor package, and a battery package. First, the seismometer package was inserted inside the caisson and the pressure sensor package was placed on the seafloor at a distance of approximately 10m from the seismometer package. And then, the battery package was put on the seafloor next to the pressure sensor package. Finally, the ROV Hyper Dolphin connected the battery package to the pressure sensor package using the underwater mateable connector. In addition, the covering plate placed on the caisson was recovered.

(a) Seismometer package

(b) Pressure sensor package

(c) The battery package

(d) Connection with the battery package

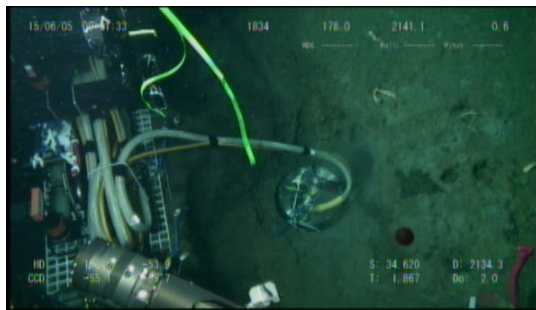
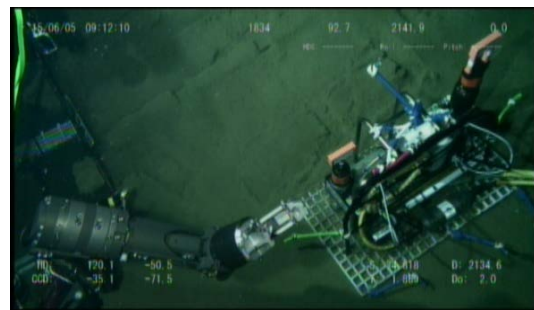
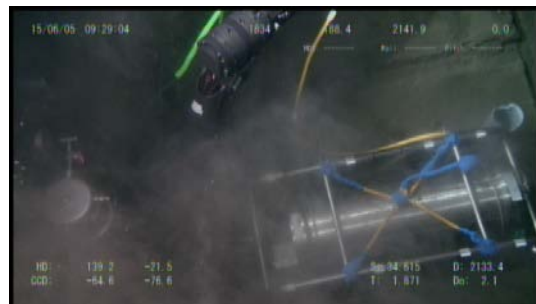
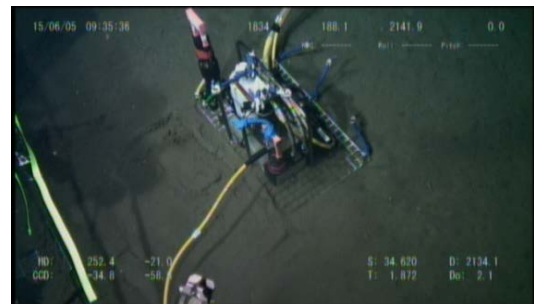
Fig. 5.9. Installation of the measurement instrument at 2G-29

In this dive, we installed an observatory system into the caisson at the point 2G-29 using an ROV Hyper Dolphin. The observatory system consists of the three parts; seismic sensor package, a pressure sensor package and a battery package. First the seismic sensor package was installed inside the caisson. The pressure sensor package was then deployed on the seafloor next to the seismic package. In addition, the battery package was deployed next to the pressure package. These three packages are connected by cables. The miniature transponder (ID: 60) was deployed close to the pressure sensor package. Finally the used caisson cover was collected before leaving the point.

(a) The lid on the caisson was covered with seaweed

(b) seismic sensor package

(c) Pressure sensor package

(d) External battery

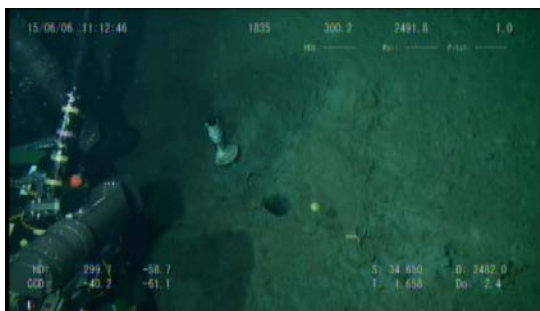
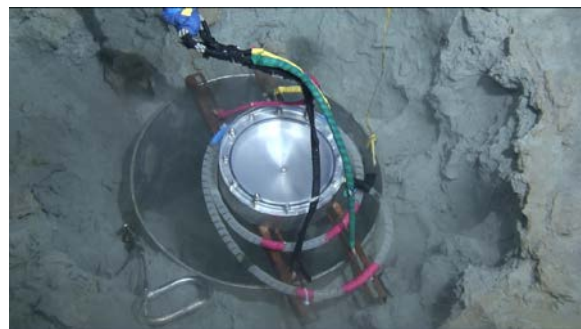
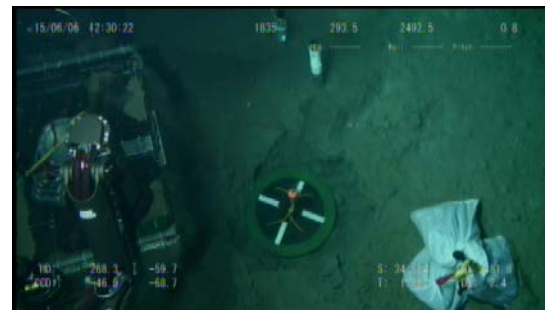
Fig. 5.10. Measuring the tilting angle and sediment removal at 2G-27

In this dive, the preparations which install measurement instrument in a caisson were carried out. After landing, the ROV moved toward the caisson at 2G-27. The tilting angle of the caisson was measured to make sure whether it is suitable for installation of the seismometer package. It was confirmed that the tilting angle is less than 10 degrees and this indicates that the caisson can be used for housing the seismometer package. After measuring the tilting angle, the sediments in the caisson were removed using the vacuum system mounted on the ROV and then a cover plate was placed on the caisson. In addition, an additional ROV-Homer (ID: 21) and a buoy were installed for easy homing. The position of the caisson is (2G-27: 32-42.525N, 134-35.979E, Depth: 2494m).

(a) Before sediment removal

(b) Measuring the tilting angle

(c) After sediment removal

(d) Placing a cover plate on the caisson

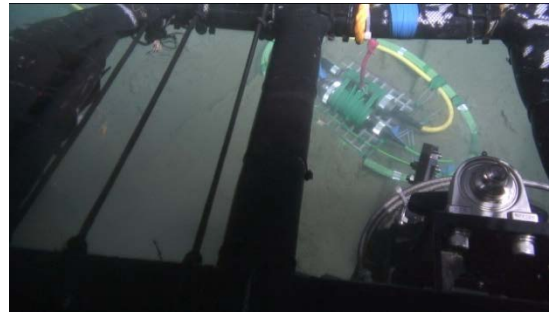
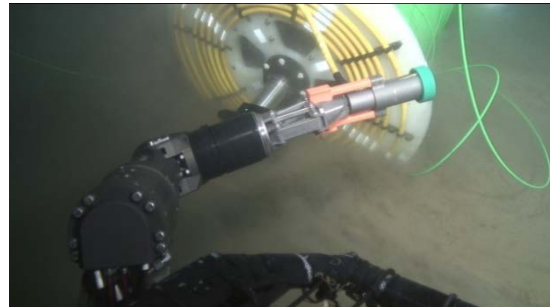
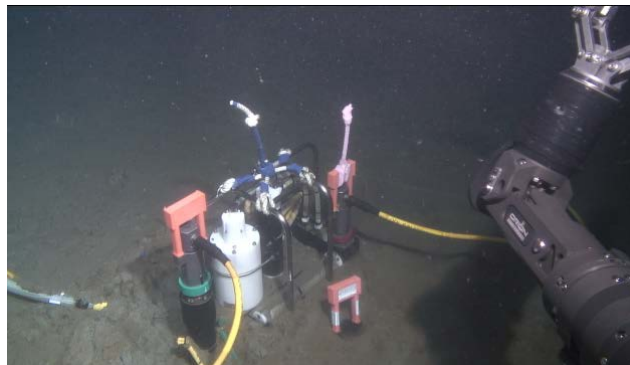
Fig 5.11. Cable-laying operation from Node 2F to the observatory 2F-23

The cable-laying operation from Node 2F to the observatory 2F-23 was carried out using the automated cable-laying system. After landing near Node 2F, the ROV first put the underwater mateable connector linking to the upper end of the cable on the cable bobbin into the port 4 of the node. After that, the junction box was placed on the seafloor and the cable-laying operation was started. After arriving at near the observatory 2F-23, the ROV placed the cable bobbin on the seafloor and connected the cable with the observatory 2F-23 using the underwater mateable connector. It was confirmed that there is no problem in communication between the observatory 2F-23 and the landing station. The length of the dispensed cable was approximately 8,236m and the traveled distance was approximately 7,797m.

(a) Connection with the node (Port No.4)

(b) Installation of the junction box

(c) Cable laying Operation

(d) Cable bobbin with cable on the seafloor

(e) The cable from “Node 2F” was connected to observatory “2F-23”

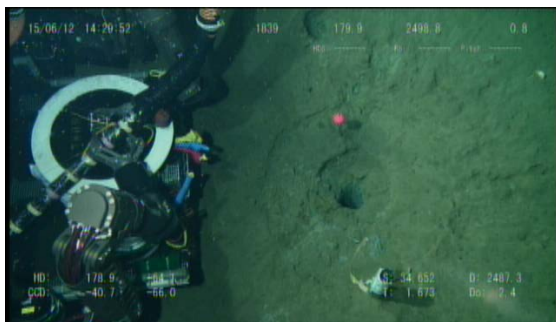
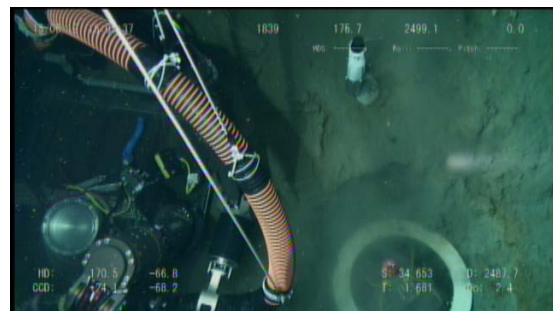
Fig. 5.14. Measuring the tilting angle and sediment removal at 2G-28

In this dive, the preparations which install measurement instrument in a caisson were carried out. After landing, the ROV moved toward the caisson at 2C-28. The tilting angle of the caisson was measured to make sure whether it is suitable for installation of the seismometer package. It was confirmed that the tilting angle is less than 10 degrees and this indicates that the caisson can be used for housing the seismometer package. After measuring the tilting angle, the sediments in the caisson were removed using the vacuum system mounted on the ROV and then a cover plate was placed on the caisson.

(a) Before sediment removal

(b) Measuring the tilting angle

(c) After sediment removal

(d) Placing a cover plate on the caisson

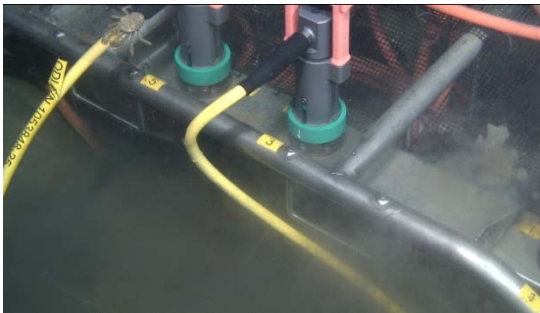
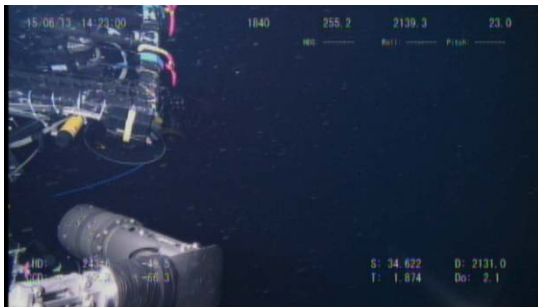
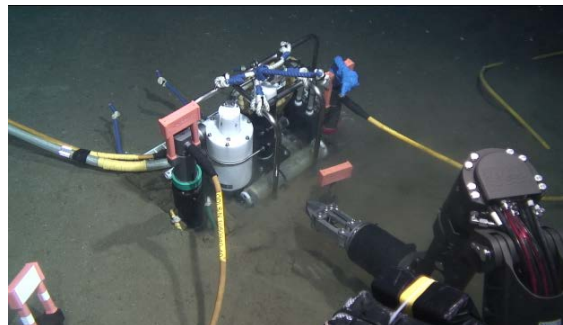
Fig 5.15. Cable-laying operation from Node 2G to the observatory 2G-29

The cable-laying operation from Node 2G to the observatory 2G-29 was carried out using the automated cable-laying system. After landing near Node 2G, the ROV first put the underwater mateable connector linking to the upper end of the cable on the cable bobbin into the port 3 of the node. After that, the junction box was placed on the seafloor and the cable-laying operation was started. After arriving at near the observatory 2G-29, the ROV placed the cable bobbin on the seafloor and connected the cable with the observatory 2G-29 using the underwater mateable connector. It was confirmed that there is no problem in communication between the observatory 2G-29 and the landing station. The length of the laid cable was approximately 8,536m and the traveled distance was approximately 8,061m.

(a) Connection with the Node 2G

(b) Installation of the junction box

(c) Cable laying operation

(d) Cable bobbin

(e) Connection with the observatory

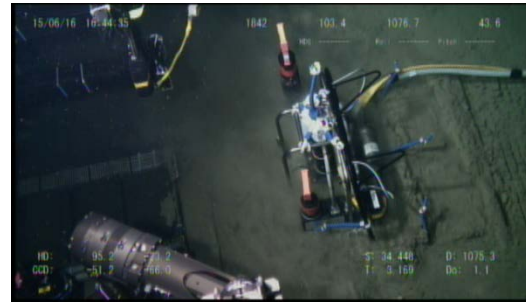
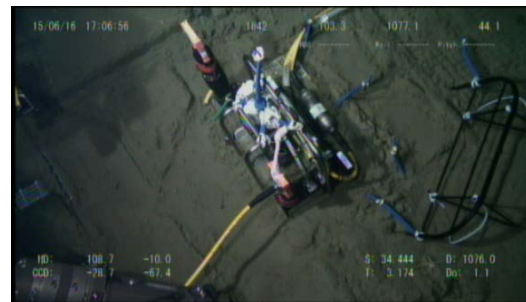
Fig. 5.17. Installation of the measurement instrument at 2B-7

In this dive, we installed an observatory system into the caisson at the point 2B-7 using an ROV Hyper Dolphin (HPD). The observatory system consists of the three parts; seismic sensor package, a pressure sensor package and a battery package. First the seismic sensor package was installed inside the caisson. The pressure sensor package was then deployed on the seafloor next to the seismic package. The battery package was connected to the pressure sensor package. These three packages are connected by cables. An ROV Homer (ID: 46) was placed near the pressure sensor package. Finally the cover plate was collected before leaving the point.

(a) Seismic sensor package

(b) Pressure sensor package

(d) Battery package was connected to the pressure sensor package

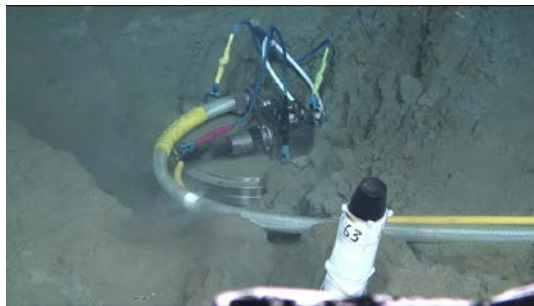
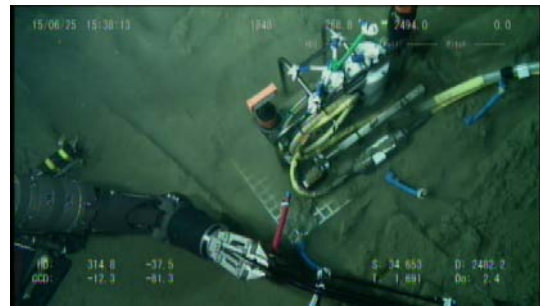
Fig 5.23: Installation of the measurement instrument at 2G-27.

In this dive, we installed observation equipment at 2G-27. The observation equipment is composed of a seismometer package, a pressure sensor package, and a battery equipment. First, the seismometer package was inserted inside the caisson and the pressure sensor package was placed on the seafloor at a distance of approximately 7m from the seismometer package. And then, the battery equipment was put on the seafloor next to the pressure sensor package. Finally, the HPD connected the battery equipment to the pressure sensor package linking with the seismometer package using the underwater mateable connector. In addition, the covering plate placed on the caisson and the ROV-Homer ID 21 were recovered.

(a) Seismometer package

(b) Pressure sensor package

(c) Battery equipment

(d) After connection with the battery equipment

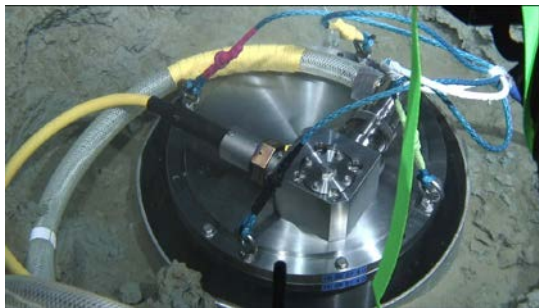
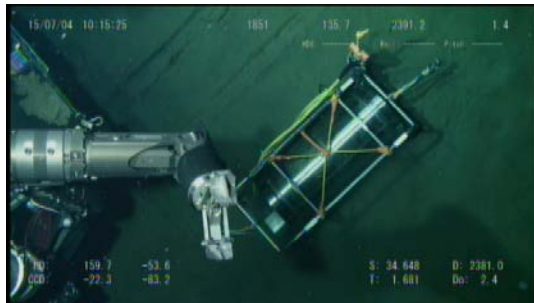
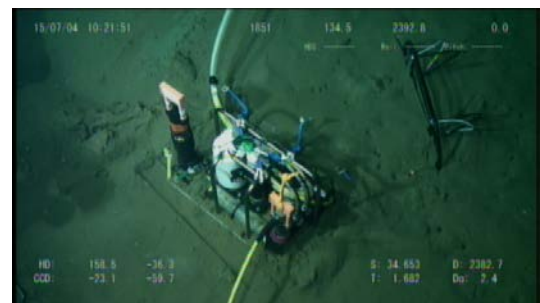
Fig 5.26: Installation of the measurement instrument at 2F-24.

In this dive, we installed observation equipment at 2F-24. The observation equipment is composed of a seismometer package, a pressure sensor package, and a battery equipment. First, the seismometer package was inserted inside the caisson and the pressure sensor package was placed on the seafloor at a distance of approximately 7m from the seismometer package. And then, the battery equipment was put on the seafloor next to the pressure sensor package. Finally, the HPD connected the battery equipment to the pressure sensor package linking with the seismometer package using the underwater mateable connector. In addition, the covering plate placed on the caisson was recovered.

(a) Seismometer package

(b) Pressure sensor package

(c) Battery equipment

(d) After connection with the battery equipment

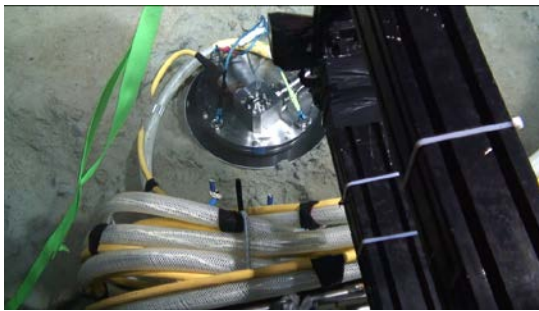
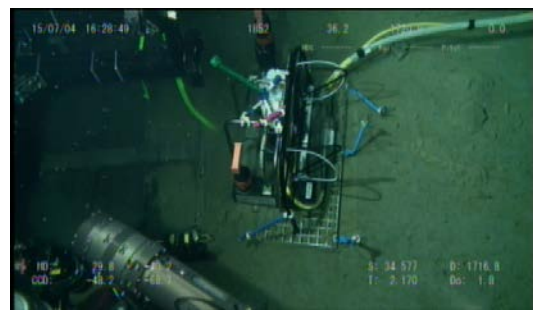
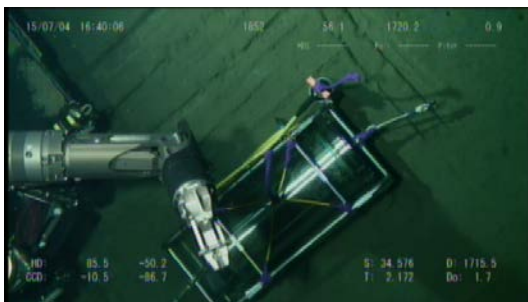
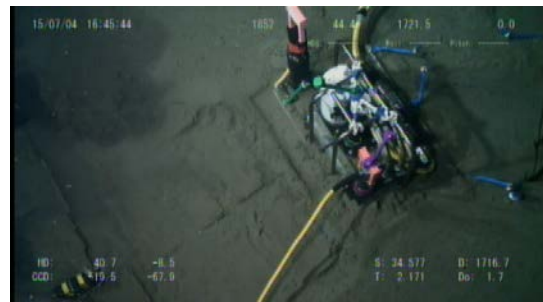
Fig. 5.27: Installation of the measurement instrument at 2C-10.

In this dive, we installed observation equipment at 2C-10. The observation equipment is composed of a seismometer package, a pressure sensor package, and a battery equipment. First, the seismometer package was inserted inside the caisson and the pressure sensor package was placed on the seafloor at a distance of approximately 7m from the seismometer package. And then, the battery equipment was put on the seafloor next to the pressure sensor package. Finally, the HPD connected the battery equipment to the pressure sensor package linking with the seismometer package using the underwater mateable connector. In addition, the covering plate placed on the caisson was recovered.

(a) Seismometer package

(b) Pressure sensor package

(c) Battery equipment

(d) After connection with the battery equipment
