## R/V Natsushima Cruise Report

NT16-02

Strategic Innovation Program (SIP), New-generation Technology  
for Ocean Resources Survey (ZIPANG in ocean), Metallogenic  
study on seafloor resources, in-situ test for the recovery of the

Iheya-North Knoll, Middle Okinawa Trough

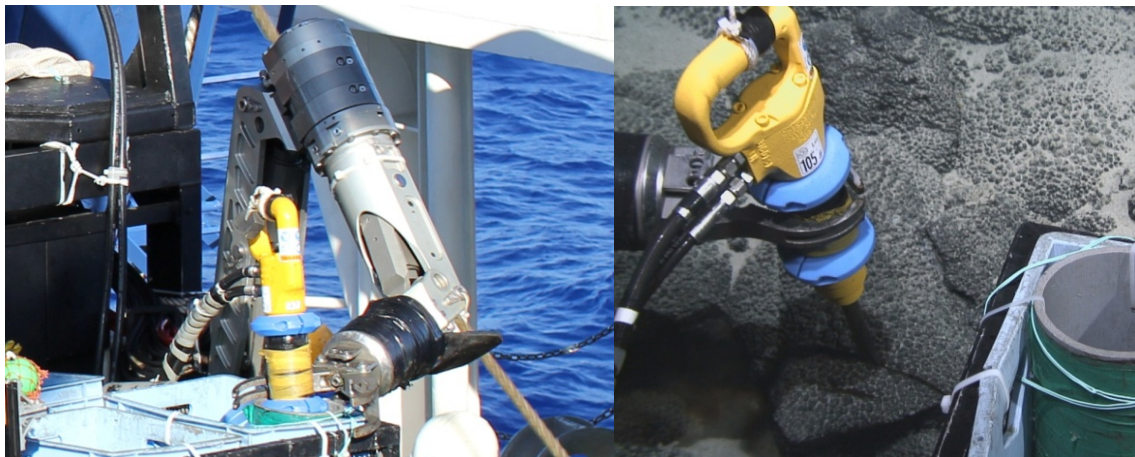
Hydraulic power chisel was originally developed to effectively collect Fe-Mn crust from the seamount basalt. We used this chisel to remove scale within the steel pipe of the corrosion cap. The hydraulic power of the chisel is supplied from a ROV directly.

Fig. 3-3 Hydraulic Power Chisel.

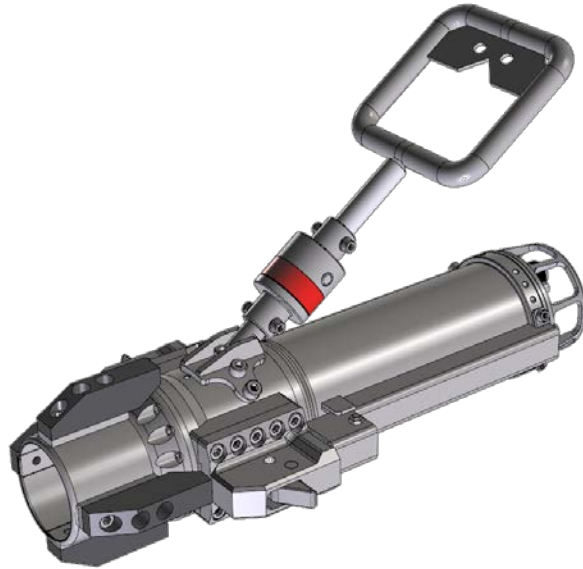
Hydraulic power torque tool was developed to rotate the flow adjuster valve of the Kuroko-ore cultivation apparatus and regulate flow rate of hydrothermal fluid. The hydraulic power of the torque tool is supplied from the IHPU.

Fig. 3-4 Hydraulic power torque tool.

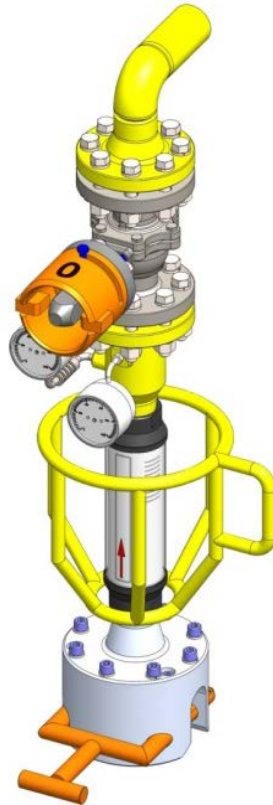
Simplified flow meter has both analogue and digital flow meters together with pressure and temperature gauges and their sensor loggers. We tried to install this simplified flow meter after remove scale within the steel pipe of the corrosion cap at Hole C0014G to do monitoring while drilling (MWD) of the artificial hydrothermal vent in the next Chikyu's cruise.

Fig. 3-6 Simplified flow meter with pressure and temperature gauges with a sensor logger.

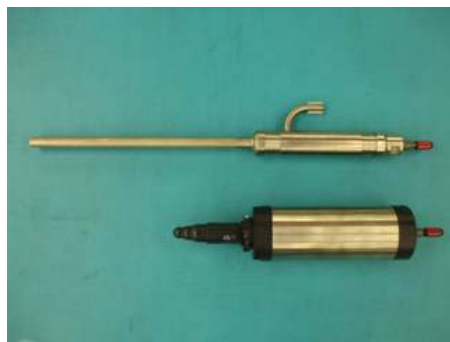
High-T thermometer was used for the measurement of hydrothermal fluid on Hole C0014G. We borrowed this thermometer from Dr. K. Okamura at Kochi University.

Fig. 3-7 Thermometer for hydrothermal fluid (borrowed from Kochi Univ.).

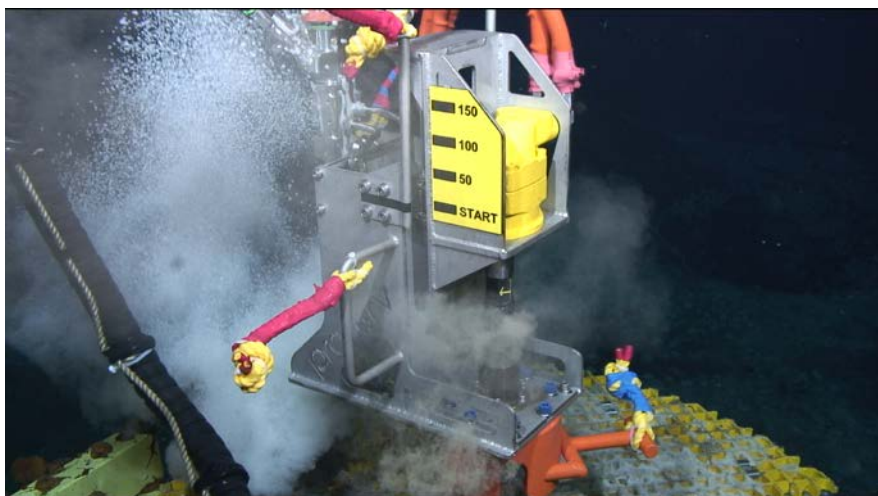
Fig. 3-14 Removing scale within the steel pipe by hydraulic power drill.

During settling down of the ROV, we noticed slow oil leakage (oil bubble) from some pipes and hot stab of the hydraulic power drill. After the arrival on a seafloor, HPD3000 went to the artificial hydrothermal vent of Hole C0014G. White soft sediment (CO<sub>2</sub> hydrate?) covered the uppermost part of the steel pipe of the corrosion cap and hydrothermal fluid weakly discharged. At first, we measured the temperature of hydrothermal fluid and the maximum temperature was 138.1°C. Since upper part of scale within the steel pipe seemed to be soft, we skipped to remove scale by chisel and tried to remove scale by hydraulic power drill. The IHPU and drill were successfully functioned and penetrated into ca. 4 cm, but marked oil leakage occurred from pipes of the hydraulic power drill. After trying to remove scale by drill several times, connection of the IHPU and host PC was stopped. Moreover, the electric circuit of the IHPU was also damaged and seawater invaded into the IHPU. Thus, we decided to stop this dive expedition.

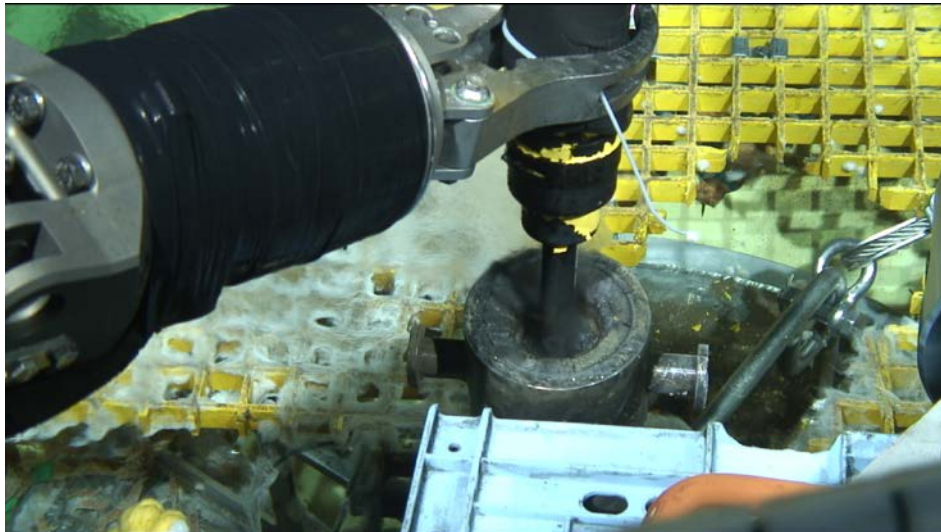
Fig. 3-18 Removing scale within the steel pipe by hydraulic power chisel.

After the arrival on a seafloor, ROV HPD again went to the artificial hydrothermal vent of Hole C0014G and continued to remove scale within the steel pipe of the corrosion cap by using a hydraulic power chisel, followed by temperature measurement whose maximum value was 270.7°C. Then, we tried to install the simplified flow meter on the steel pipe many times. However, the simplified flowmeter was not easy to handle by HPD3000 due to its height, weight and weight balance. Although we have tried to install the simplified flow meter many times, we could not attain to install it.
