# Hydrogeological and Geothermal studies around Nankai Trough (KR02-10 Nankai Trough Cruise Report)

**Keywords :** Nankai Trough, Seismogenic Zone, Advanced CORKs, Hydrogeological Studies, Geothermal Studies, Ocean Drilling Program

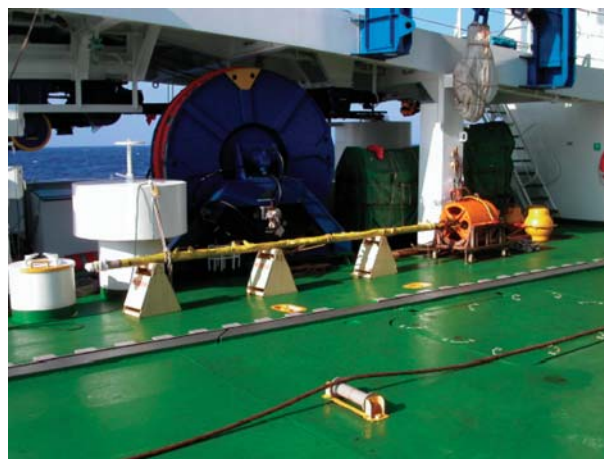
Fig. 5 Heat flow meter (HF) deployed in KR02-10.

meters (SAHF: Stand-Alone Heat Flow meter: Fig. 4) and ordinary heat flow meter (HF: Fig. 5). Since heat flow measurements at seafloor are known unstable where there are fluctuations in water-temperature, such fluctuations and heat flow must be monitored along for at least a year to obtain heat flow estimates.
