KAIYO Cruise Report

KY14-14

Construction of DONET2 system

Japan Agency for Marine-Earth Science and Technology

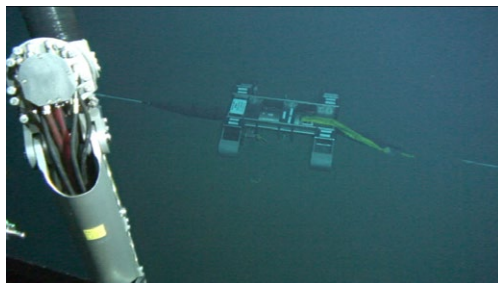
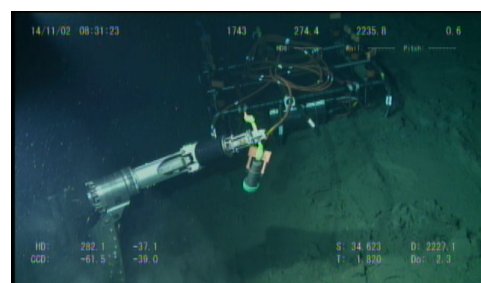
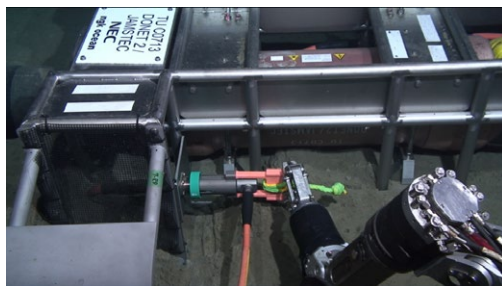
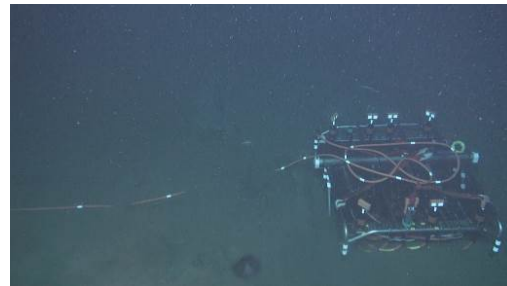
Fig. 5.1. Installation of the node at Area 2G.

This dive is the first dive of the ROV “Hyper Dolphin” (HPD) for DONET2 construction in this expedition. In this dive, a node has been deployed at 2G. After landing on the seafloor, the HPD moved toward the terminal unit installed by a cable ship and placed the node on the seafloor near the terminal unit. Then, the HPD pulled the underwater mateable connector from the node and took it to the terminal unit for connection. After the connection, it was confirmed in the landing station that the node is operated correctly. The figure shows the procedures of the installation operation. The position of the terminal unit is (32-41.507N, 134-31.027E, 2236m, ROV-Homer ID: 27) and the node is (32-41.500N, 134-31.031E, 2237m)

(a) Terminal unit

(b) The node installed on the seafloor

(c) Connection with the terminal

(d) After the connection

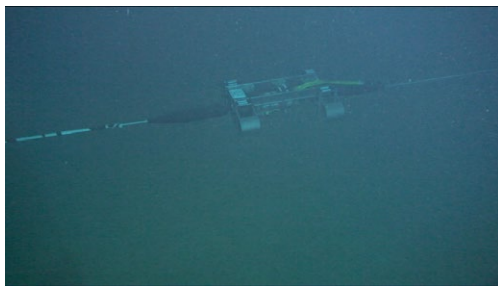
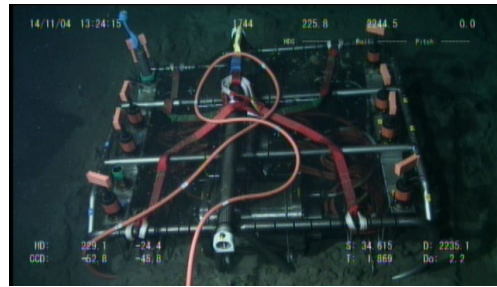
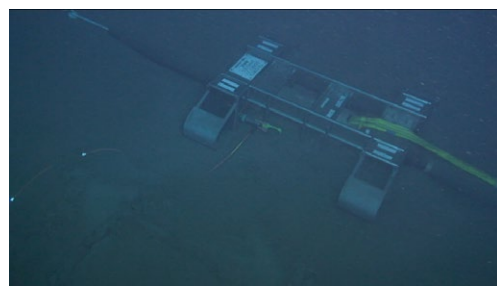
Fig. 5.2. Installation of the node at Area 2F.

In this dive, we installed a Node system at 2F. Before landing on the seafloor, we confirmed a condition of a Terminal Unit (TU) deployed by the cable laying vessel “Segero”. Then the HPD landed about 15 meters away from the TU. The Node system was deployed there. The HPD pulled the Underwater Mateable Connector (UMC) from the Node system using a manipulator equipped on the HPD and moved toward the TU with the UMC. The UMC was connected with the TU. After the connection, an establishment of communication with the land station was confirmed. The figures show the procedures of the installation operation. The position of the terminal unit is (32-54.964N, 135-14.088E, 2245 m,

(a) Terminal unit

(b) The node installed on the seafloor

(c) Connection with the terminal

(d) The Terminal unit after the connection

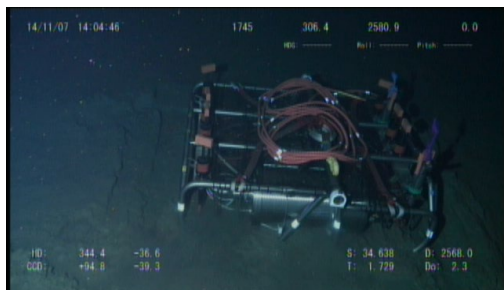
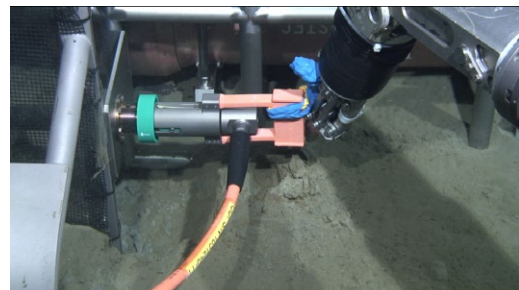
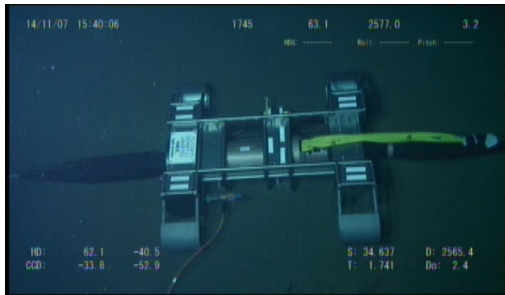
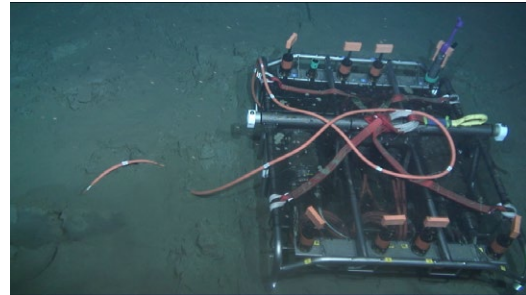
Fig. 5.3. Installation of the node at Area 2D.

In this dive, a node has been deployed at 2D. After landing on the seafloor, the HPD moved toward the terminal unit using an ROV-Homer (ID: 24) and placed the node on the seafloor near the terminal unit. Then, the HPD pulled the underwater mateable connector from the node and took it to the terminal unit for connection. It was confirmed that the node is operated correctly after the connection. The figure below shows the procedures of the installation operation. The position of the terminal unit is (33-05.746N, 135-47.869E, 2580m) and the node is (33-05.740N, 135-47.8614E, 258m)

(a) The node deployed on the seafloor

(b) Connection with the terminal unit

(c) The terminal unit after the connection

(d) The node after the connection

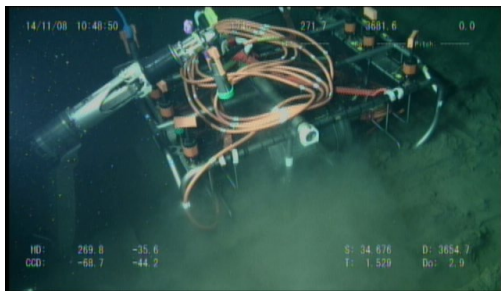
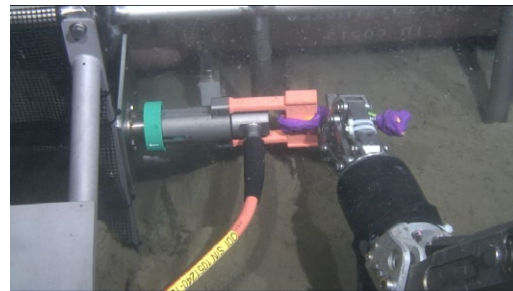
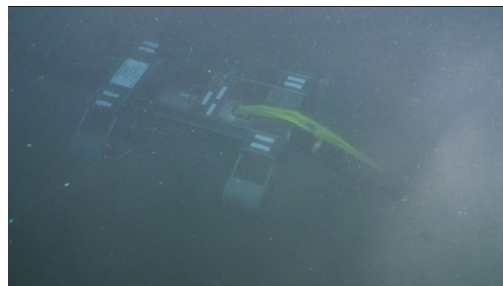
Fig. 5.4. Installation of the node at 2E

In this dive, we installed a Node system at 2E. Before landing on the seafloor, we confirmed a condition of a Terminal Unit (TU) deployed by the cable laying vessel “Segero”. Then the HPD landed about 17 meters away from the TU. The Node system was deployed there. The HPD pulled the Underwater Matable Connector (UMC) from the Node system using a manipulator equipped on the HPD and moved toward the TU with the UMC. The UMC was connected with the TU. After the connection, an establishment of communication with the land station was confirmed. The figures show the procedures of the installation operation. The position of the terminal unit is (32-54.543N, 135-45.067E, 3681 m, ROV-Homer ID: 25) and the Node is (32-52.536N, 135-45.064E, 3682 m)

(a) The node deployed on the seafloor

(b) Connection with the Terminal Unit

(c) The node after the connection

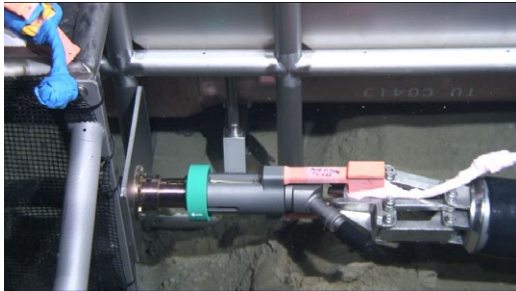
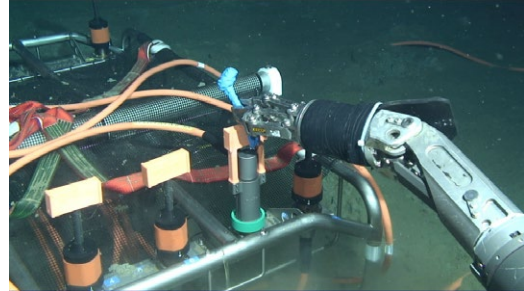
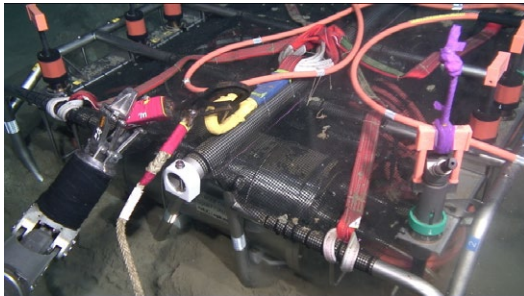
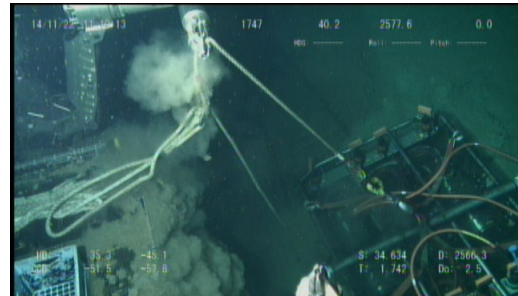
Fig. 5.5. Recovering process of Node 2D

A failure has been occurred on Node 2D during system test that was carried out on Nov. 10, 2014 after deploying all nodes of DONET2. A part of Node 2D or TU 2D is estimated to be the cause of the failure; however, it is difficult to identify the faulty place unless an evaluation node is connected to TU-2D; the faulty place will be a part of Node 2D if the evaluation node is operated correctly. In this dive, we have recovered Node 2D to install the evaluation node. The recovering process is as follows. After landing on the seafloor, the HPD first placed the weight of 150kg on the seafloor at a distance of 300m from Node 2D and moved toward Node 2D using an ROV-Homer (ID: 24). The HPD then landed on the seafloor close to TU 2D and pulled the connector of Node 2D from TU 2D. After that, a loopback connector was connected to TU 2D and the connector of Node 2D was collected to Node 2D with its cable. Lastly, the HPD connected the hook for recovery to Node 2D and ascended for recovery.

(a) Connecting a loopback connector to TU 2D

(b) Collecting the connector of Node 2D

(c) Connecting the hook for recovery to Node 2D

(d) Recovering

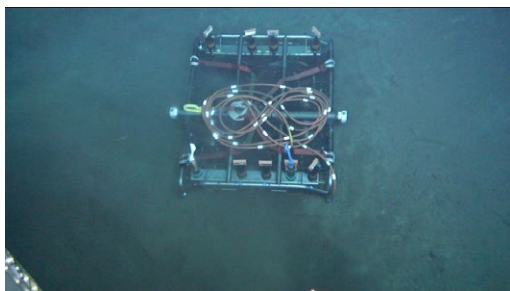
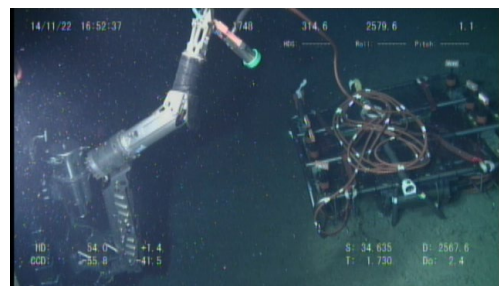
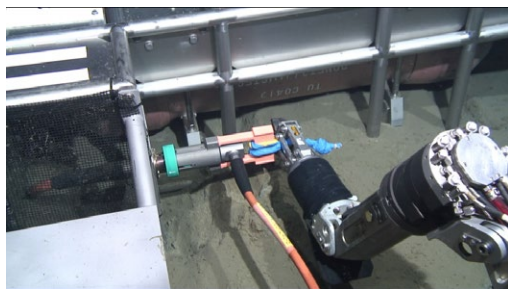
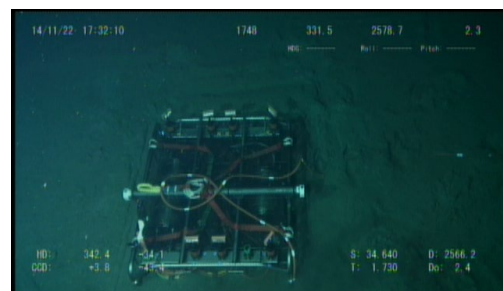
Fig. 5.6. Installation process of the Verification Node

In this dive, the Verification Node has been connected to TU 2D instead of the recovered Node 2D for fault diagnosis. After landing on the seafloor, the HPD moved toward TU 2D using an ROV-Homer (ID: 24) and placed the Verification Node on the seafloor near TU 2D. The HPD then pulled the connector from the Verification Node and took it to TU 2D for connection. It was confirmed through tests in the landing station that the faulty place is a part of TU 2D. As a result, the installed Verification Node will be recovered by the HPD on the next dive and TU 2D will also be recovered by a cable ship.

(a) The Verification Node on the seafloor

(b) Taking the connector to TU 2D for connection

(c) Connection with TU-2D

(d) The Verification Node after the connection

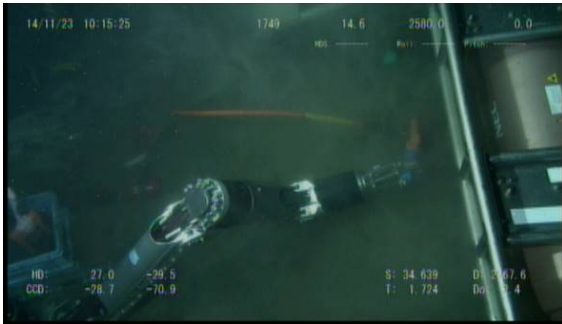
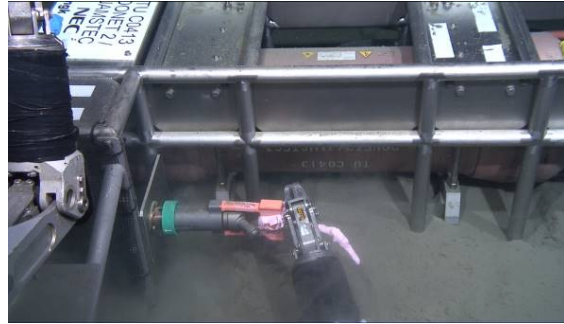
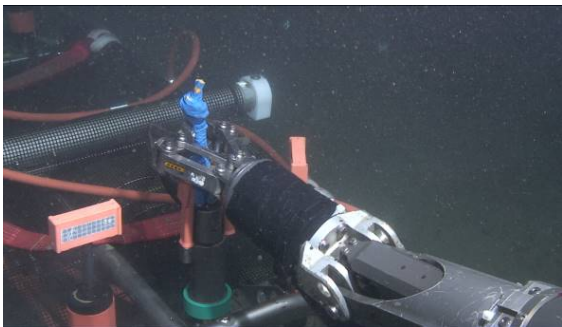
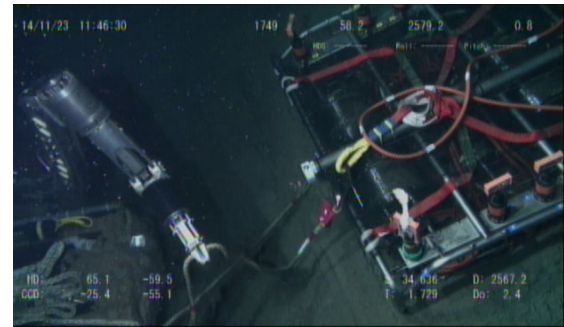
Fig. 5.7. Recovering process of the Verification Node

In this dive, the Verification Node was recovered. After landing on the seafloor, the HPD deployed the sinker of 150kg on the seafloor at a distance of 300m from the Verification Node and moved toward TU 2D using an ROV-Homer (ID: 24). The HPD landed close to TU 2D and pulled the Underwater Matable Connector (UMC) of the Verification Node from TU 2D. After that, a loopback connector was connected with TU 2D and the connector of the Verification Node was collected with its cable. Lastly, the HPD connected the hook for recovery to the Verification Node and ascended for recovery.

(a) Pulling out the UMC from TU-2D.

(b) Connecting a loopback connector to TU 2D

(c) Connected the UMC to the Verification Node.

(d) Connecting the hook for recovery

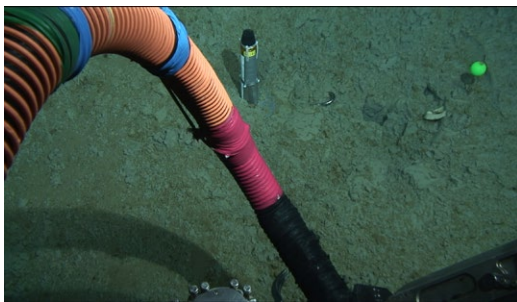
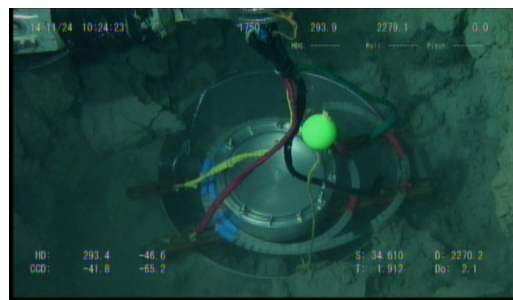
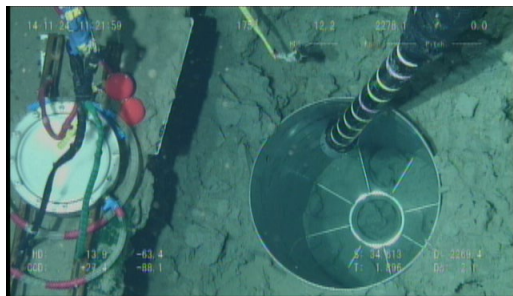
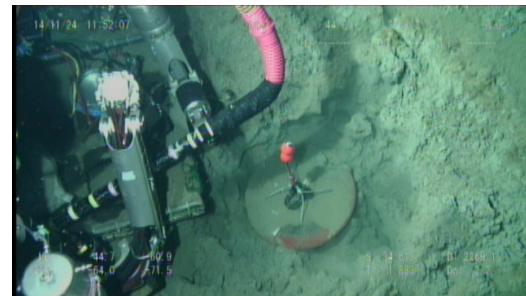
Fig. 5.8. Remove the sediment in the caisson

In this dive, ROV Hyper Dolphin (HPD) was operated around the observatory site 2F-25. Measuring the casing tilt angle and cleaning inside of the casing was objectives of this dive. For the first objective, the measured casing tilt angle was less than 10 degrees. Therefore it was confirmed that the casing was installed properly. Sediments in the casing was then removed using a suction pump equipped with the ROV. Finally, the casing cover plate was deployed on the casing.

(a) Initial state

(b) Casing tilt angle measurement

(c) Cleaned casing

(d) Casing cover

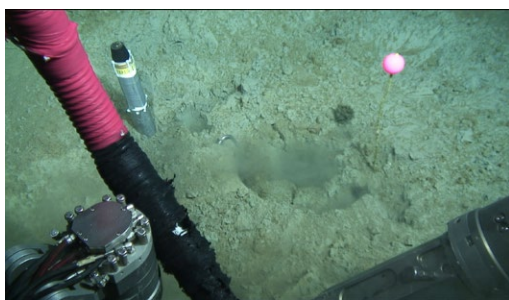
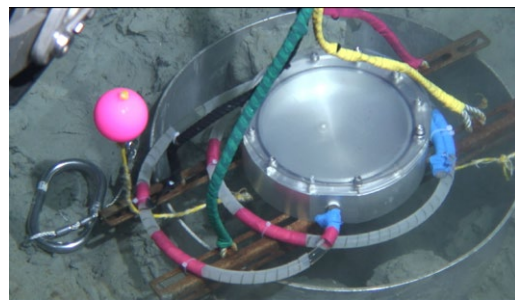
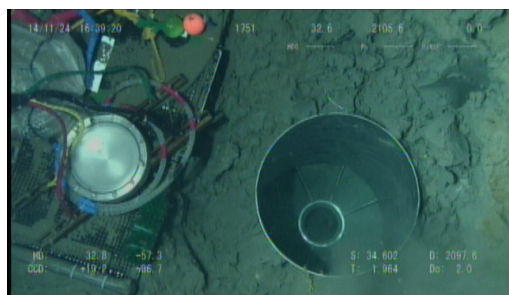
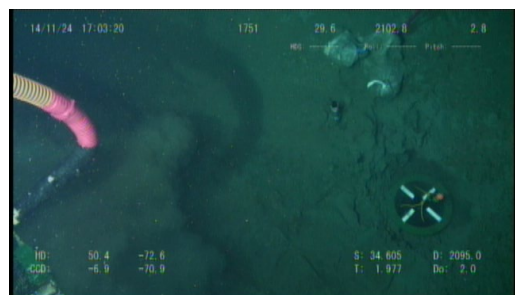
In this dive, ROV Hyper Dolphin (HPD) was operated around the observatory site 2F-22. The mission objective is measuring the casing tilt angle and cleaning inside of the casing. First, the casing tilt angle was measured and confirmed that it is less than 10 degrees. Sediments in the casing was then removed using a suction pump equipped with the ROV. Finally, the casing cover plate was deployed on the casing.

(a) Before cleaning

(b) Measuring the tilting angle.

(c) After cleaning.

(d) The lid was put on the casing

Fig. 5.9. Measuring the tilting angle and cleaning of the casing 2F-22.

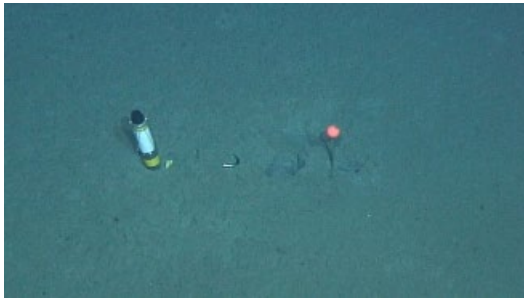
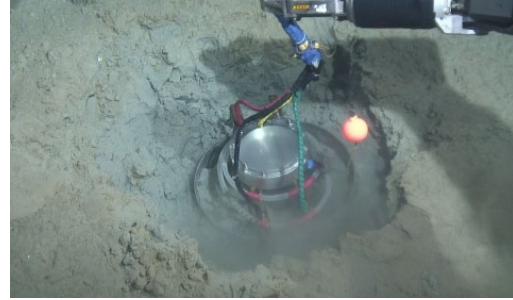
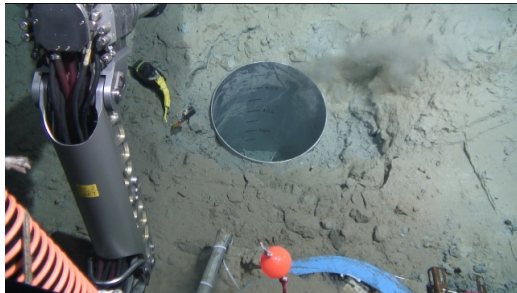
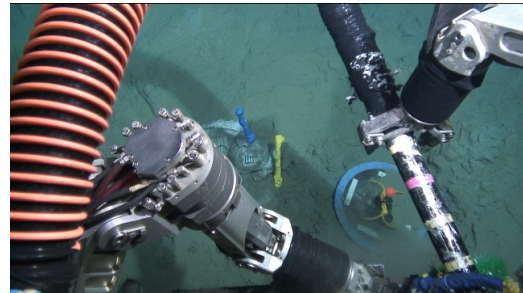
In this dive, ROV Hyper Dolphin (HPD) was operated around the observatory site 2G-26. The mission objective is measuring the casing tilt angle and cleaning inside of the casing. First, the casing tilt angle was measured and confirmed that it is less than 10 degrees. Sediments in the casing was then removed using a suction pump equipped with the ROV. Finally, the casing cover plate was deployed on the casing. This installation taken time than usually for cleaning inside of the casing.

(a) Before cleaning

(b) Measuring the tilting angle

(c) After cleaning.

(d) The lid was put on the casing

Fig. 5.10. Measuring the tilting angle and cleaning of the casing 2G-26.

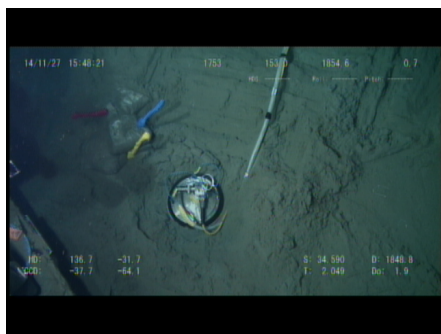
In this dive, we installed an observatory at 2G-26 using the HPD. The observatory system consists of a seismometer package, a pressure sensor package, and a battery equipment. After landing on the seafloor, the seismometer package was first installed inside the caisson and the pressure sensor package was then placed on the seafloor at a distance of approximately 9m from the seismometer package. After that, the battery equipment was put on the seafloor next to the pressure sensor package. Finally, the HPD connected the battery equipment to the pressure package linking with the seismometer package using the underwater mateable connector. Before taking off, the HPD moved the ROV Homer (ID: 45) from near the seismometer package to near the pressure sensor package and the covering plate placed on the caisson was recovered.

(a) Seismometer package

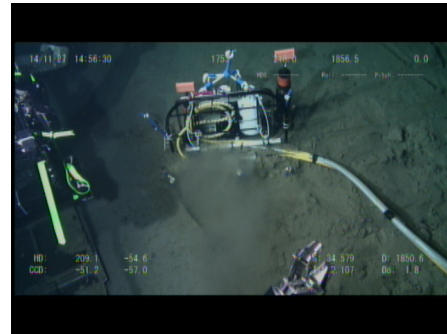
(b) Pressure sensor package

Fig. 5.11. Observatory installation at 2G-26.

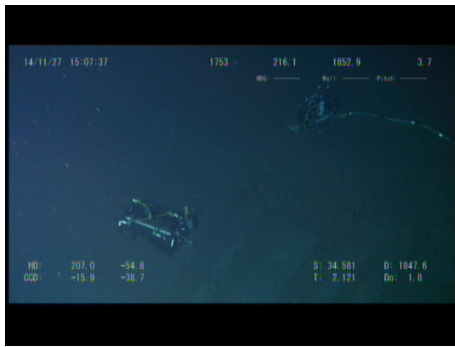
(c) Battery equipment

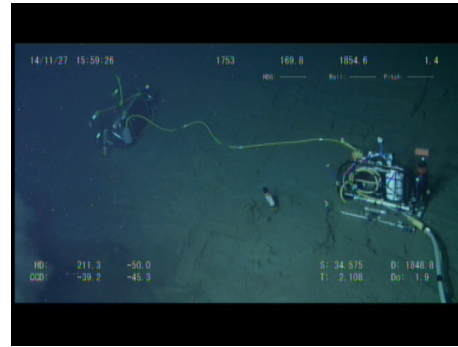
(d) After connection with the battery equipment

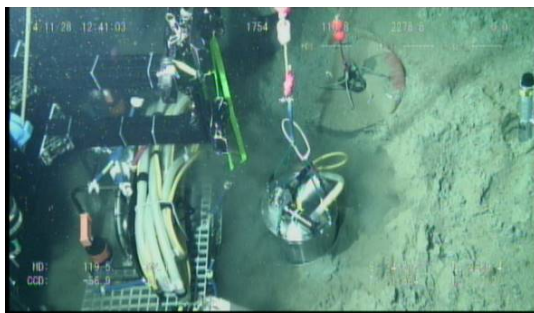
(a) Installation of the seismometer package

Fig. 5.12. Observatory installation at 2F-25c

In this dive, we installed an observatory at 2F-25 using the HPD. The observatory system consists of a seismometer package, a pressure sensor package, and a battery equipment. After landing on the seafloor, the seismometer package was first installed inside the caisson and the pressure sensor package was placed on the seafloor at a distance of approximately 9m from the seismometer package. After that, the battery equipment was put on the seafloor next to the pressure sensor package. Finally, the HPD connected the battery equipment to the pressure package linking with the seismometer package using the underwater mateable connector. Before taking off, the HPD moved the ROV Homer (ID: 42) from near the seismometer package to near the pressure sensor package and the covering plate placed on the caisson was recovered.

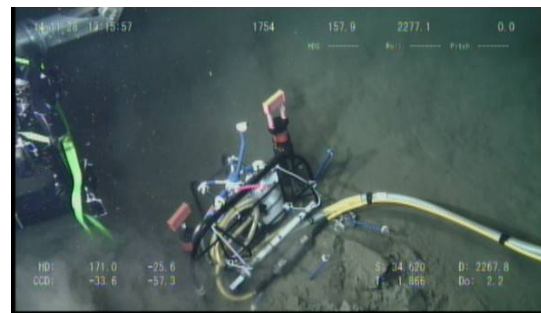
(b) Pressure sensor package

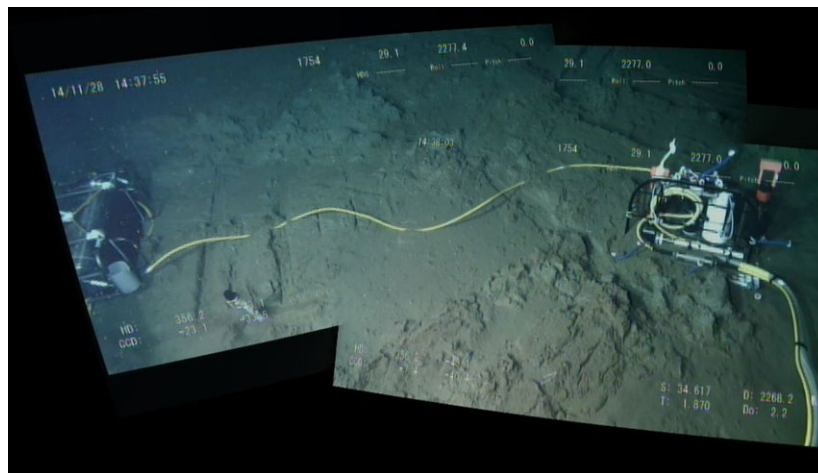
(c) After connection with the battery equipment

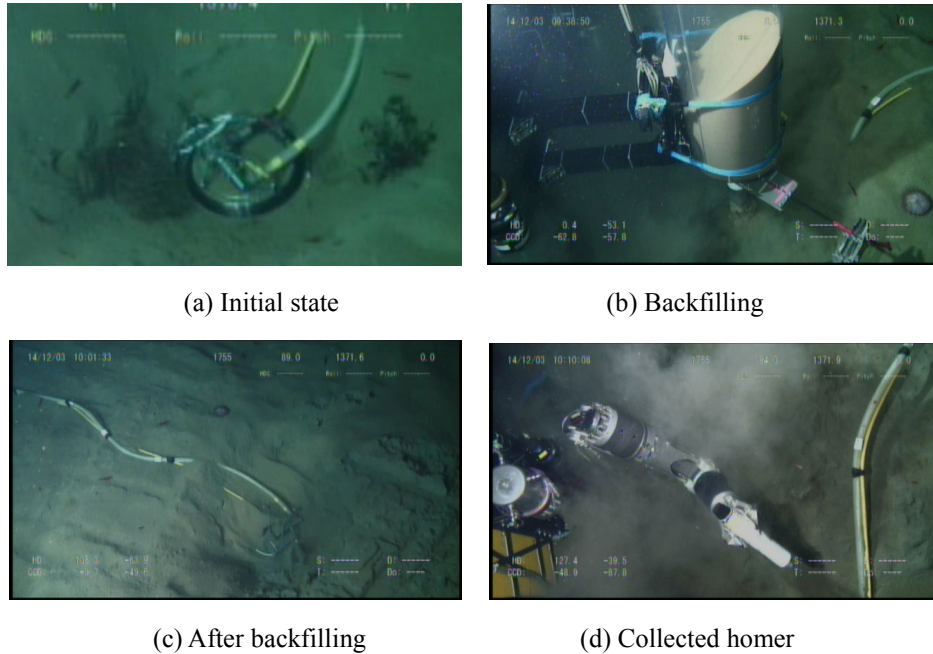
Fig. 5.13. Backfilling of the seismometer at the observatory 2A-4

In this dive, ROV Hyper Dolphin (HPD) was operated around the observatory 2A-4. This dive objective is backfilling the seismometer casing of observatory 2A-4 by sand. Backfilling is conducted in order to

reduce the measurement noise. In addition, the deployed homer is collected because this dive completes the 2A-4 observatory development.

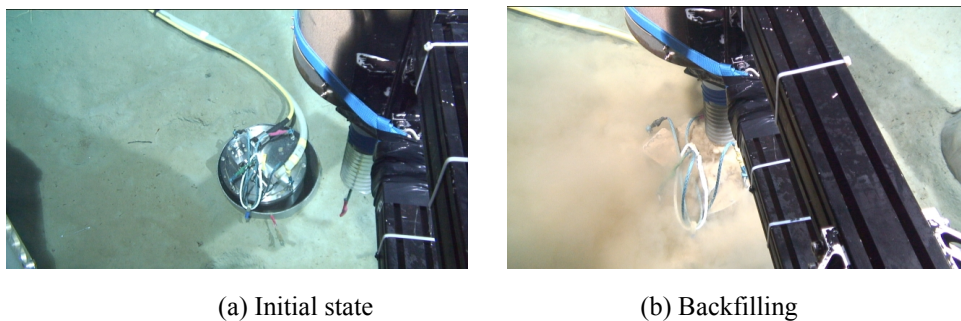
Fig. 5.14. Backfilling of the seismometer at the observatory 2B-8

In this dive, ROV Hyper Dolphin (HPD) was operated around the planned observatory 2B-8. This dive objective is backfilling the seismometer casing of observatory 2B-8 by sand. Backfilling is conducted in order to reduce the measurement noise. In addition, the deployed homer is collected because this dive completes the 2B-8 observatory development.

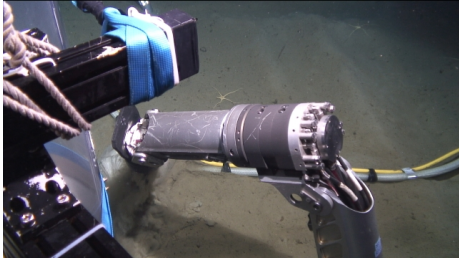
(c) After backfilling

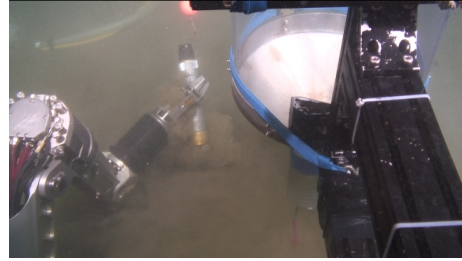
(d) Collected homer
